Profile/Photo Observation Report

Date:	04/27/2018	Weather:		Coding:	PACP 6.0
Pipe Length (ft):		Owner:	City of Hobart	Pre Clean:	No Pre-Cleaning
P.O.#:	119	Surveyor:	M. Pielacha	PSR:	P-404-028.1-028
Customer:	City of Hobart	Clean Date:		Shape:	C

Street:	Old Ridge Road	Flow Control:	Not Controlled
City:	Hobart, IN	Year Renewed:	
Location:	Light Highway	Tape/Media #:	DEP 119
Purpose:	Routine Assessment	Dia/Height:	6"
Use:	Sanitary	Material:	PVC
Drain Area:		Lining:	
Category:	NA		
Comment:	YES501824 Submittal 2		
Location Details:		Direction of Survey:	Upstream
US MH:	M-404-028.1	DS MH:	M-404-028
		Total Length Surveyed (ft):	48.4

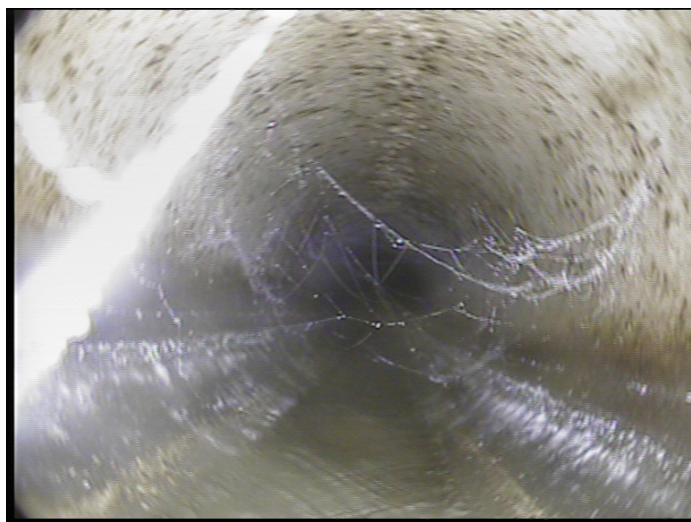
Code: **AMH**
Description: **Manhole**

Distance (ft): **.0**
Structural Grade: **0**
O&M Grade: **0**
Clock Start/From:
Clock To:
1st Value:
2nd Value:
Value Percent:
Continuous Index:
Within 8" of Joint: **NO**
Remarks: **M-404-028**

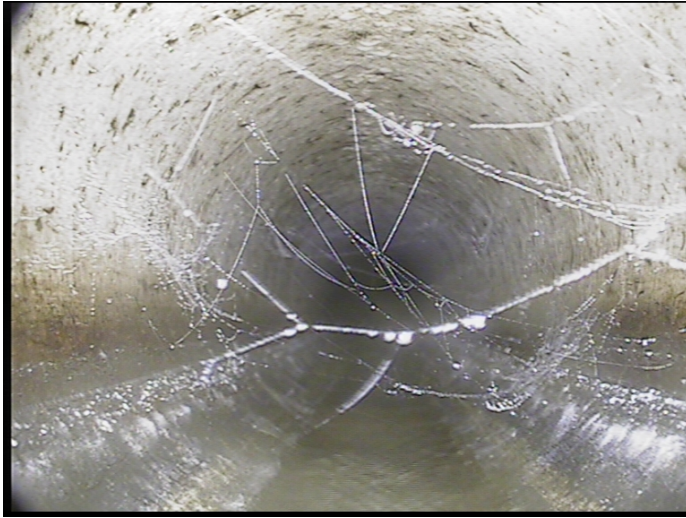
Code: **MWL**
Description: **Water Level**

Distance (ft): **.0**
Structural Grade: **0**
O&M Grade: **0**
Clock Start/From:
Clock To:
1st Value:
2nd Value:
Value Percent: **5.000**
Continuous Index:
Within 8" of Joint: **NO**
Remarks:

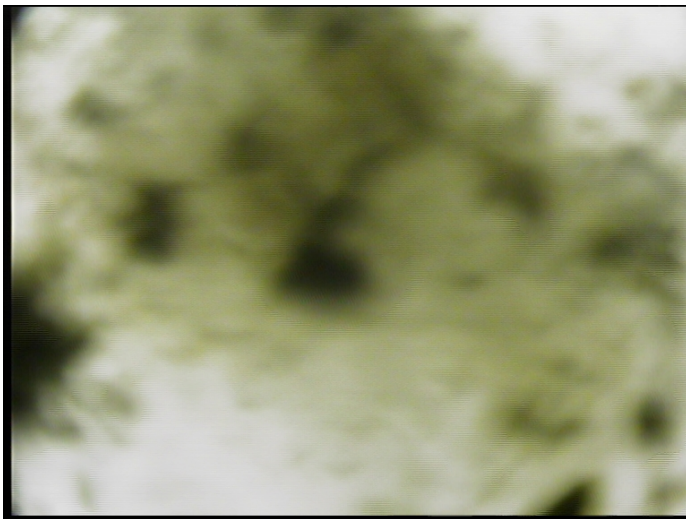
Code: **MCU**
Description: **Camera Underwater**

Distance (ft): **34.8**
Structural Grade: **0**
O&M Grade: **4**
Clock Start/From:
Clock To:
1st Value:
2nd Value:
Value Percent:
Continuous Index:
Within 8" of Joint: **NO**
Remarks:

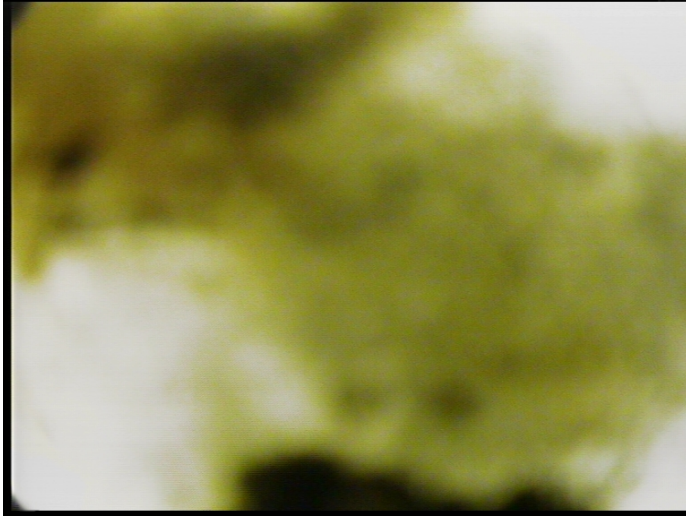
Code:	DSF
Description:	Deposits Settled Fine
Distance (ft):	45.2
Structural Grade:	0
O&M Grade:	3
Clock Start/From:	5
Clock To:	7
1st Value:	
2nd Value:	
Value Percent:	20.000
Continuous Index:	
Within 8" of Joint:	NO
Remarks:
