Profile/Photo Observation Report

Date:	09/09/2021	Weather:		Coding:	PACP 7.0
Pipe Length (ft):	301.5	Owner:	City of Hobart	Pre Clean:	Heavy Cleaning
P.O.#:	YES502259	Surveyor:	S. Bucklin	PSR:	P-404-029-028
Customer:	City of Hobart	Clean Date:	09/09/2021	Shape:	C

Street:	North Clark Street	Flow Control:	Not Controlled
City:	Hobart, IN	Year Renewed:	
Location:	Local rural streets with light traffic, t	Tape/Media #:	
Purpose:	Routine Assessment	Dia/Height:	12"
Use:	Sanitary Sewage Pipe	Material:	VCP
Drain Area:		Lining:	None
Category:	NA		
Comment:			
Location Details:		Direction of Survey:	Downstream
US MH:	M-404-028	DS MH:	M-404-029
		Total Length Surveyed (ft):	301.5

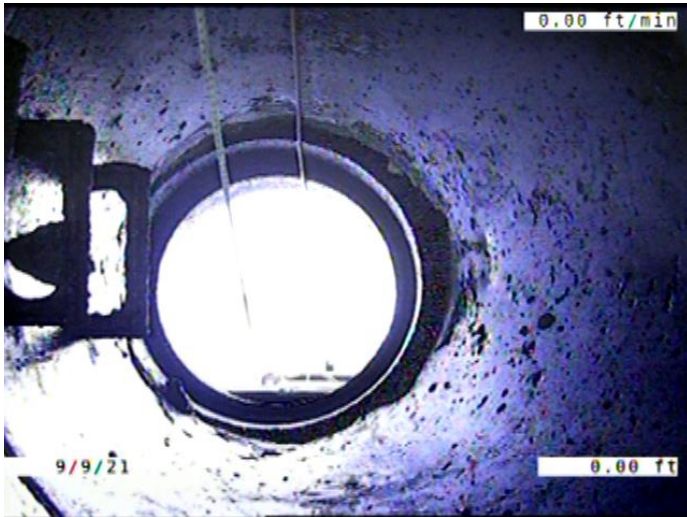
Code: **AMH**
 Description: **Manhole**

Distance (ft): **.0**
 Structural Grade: **0**
 O&M Grade: **0**
 Clock Start/From:
 Clock To:
 1st Value:
 2nd Value:
 Value Percent:
 Continuous Index:
 Within 8" of Joint: **NO**
 Remarks: **M-404-028**

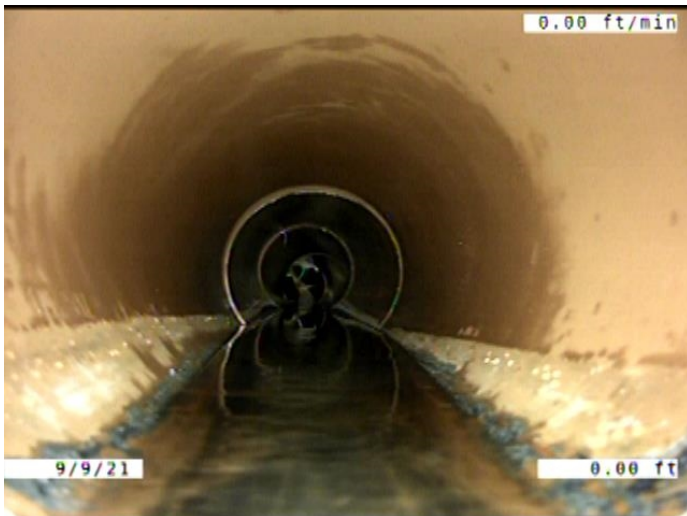
Code: **MWL**
 Description: **Miscellaneous Water Level**

Distance (ft): **.0**
 Structural Grade: **0**
 O&M Grade: **0**
 Clock Start/From:
 Clock To:
 1st Value:
 2nd Value:
 Value Percent: **5.000**
 Continuous Index:
 Within 8" of Joint: **NO**
 Remarks:

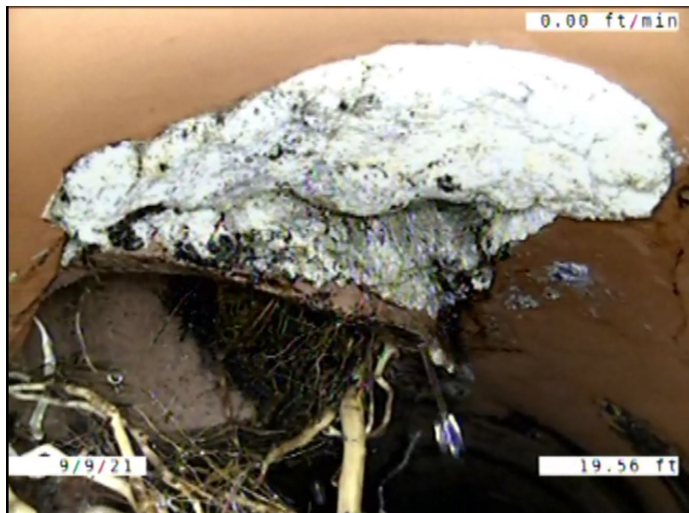
Code: **CM**
 Description: **Crack Multiple**

Distance (ft): **19.6**
 Structural Grade: **3**
 O&M Grade: **0**
 Clock Start/From: **2**
 Clock To: **4**
 1st Value:
 2nd Value:
 Value Percent:
 Continuous Index:
 Within 8" of Joint: **NO**
 Remarks:

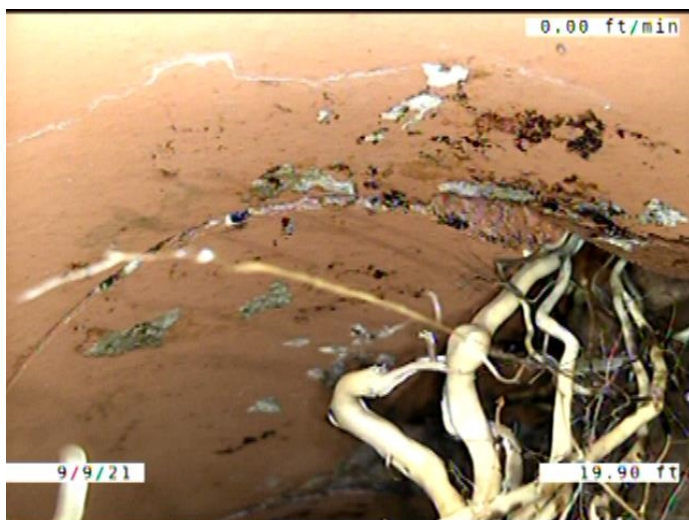
Code: **B**
 Description: **Broken**

Distance (ft): **19.9**
 Structural Grade: **4**
 O&M Grade: **0**
 Clock Start/From: **8**
 Clock To: **12**
 1st Value:
 2nd Value:
 Value Percent:
 Continuous Index:
 Within 8" of Joint: **YES**
 Remarks:

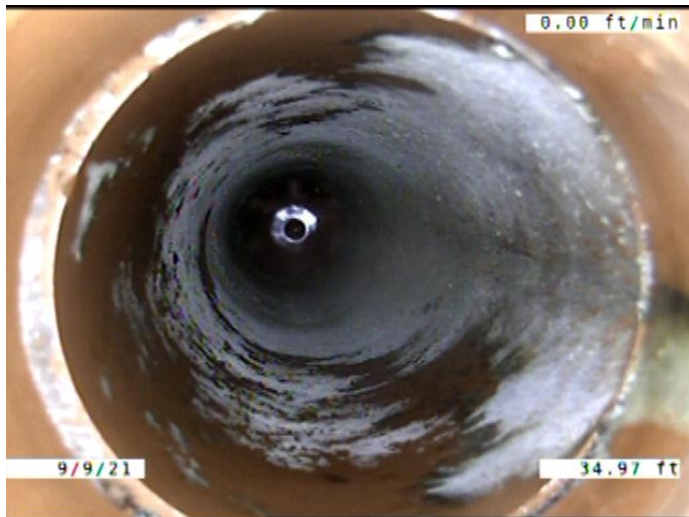
Code: **TFC**
 Description: **Tap Factory Capped**

Distance (ft): **35.0**
 Structural Grade: **0**
 O&M Grade: **0**
 Clock Start/From: **2**
 Clock To:
 1st Value: **4.000**
 2nd Value:
 Value Percent:
 Continuous Index:
 Within 8" of Joint: **YES**
 Remarks:

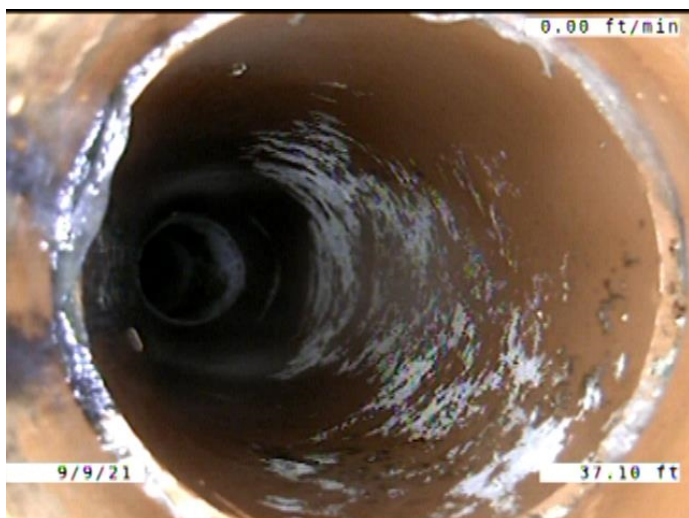
Code: **TF**
 Description: **Tap Factory**

Distance (ft): **37.1**
 Structural Grade: **0**
 O&M Grade: **0**
 Clock Start/From: **10**
 Clock To:
 1st Value: **4.000**
 2nd Value:
 Value Percent:
 Continuous Index:
 Within 8" of Joint: **YES**
 Remarks: **CONSTANTLY RUNNING WATER**

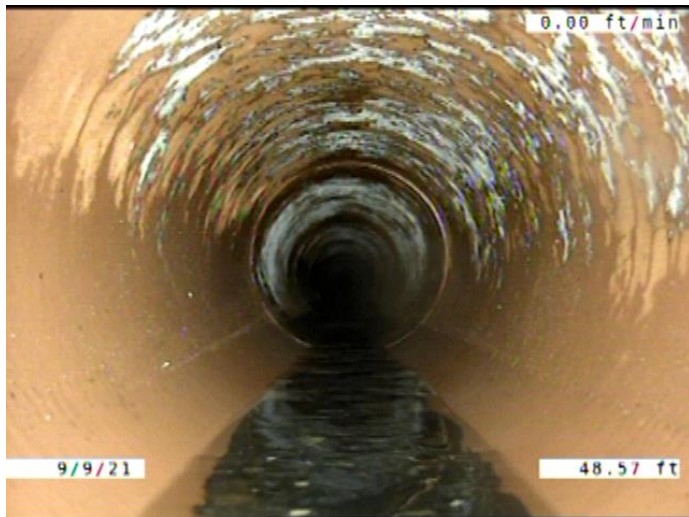
Code: **DSF**
 Description: **Deposits Settled Fine**

Distance (ft): **48.6**
 Structural Grade: **0**
 O&M Grade: **2**
 Clock Start/From: **5**
 Clock To: **7**
 1st Value:
 2nd Value:
 Value Percent: **5.000**
 Continuous Index: **S01**
 Within 8" of Joint: **YES**
 Remarks:

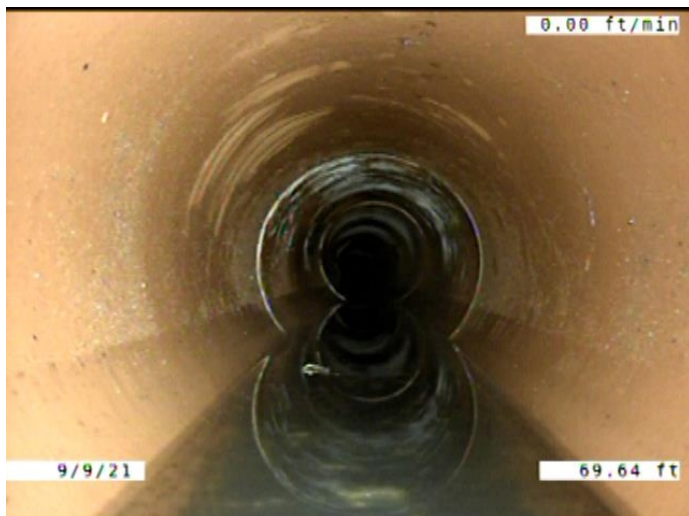
Code: **MWLS**
 Description: **Miscellaneous Water Level Sag**

Distance (ft): **69.6**
 Structural Grade: **2**
 O&M Grade: **0**
 Clock Start/From:
 Clock To:
 1st Value:
 2nd Value:
 Value Percent: **5.000**
 Continuous Index: **S02**
 Within 8" of Joint: **NO**
 Remarks:

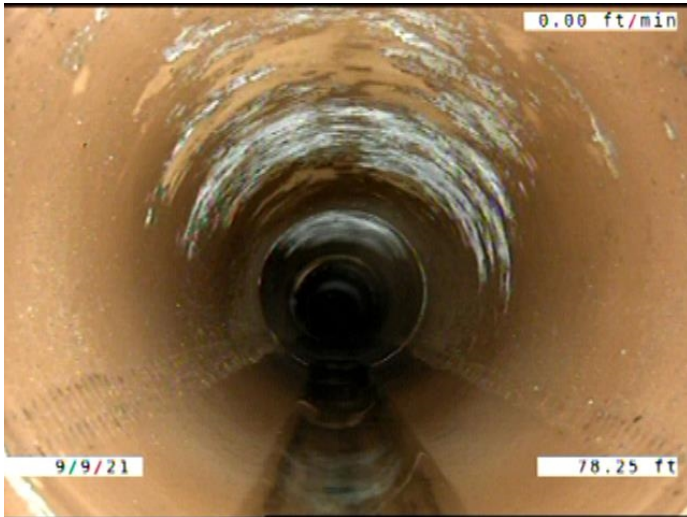
Code: **MWLS**
 Description: **Miscellaneous Water Level Sag**

Distance (ft): **78.3**
 Structural Grade: **2**
 O&M Grade: **0**
 Clock Start/From:
 Clock To:
 1st Value:
 2nd Value:
 Value Percent: **5.000**
 Continuous Index: **F02**
 Within 8" of Joint: **NO**
 Remarks:

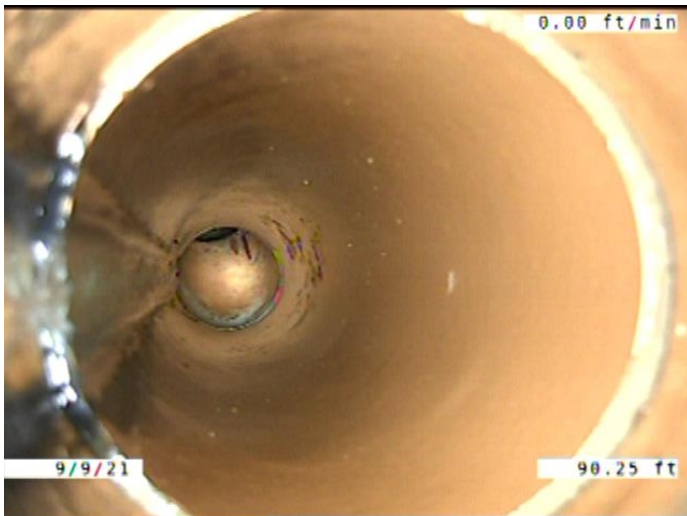
Code: **TF**
 Description: **Tap Factory**

Distance (ft): **90.2**
 Structural Grade: **0**
 O&M Grade: **0**
 Clock Start/From: **10**
 Clock To:
 1st Value: **4.000**
 2nd Value:
 Value Percent:
 Continuous Index:
 Within 8" of Joint: **YES**
 Remarks: **CONSTANTLY RUNNING WATER**

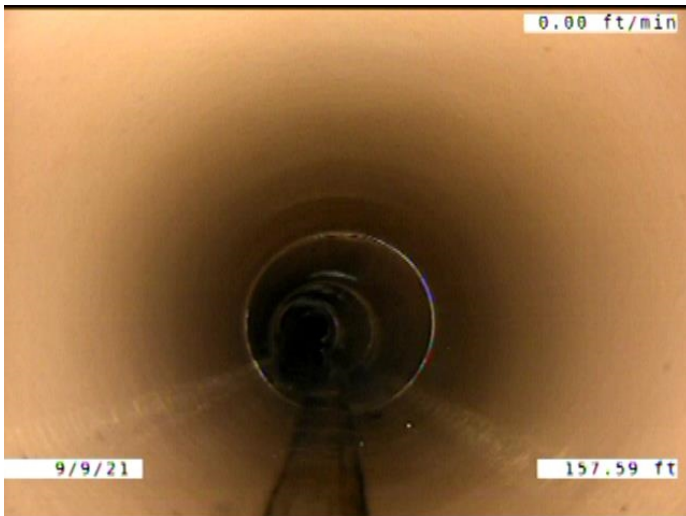
Code: **MWLS**
Description: **Miscellaneous Water Level Sag**

Distance (ft): **157.6**
Structural Grade: **2**
O&M Grade: **0**
Clock Start/From:
Clock To:
1st Value:
2nd Value:
Value Percent: **10.000**
Continuous Index: **F04**
Within 8" of Joint: **NO**
Remarks:

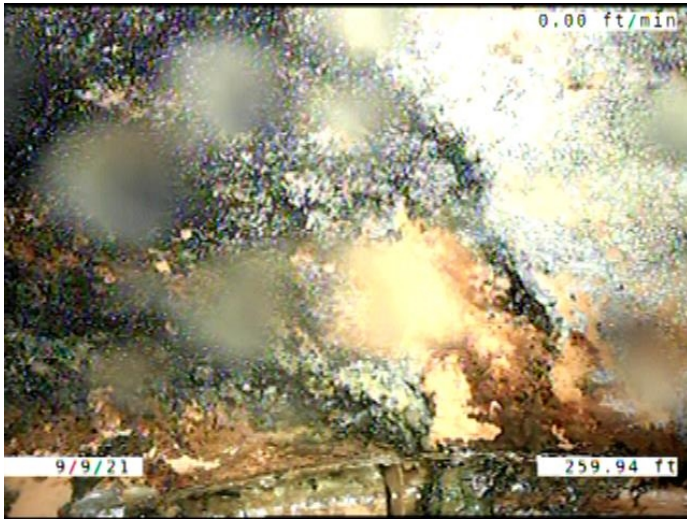
Code: **DAE**
 Description: **Deposits Attached Encrustation**

Distance (ft): **259.9**
 Structural Grade: **0**
 O&M Grade: **2**
 Clock Start/From: **7**
 Clock To: **4**
 1st Value:
 2nd Value:
 Value Percent: **5.000**
 Continuous Index:
 Within 8" of Joint: **YES**
 Remarks:

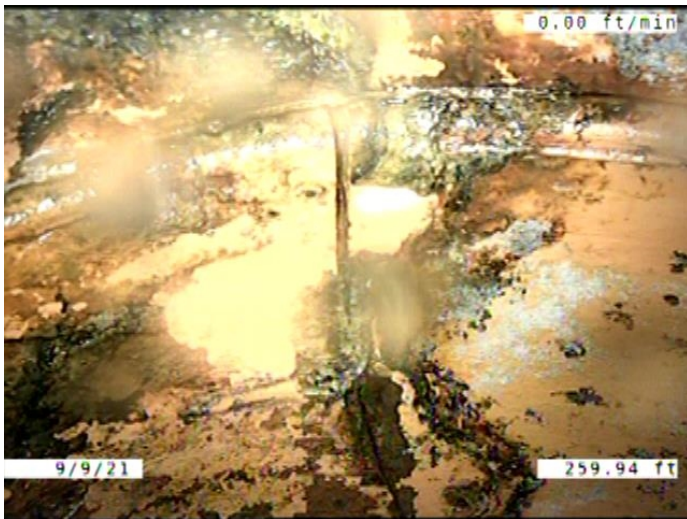
Code: **FS**
 Description: **Fracture Spiral**

Distance (ft): **259.9**
 Structural Grade: **3**
 O&M Grade: **0**
 Clock Start/From: **10**
 Clock To: **2**
 1st Value:
 2nd Value:
 Value Percent:
 Continuous Index:
 Within 8" of Joint: **YES**
 Remarks:

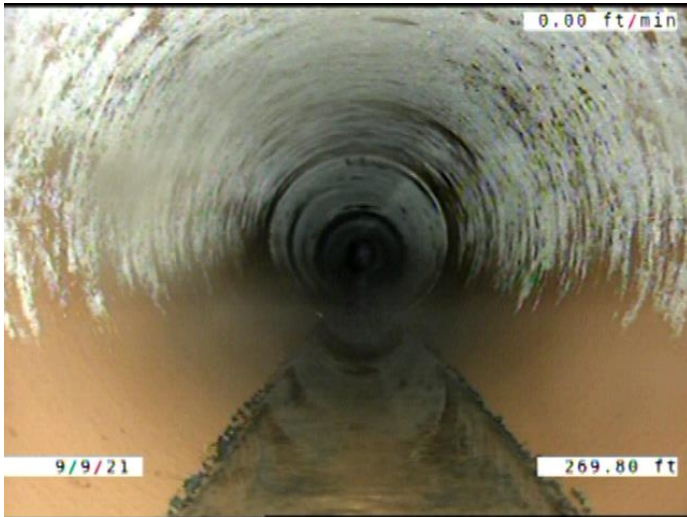
Code: **MWLS**
 Description: **Miscellaneous Water Level Sag**

Distance (ft): **269.8**
 Structural Grade: **2**
 O&M Grade: **0**
 Clock Start/From:
 Clock To:
 1st Value:
 2nd Value:
 Value Percent: **5.000**
 Continuous Index:
 Within 8" of Joint: **NO**
 Remarks:

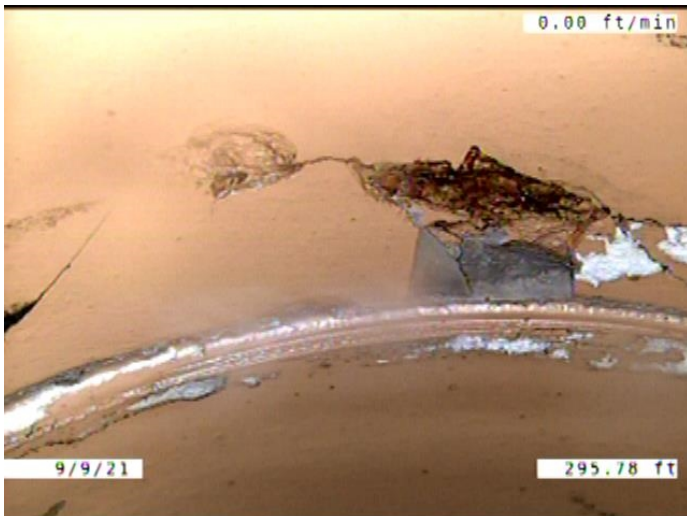
Code: **CM**
 Description: **Crack Multiple**

Distance (ft): **295.8**
 Structural Grade: **3**
 O&M Grade: **0**
 Clock Start/From: **7**
 Clock To: **10**
 1st Value:
 2nd Value:
 Value Percent:
 Continuous Index:
 Within 8" of Joint: **YES**
 Remarks:

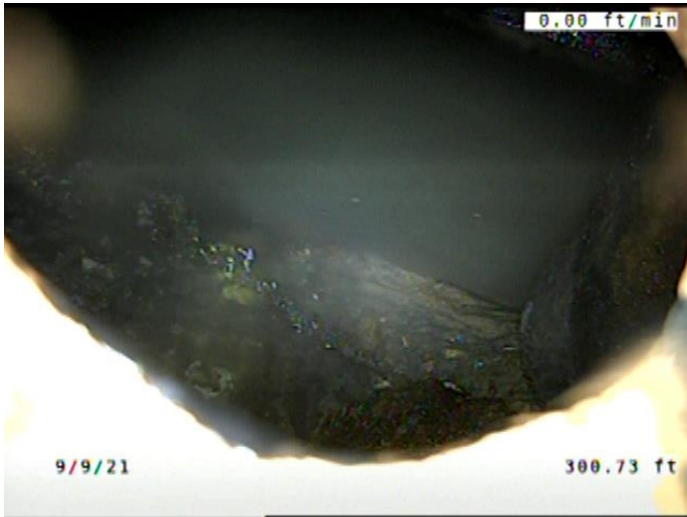
Code: **HVV**
 Description: **Hole Void Visible**

Distance (ft): **300.7**
 Structural Grade: **5**
 O&M Grade: **0**
 Clock Start/From: **4**
 Clock To: **7**
 1st Value:
 2nd Value:
 Value Percent:
 Continuous Index:
 Within 8" of Joint: **YES**
 Remarks:

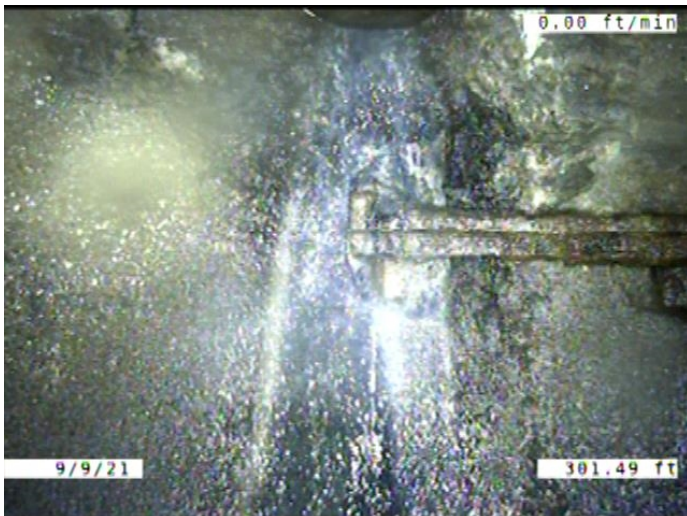
Code: **DSF**
 Description: **Deposits Settled Fine**

Distance (ft): **301.5**
 Structural Grade: **0**
 O&M Grade: **2**
 Clock Start/From: **5**
 Clock To: **7**
 1st Value:
 2nd Value:
 Value Percent: **5.000**
 Continuous Index: **F01**
 Within 8" of Joint: **YES**
 Remarks:

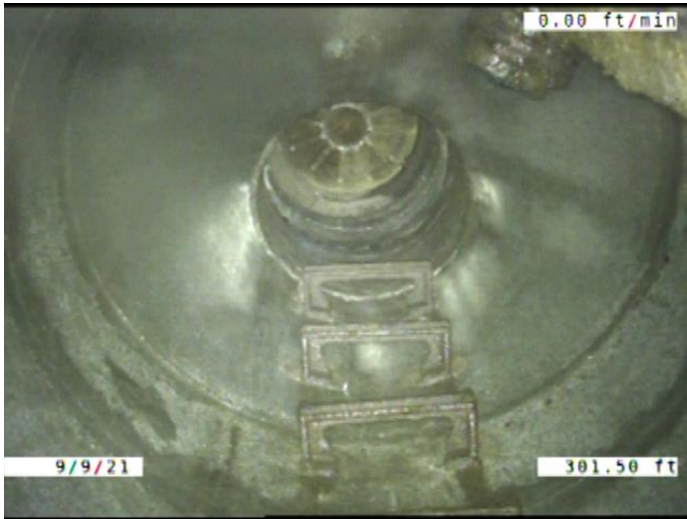
Code:	AMH
Description:	Manhole
Distance (ft):	301.5
Structural Grade:	0
O&M Grade:	0
Clock Start/From:	
Clock To:	
1st Value:	
2nd Value:	
Value Percent:	
Continuous Index:	
Within 8" of Joint:	NO
Remarks:	M-404-029
