## Profile/Photo Observation Report

Date:	<b>09/09/2021</b>	Weather:		Coding:	<b>PACP 7.0</b>
Pipe Length (ft):	<b>301.5</b>	Owner:	<b>City of Hobart</b>	Pre Clean:	<b>Heavy Cleaning</b>
P.O.#:	<b>YES502259</b>	Surveyor:	<b>S. Bucklin</b>	PSR:	<b>P-404-029-028</b>
Customer:	<b>City of Hobart</b>	Clean Date:	<b>09/09/2021</b>	Shape:	<b>C</b>

Street:	<b>North Clark Street</b>	Flow Control:	<b>Not Controlled</b>
City:	<b>Hobart, IN</b>	Year Renewed:	
Location:	<b>Local rural streets with light traffic, t</b>	Tape/Media #:	
Purpose:	<b>Routine Assessment</b>	Dia/Height:	<b>12"</b>
Use:	<b>Sanitary Sewage Pipe</b>	Material:	<b>VCP</b>
Drain Area:		Lining:	<b>None</b>
Category:	<b>NA</b>		
Comment:			
Location Details:		Direction of Survey:	<b>Downstream</b>
US MH:	<b>M-404-028</b>	DS MH:	<b>M-404-029</b>
		Total Length Surveyed (ft):	<b>301.5</b>

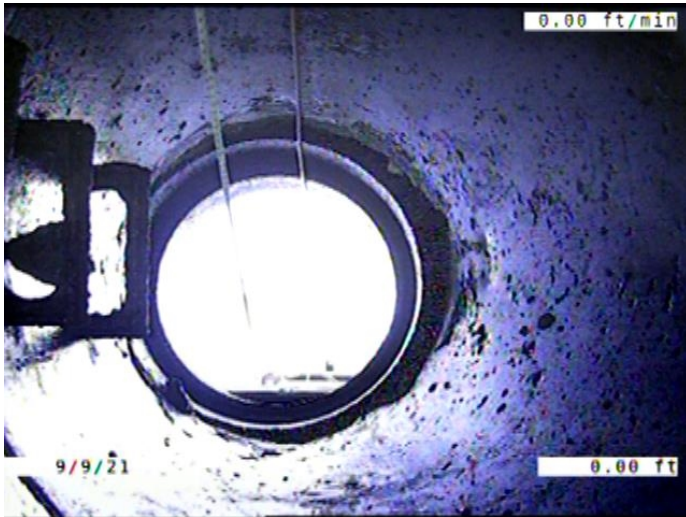
Code: **AMH**  
Description: **Manhole**

Distance (ft): **.0**  
Structural Grade: **0**  
O&M Grade: **0**  
Clock Start/From:  
Clock To:  
1st Value:  
2nd Value:  
Value Percent:  
Continuous Index:  
Within 8" of Joint: **NO**  
Remarks: **M-404-028**

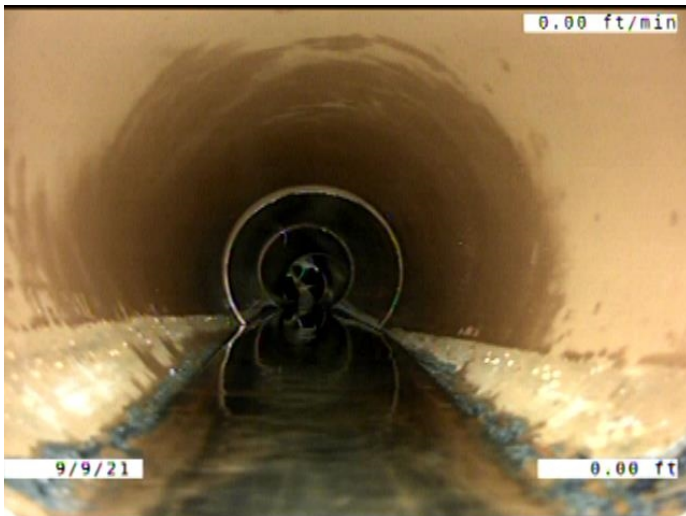
Code: **MWL**  
Description: **Miscellaneous Water Level**

Distance (ft): **.0**  
Structural Grade: **0**  
O&M Grade: **0**  
Clock Start/From:  
Clock To:  
1st Value:  
2nd Value:  
Value Percent: **5.000**  
Continuous Index:  
Within 8" of Joint: **NO**  
Remarks:

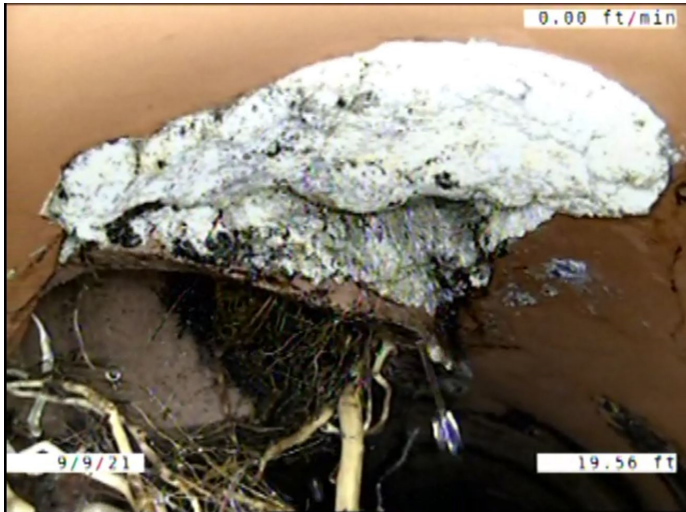
Code: **CM**  
 Description: **Crack Multiple**

Distance (ft): **19.6**  
 Structural Grade: **3**  
 O&M Grade: **0**  
 Clock Start/From: **2**  
 Clock To: **4**  
 1st Value:  
 2nd Value:  
 Value Percent:  
 Continuous Index:  
 Within 8" of Joint: **NO**  
 Remarks:

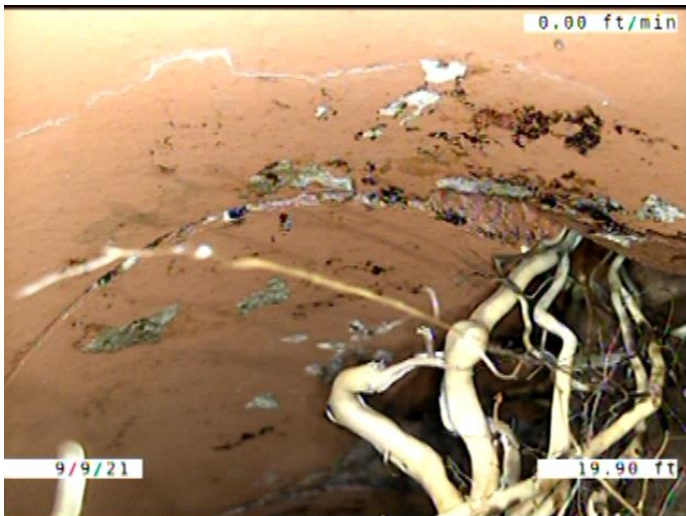
Code: **B**  
 Description: **Broken**

Distance (ft): **19.9**  
 Structural Grade: **4**  
 O&M Grade: **0**  
 Clock Start/From: **8**  
 Clock To: **12**  
 1st Value:  
 2nd Value:  
 Value Percent:  
 Continuous Index:  
 Within 8" of Joint: **YES**  
 Remarks:

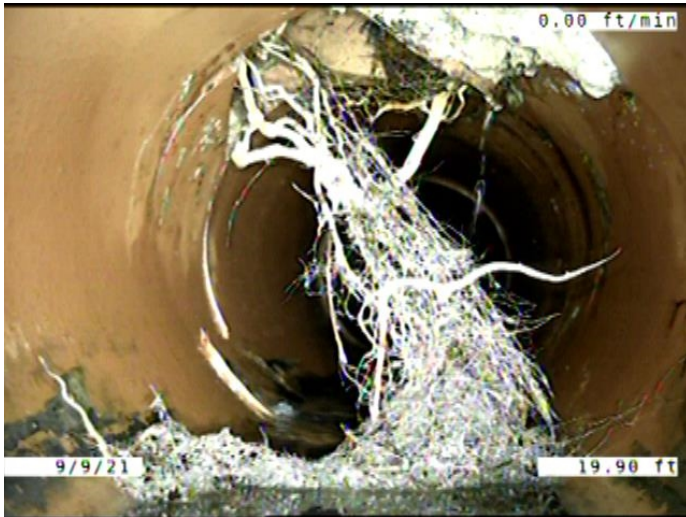
Code: **RMC**  
 Description: **Roots Medium Connection**

Distance (ft): **19.9**  
 Structural Grade: **0**  
 O&M Grade: **3**  
 Clock Start/From: **10**  
 Clock To: **1**  
 1st Value:  
 2nd Value:  
 Value Percent: **10.000**  
 Continuous Index:  
 Within 8" of Joint: **NO**  
 Remarks:

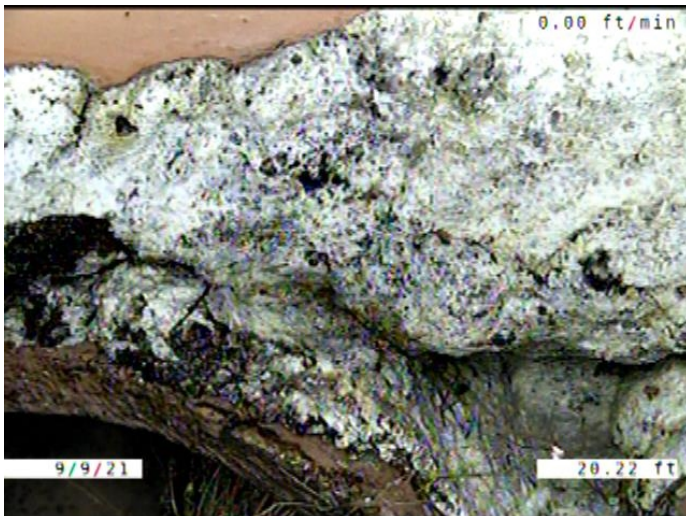
Code: **DAE**  
 Description: **Deposits Attached Encrustation**

Distance (ft): **20.2**  
 Structural Grade: **0**  
 O&M Grade: **2**  
 Clock Start/From: **11**  
 Clock To: **2**  
 1st Value:  
 2nd Value:  
 Value Percent: **5.000**  
 Continuous Index:  
 Within 8" of Joint: **NO**  
 Remarks:

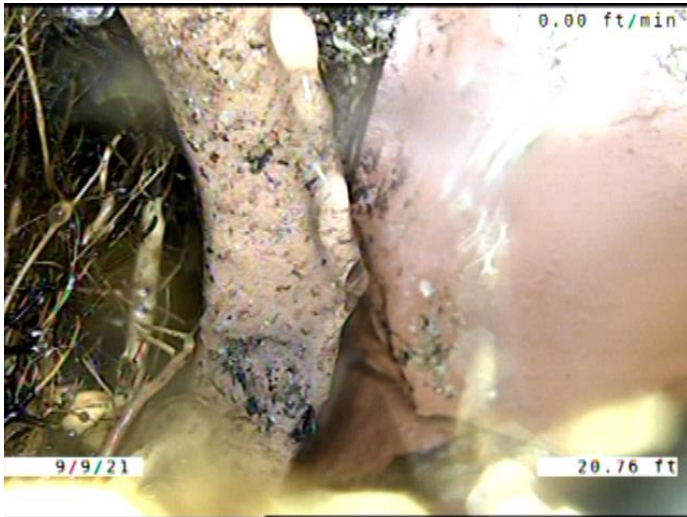
Code: **IRC**  
 Description: **Infiltration Runner Connection**

Distance (ft): **20.8**  
 Structural Grade: **0**  
 O&M Grade: **4**  
 Clock Start/From: **1**  
 Clock To:  
 1st Value:  
 2nd Value:  
 Value Percent:  
 Continuous Index:  
 Within 8" of Joint: **NO**  
 Remarks:

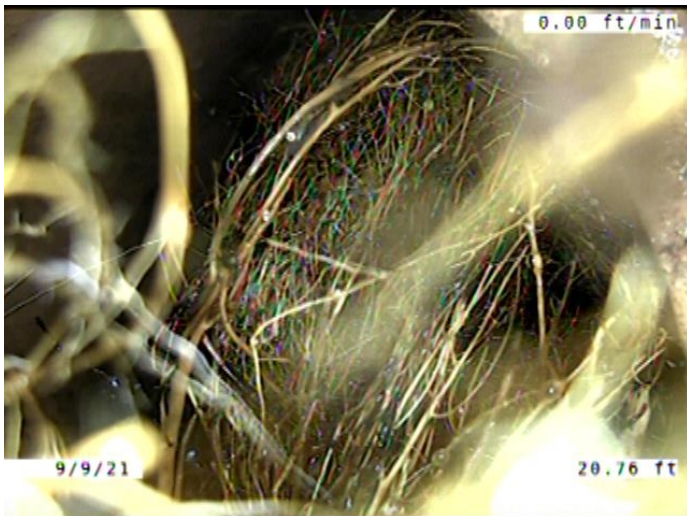
Code: **TBI**  
 Description: **Tap Break-in Intruding**

Distance (ft): **20.8**  
 Structural Grade: **0**  
 O&M Grade: **2**  
 Clock Start/From: **12**  
 Clock To:  
 1st Value: **4.000**  
 2nd Value: **1.000**  
 Value Percent:  
 Continuous Index:  
 Within 8" of Joint: **NO**  
 Remarks: **LOOKS TO BE 100% PLUGGED WITH ROOTS**

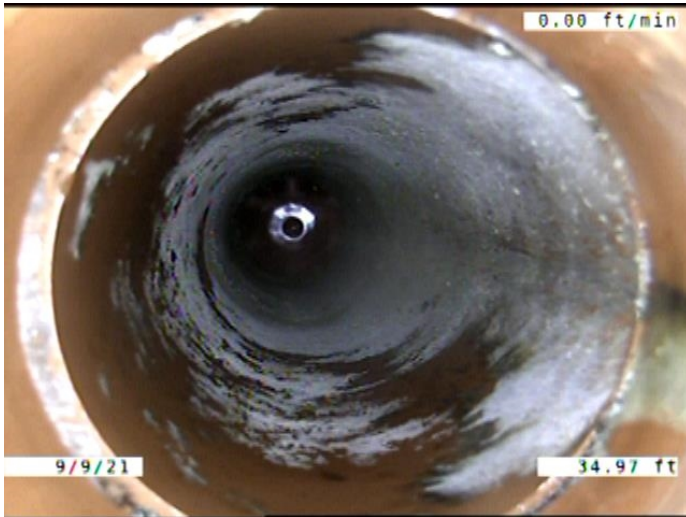
Code: **TFC**  
 Description: **Tap Factory Capped**

Distance (ft): **35.0**  
 Structural Grade: **0**  
 O&M Grade: **0**  
 Clock Start/From: **2**  
 Clock To:  
 1st Value: **4.000**  
 2nd Value:  
 Value Percent:  
 Continuous Index:  
 Within 8" of Joint: **YES**  
 Remarks:

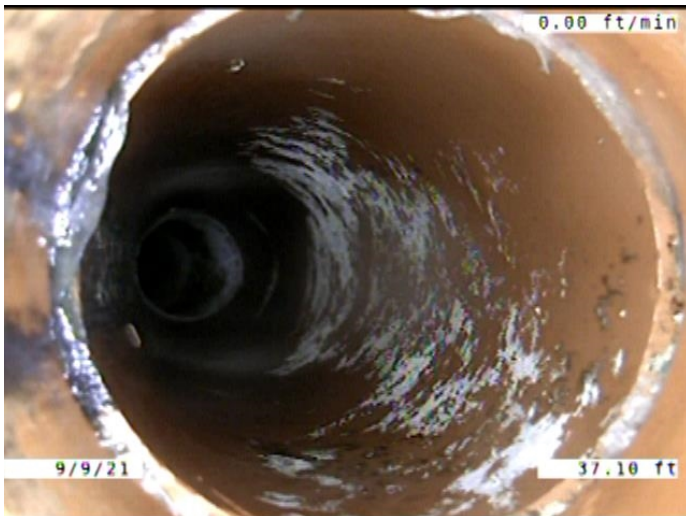
Code: **TF**  
 Description: **Tap Factory**

Distance (ft): **37.1**  
 Structural Grade: **0**  
 O&M Grade: **0**  
 Clock Start/From: **10**  
 Clock To:  
 1st Value: **4.000**  
 2nd Value:  
 Value Percent:  
 Continuous Index:  
 Within 8" of Joint: **YES**  
 Remarks: **CONSTANTLY RUNNING WATER**

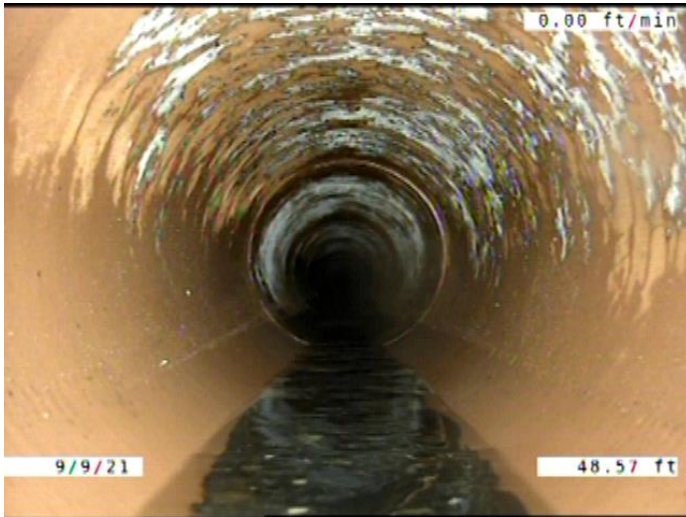
Code: **DSF**  
 Description: **Deposits Settled Fine**

Distance (ft): **48.6**  
 Structural Grade: **0**  
 O&M Grade: **2**  
 Clock Start/From: **5**  
 Clock To: **7**  
 1st Value:  
 2nd Value:  
 Value Percent: **5.000**  
 Continuous Index: **S01**  
 Within 8" of Joint: **YES**  
 Remarks:

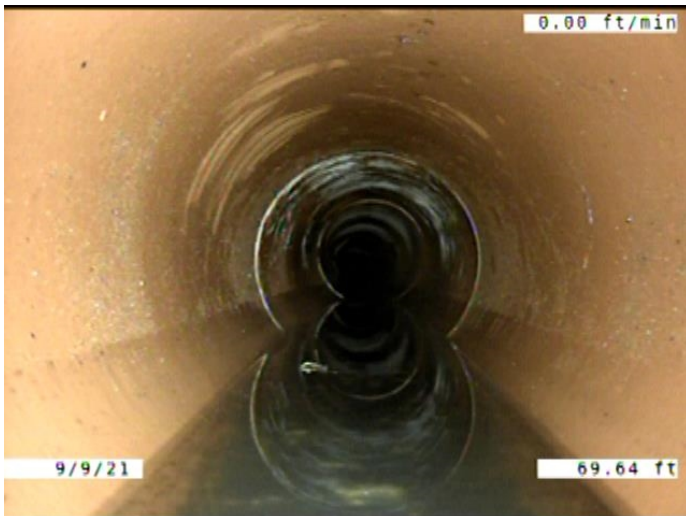
Code: **MWLS**  
 Description: **Miscellaneous Water Level Sag**

Distance (ft): **69.6**  
 Structural Grade: **2**  
 O&M Grade: **0**  
 Clock Start/From:  
 Clock To:  
 1st Value:  
 2nd Value:  
 Value Percent: **5.000**  
 Continuous Index: **S02**  
 Within 8" of Joint: **NO**  
 Remarks:

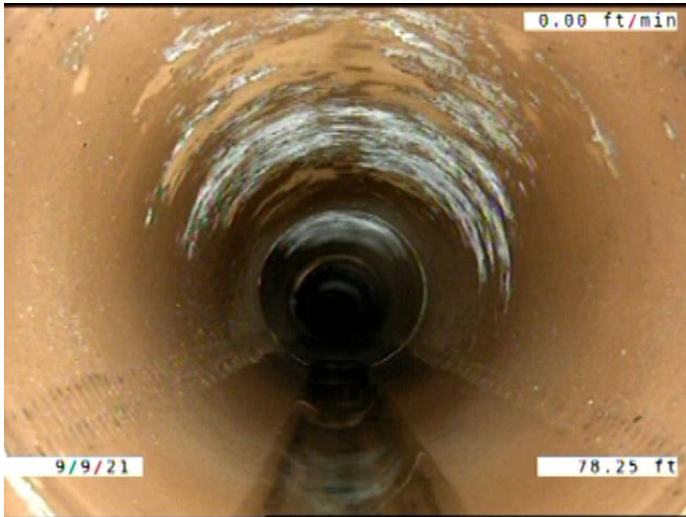
Code: **MWLS**  
 Description: **Miscellaneous Water Level Sag**

Distance (ft): **78.3**  
 Structural Grade: **2**  
 O&M Grade: **0**  
 Clock Start/From:  
 Clock To:  
 1st Value:  
 2nd Value:  
 Value Percent: **5.000**  
 Continuous Index: **F02**  
 Within 8" of Joint: **NO**  
 Remarks:

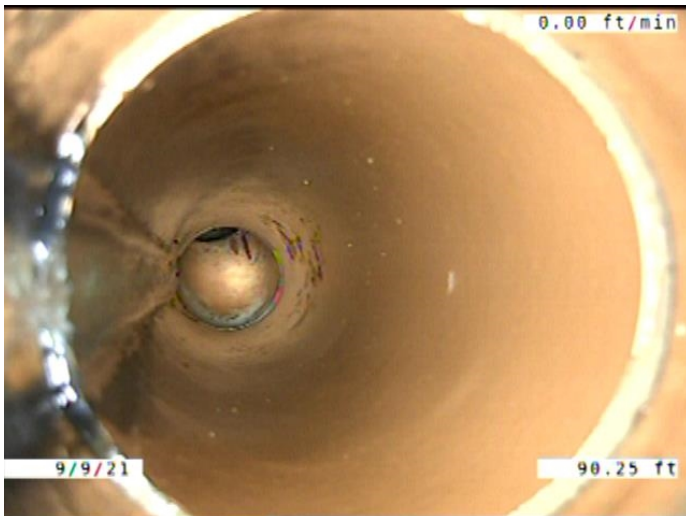
Code: **TF**  
 Description: **Tap Factory**

Distance (ft): **90.2**  
 Structural Grade: **0**  
 O&M Grade: **0**  
 Clock Start/From: **10**  
 Clock To:  
 1st Value: **4.000**  
 2nd Value:  
 Value Percent:  
 Continuous Index:  
 Within 8" of Joint: **YES**  
 Remarks: **CONSTANTLY RUNNING WATER**

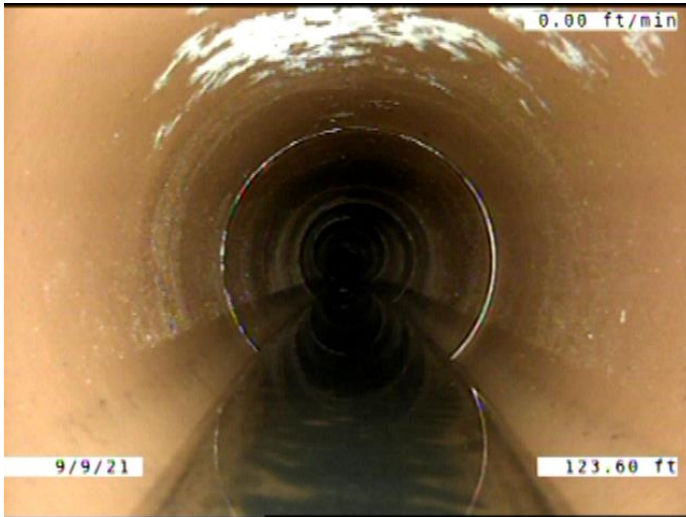
Code: **MWLS**  
Description: **Miscellaneous Water Level Sag**

Distance (ft): **123.6**  
Structural Grade: **2**  
O&M Grade: **0**  
Clock Start/From:  
Clock To:  
1st Value:  
2nd Value:  
Value Percent: **5.000**  
Continuous Index: **S03**  
Within 8" of Joint: **NO**  
Remarks:

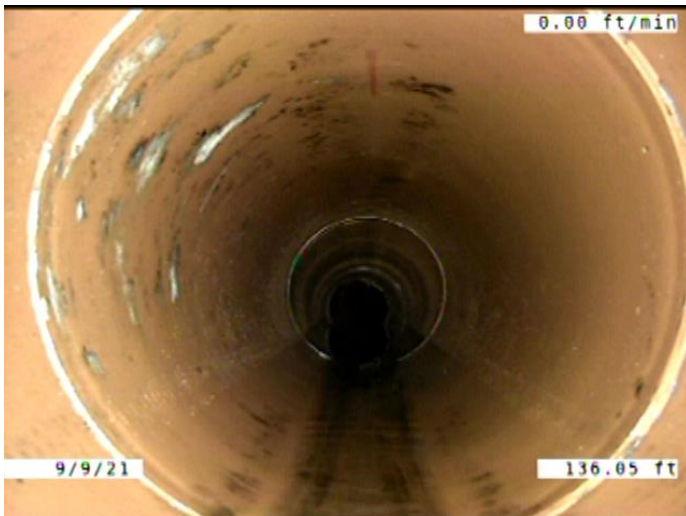
Code: **MWLS**  
Description: **Miscellaneous Water Level Sag**

Distance (ft): **136.1**  
Structural Grade: **2**  
O&M Grade: **0**  
Clock Start/From:  
Clock To:  
1st Value:  
2nd Value:  
Value Percent: **5.000**  
Continuous Index: **F03**  
Within 8" of Joint: **NO**  
Remarks:

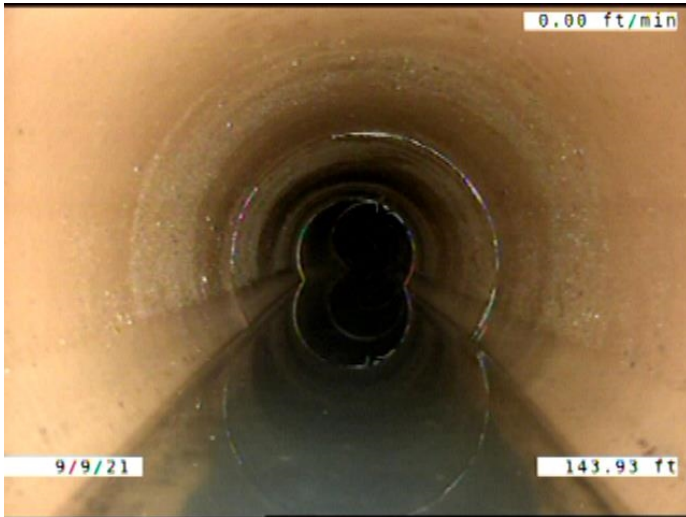
Code: **MWLS**  
Description: **Miscellaneous Water Level Sag**

Distance (ft): **143.9**  
Structural Grade: **2**  
O&M Grade: **0**  
Clock Start/From:  
Clock To:  
1st Value:  
2nd Value:  
Value Percent: **10.000**  
Continuous Index: **S04**  
Within 8" of Joint: **NO**  
Remarks:

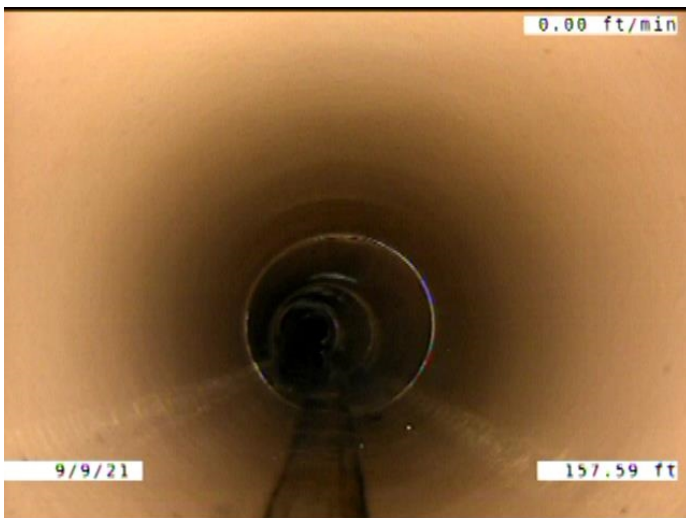
Code: **MWLS**  
Description: **Miscellaneous Water Level Sag**

Distance (ft): **157.6**  
Structural Grade: **2**  
O&M Grade: **0**  
Clock Start/From:  
Clock To:  
1st Value:  
2nd Value:  
Value Percent: **10.000**  
Continuous Index: **F04**  
Within 8" of Joint: **NO**  
Remarks:

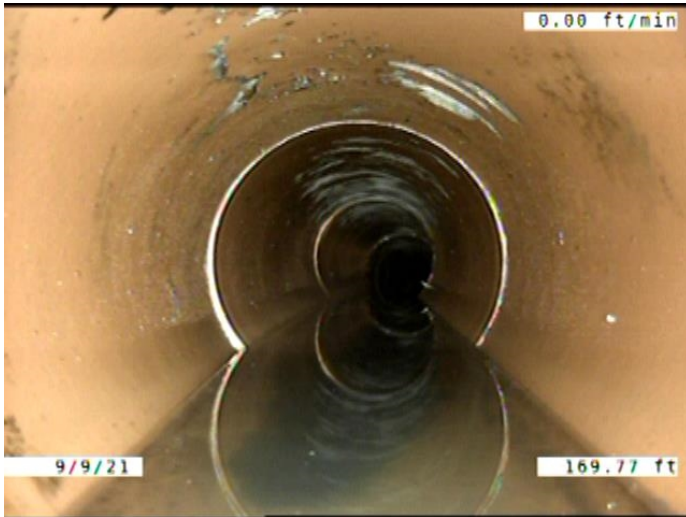
Code: **MWLS**  
Description: **Miscellaneous Water Level Sag**

Distance (ft): **169.8**  
Structural Grade: **2**  
O&M Grade: **0**  
Clock Start/From:  
Clock To:  
1st Value:  
2nd Value:  
Value Percent: **10.000**  
Continuous Index: **S05**  
Within 8" of Joint: **NO**  
Remarks:

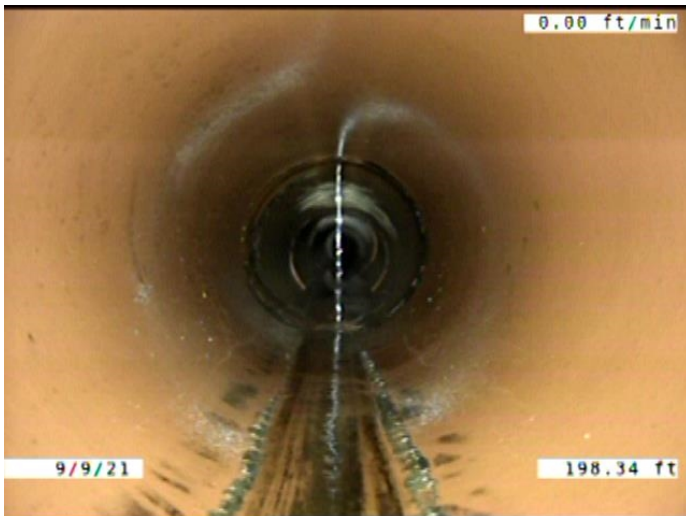
Code: **MWLS**  
Description: **Miscellaneous Water Level Sag**

Distance (ft): **198.3**  
Structural Grade: **2**  
O&M Grade: **0**  
Clock Start/From:  
Clock To:  
1st Value:  
2nd Value:  
Value Percent: **10.000**  
Continuous Index: **F05**  
Within 8" of Joint: **NO**  
Remarks:

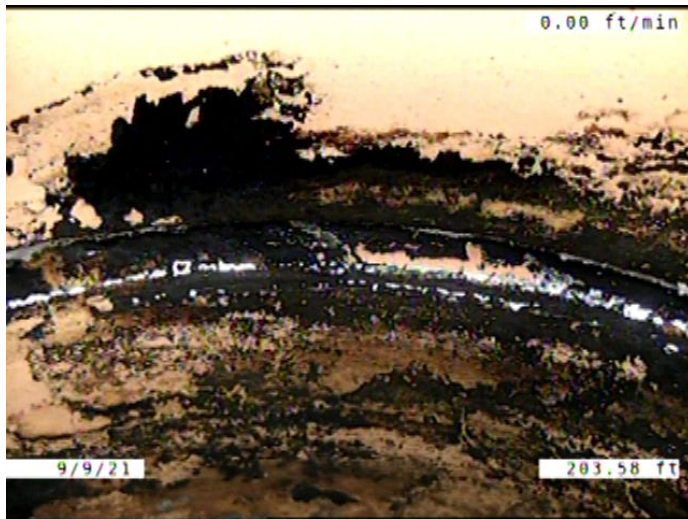
Code: **ISB**  
 Description: **Infiltration Stain Barrel**

Distance (ft): **203.6**  
 Structural Grade: **0**  
 O&M Grade: **1**  
 Clock Start/From: **7**  
 Clock To: **5**  
 1st Value:  
 2nd Value:  
 Value Percent:  
 Continuous Index:  
 Within 8" of Joint: **YES**  
 Remarks:

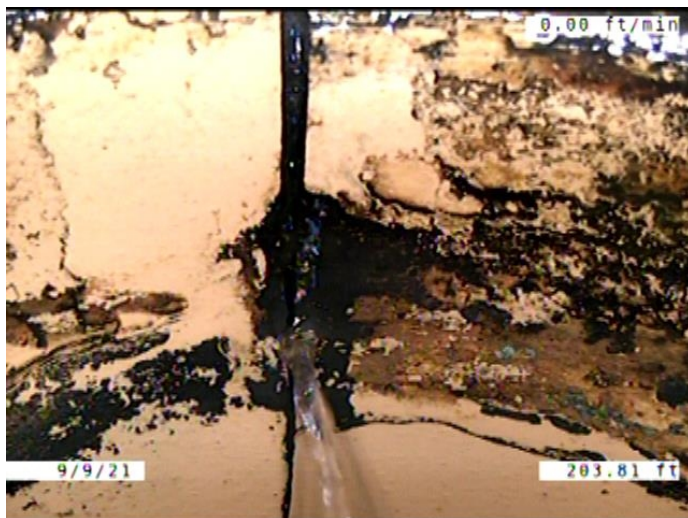
Code: **IRB**  
 Description: **Infiltration Runner Barrel**

Distance (ft): **203.8**  
 Structural Grade: **0**  
 O&M Grade: **4**  
 Clock Start/From: **12**  
 Clock To:  
 1st Value:  
 2nd Value:  
 Value Percent:  
 Continuous Index:  
 Within 8" of Joint: **YES**  
 Remarks:

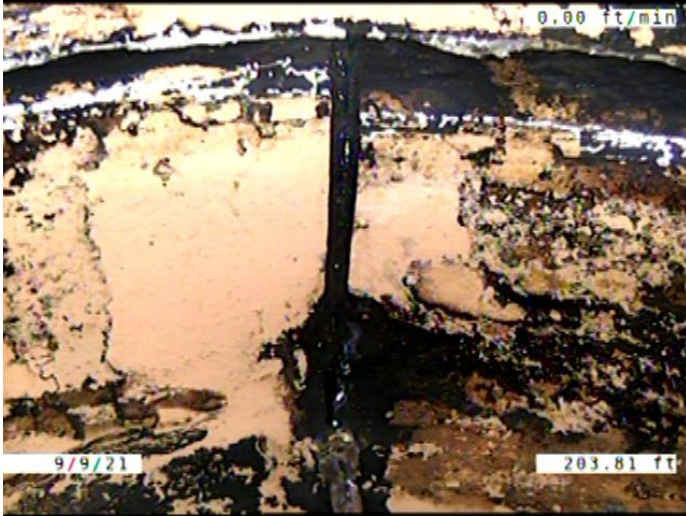
Code: **FM**  
 Description: **Fracture Multiple**

Distance (ft): **203.8**  
 Structural Grade: **4**  
 O&M Grade: **0**  
 Clock Start/From: **8**  
 Clock To: **12**  
 1st Value:  
 2nd Value:  
 Value Percent:  
 Continuous Index:  
 Within 8" of Joint: **YES**  
 Remarks:

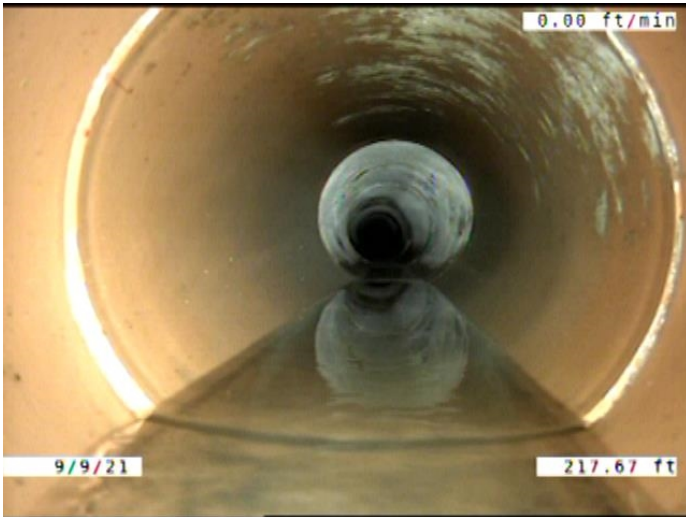
Code: **MWLS**  
 Description: **Miscellaneous Water Level Sag**

Distance (ft): **217.7**  
 Structural Grade: **2**  
 O&M Grade: **0**  
 Clock Start/From:  
 Clock To:  
 1st Value:  
 2nd Value:  
 Value Percent: **5.000**  
 Continuous Index:  
 Within 8" of Joint: **NO**  
 Remarks:

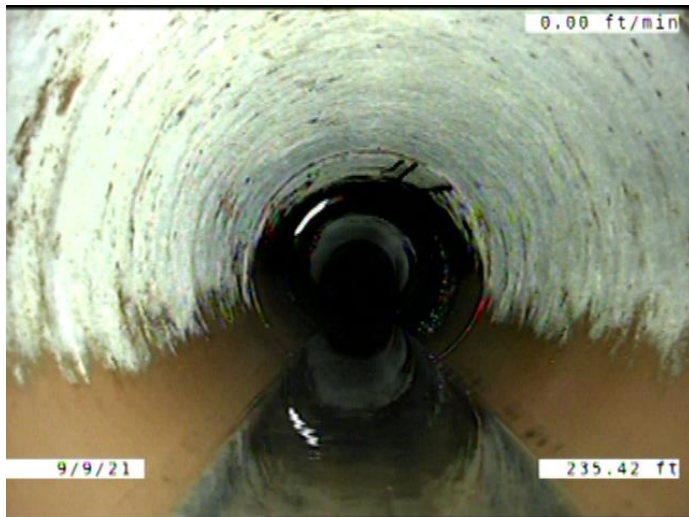
Code: **MWLS**  
 Description: **Miscellaneous Water Level Sag**

Distance (ft): **235.4**  
 Structural Grade: **2**  
 O&M Grade: **0**  
 Clock Start/From:  
 Clock To:  
 1st Value:  
 2nd Value:  
 Value Percent: **5.000**  
 Continuous Index:  
 Within 8" of Joint: **NO**  
 Remarks:

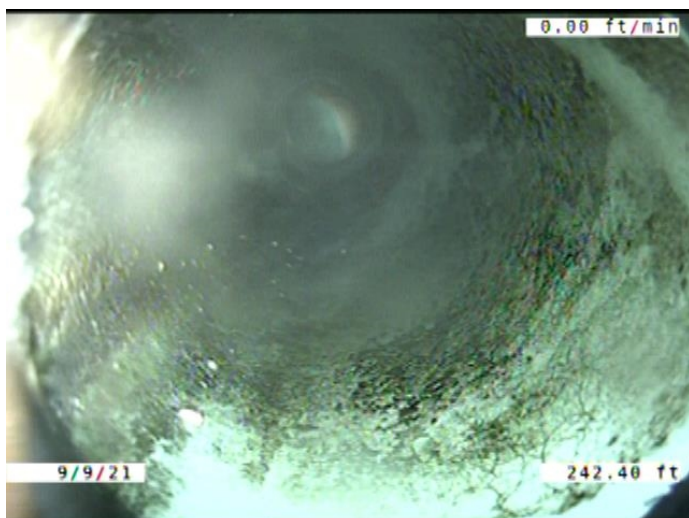
Code: **TBA**  
 Description: **Tap Break-in Activity**

Distance (ft): **242.4**  
 Structural Grade: **0**  
 O&M Grade: **0**  
 Clock Start/From: **10**  
 Clock To:  
 1st Value: **4.000**  
 2nd Value:  
 Value Percent:  
 Continuous Index:  
 Within 8" of Joint: **NO**  
 Remarks:

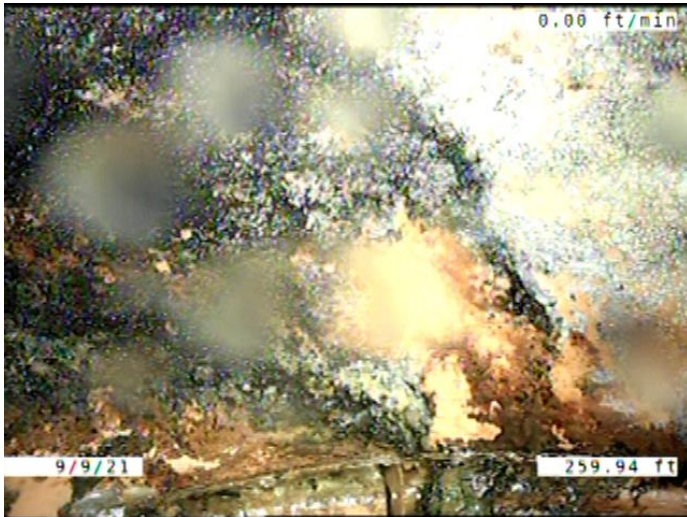
Code: **DAE**  
 Description: **Deposits Attached Encrustation**

Distance (ft): **259.9**  
 Structural Grade: **0**  
 O&M Grade: **2**  
 Clock Start/From: **7**  
 Clock To: **4**  
 1st Value:  
 2nd Value:  
 Value Percent: **5.000**  
 Continuous Index:  
 Within 8" of Joint: **YES**  
 Remarks:

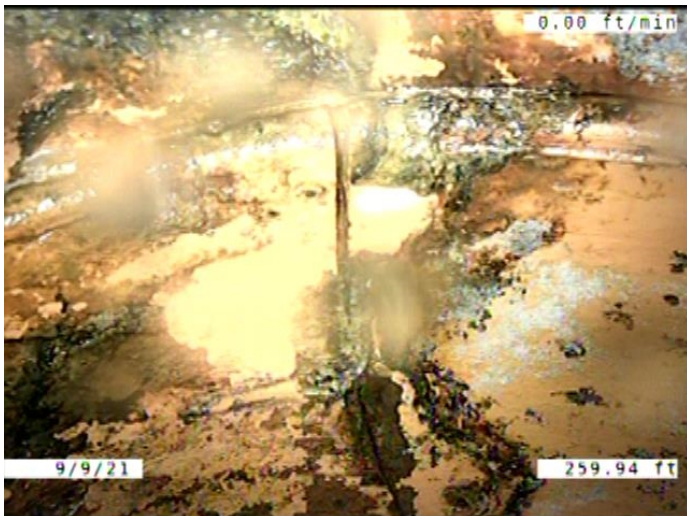
Code: **FS**  
 Description: **Fracture Spiral**

Distance (ft): **259.9**  
 Structural Grade: **3**  
 O&M Grade: **0**  
 Clock Start/From: **10**  
 Clock To: **2**  
 1st Value:  
 2nd Value:  
 Value Percent:  
 Continuous Index:  
 Within 8" of Joint: **YES**  
 Remarks:

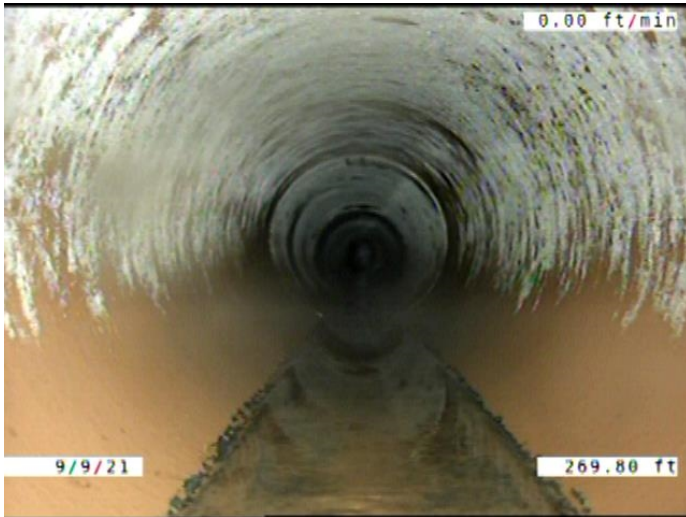
Code: **MWLS**  
 Description: **Miscellaneous Water Level Sag**

Distance (ft): **269.8**  
 Structural Grade: **2**  
 O&M Grade: **0**  
 Clock Start/From:  
 Clock To:  
 1st Value:  
 2nd Value:  
 Value Percent: **5.000**  
 Continuous Index:  
 Within 8" of Joint: **NO**  
 Remarks:

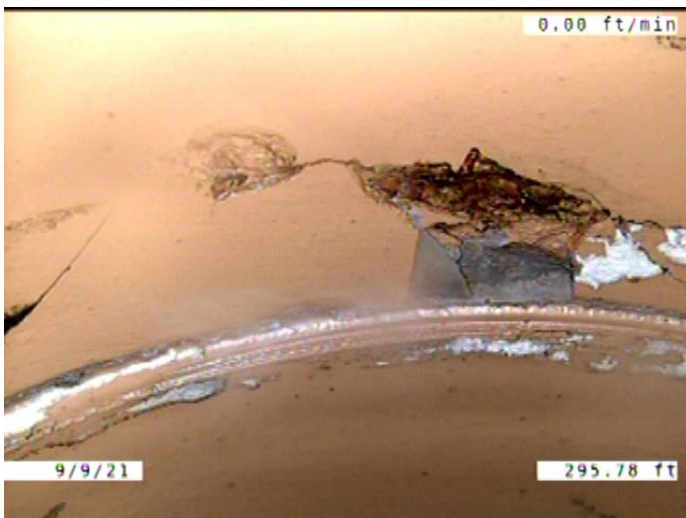
Code: **CM**  
 Description: **Crack Multiple**

Distance (ft): **295.8**  
 Structural Grade: **3**  
 O&M Grade: **0**  
 Clock Start/From: **7**  
 Clock To: **10**  
 1st Value:  
 2nd Value:  
 Value Percent:  
 Continuous Index:  
 Within 8" of Joint: **YES**  
 Remarks:

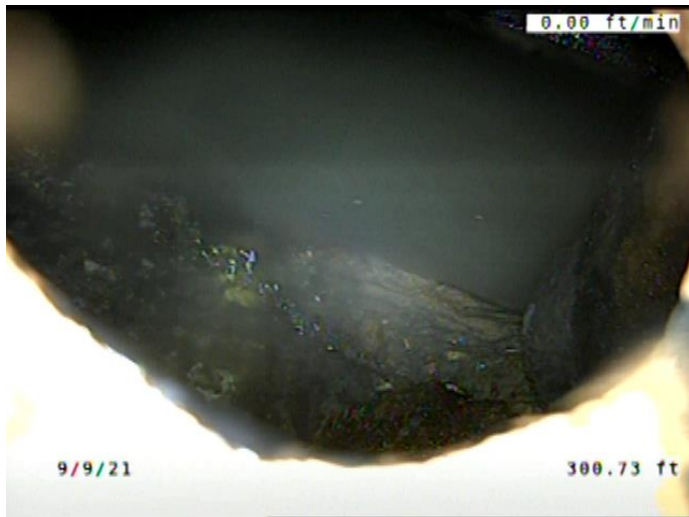
Code: **HVV**  
Description: **Hole Void Visible**

Distance (ft): **300.7**  
Structural Grade: **5**  
O&M Grade: **0**  
Clock Start/From: **4**  
Clock To: **7**  
1st Value:  
2nd Value:  
Value Percent:  
Continuous Index:  
Within 8" of Joint: **YES**  
Remarks:

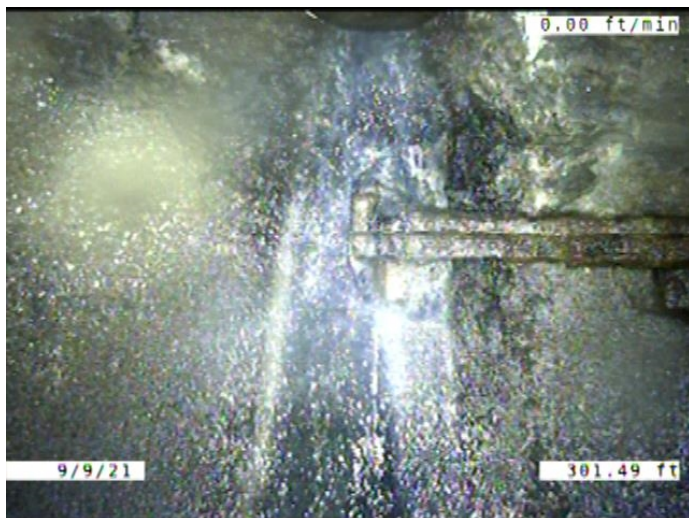
Code: **DSF**  
Description: **Deposits Settled Fine**

Distance (ft): **301.5**  
Structural Grade: **0**  
O&M Grade: **2**  
Clock Start/From: **5**  
Clock To: **7**  
1st Value:  
2nd Value:  
Value Percent: **5.000**  
Continuous Index: **F01**  
Within 8" of Joint: **YES**  
Remarks:

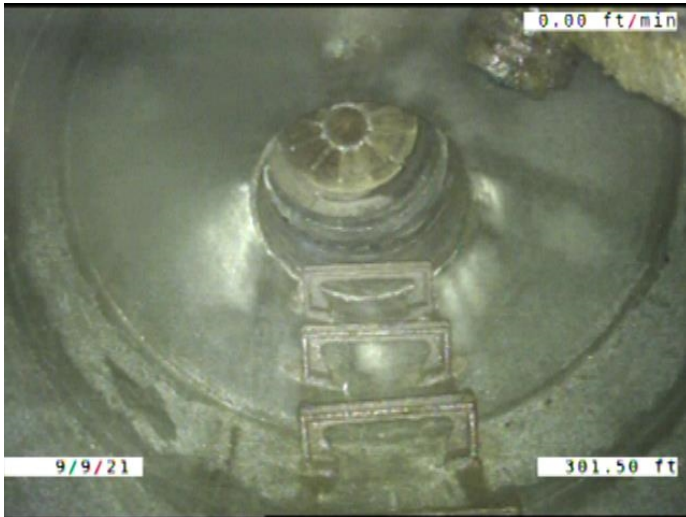
Code:	<b>AMH</b>
Description:	<b>Manhole</b>
Distance (ft):	<b>301.5</b>
Structural Grade:	<b>0</b>
O&M Grade:	<b>0</b>
Clock Start/From:	
Clock To:	
1st Value:	
2nd Value:	
Value Percent:	
Continuous Index:	
Within 8" of Joint:	<b>NO</b>
Remarks:	<b>M-404-029</b>
