## Profile/Photo Observation Report

Date:	<b>09/10/2021</b>	Weather:		Coding:	<b>PACP 7.0</b>
Pipe Length (ft):	<b>88.0</b>	Owner:	<b>City of Hobart</b>	Pre Clean:	<b>No Pre-Cleaning</b>
P.O.#:	<b>YES502259</b>	Surveyor:	<b>S. Bucklin</b>	PSR:	<b>P-404-040-028.1</b>
Customer:	<b>City of Hobart</b>	Clean Date:		Shape:	<b>C</b>

Street:	<b>Old Ridge Road</b>	Flow Control:	<b>Not Controlled</b>
City:	<b>Hobart, IN</b>	Year Renewed:	
Location:	<b>Woods</b>	Tape/Media #:	
Purpose:	<b>Routine Assessment</b>	Dia/Height:	<b>8"</b>
Use:	<b>Sanitary Sewage Pipe</b>	Material:	<b>PVC</b>
Drain Area:		Lining:	<b>None</b>
Category:	<b>NA</b>		
Comment:			
Location Details:		Direction of Survey:	<b>Upstream</b>
US MH:	<b>M-404-028.1</b>	DS MH:	<b>M-404-040</b>
		Total Length Surveyed (ft):	<b>88.0</b>

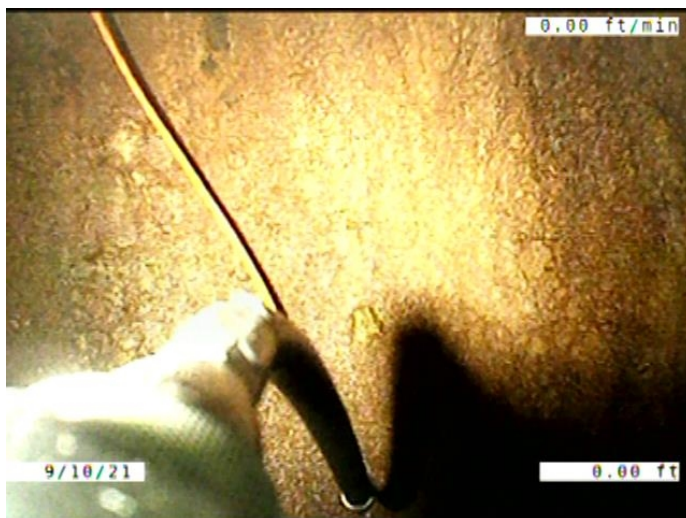
Code: **AMH**  
Description: **Manhole**

Distance (ft): **.0**  
Structural Grade: **0**  
O&M Grade: **0**  
Clock Start/From:  
Clock To:  
1st Value:  
2nd Value:  
Value Percent:  
Continuous Index:  
Within 8" of Joint: **NO**  
Remarks: **M-404-040**

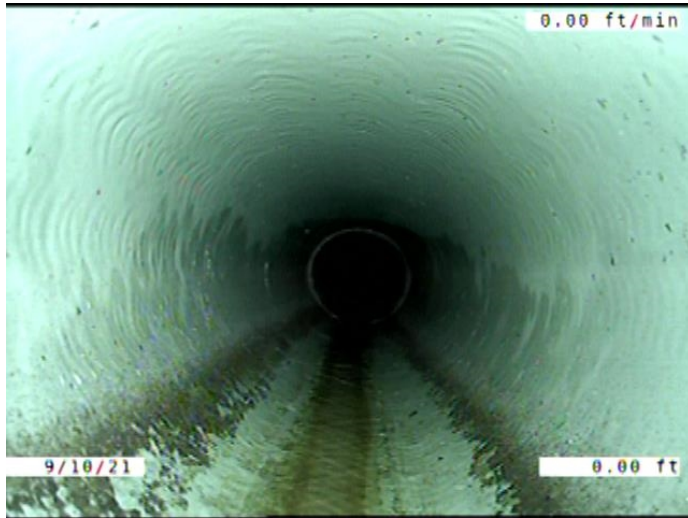
Code: **MWL**  
Description: **Miscellaneous Water Level**

Distance (ft): **.0**  
Structural Grade: **0**  
O&M Grade: **0**  
Clock Start/From:  
Clock To:  
1st Value:  
2nd Value:  
Value Percent: **5.000**  
Continuous Index:  
Within 8" of Joint: **NO**  
Remarks:

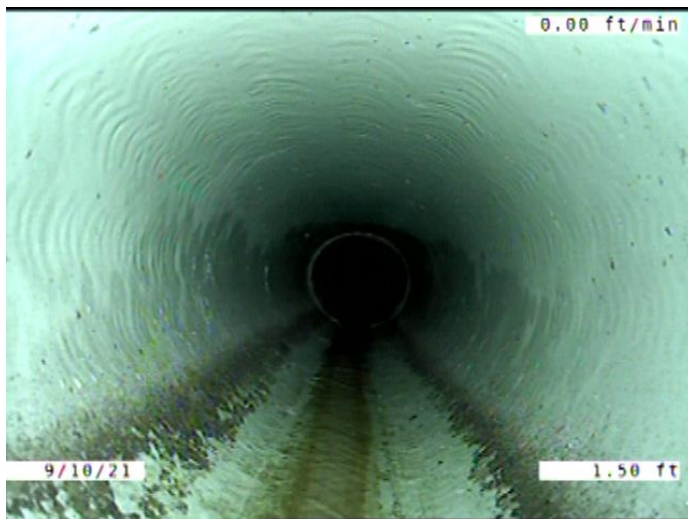
Code: **MGO**  
Description: **Miscellaneous General Observation**

Distance (ft): **1.5**  
Structural Grade: **0**  
O&M Grade: **0**  
Clock Start/From:  
Clock To:  
1st Value:  
2nd Value:  
Value Percent:  
Continuous Index:  
Within 8" of Joint: **NO**  
Remarks: **DROP INTO THE MANHOLE. HAD TO START IN THE PIPE.**

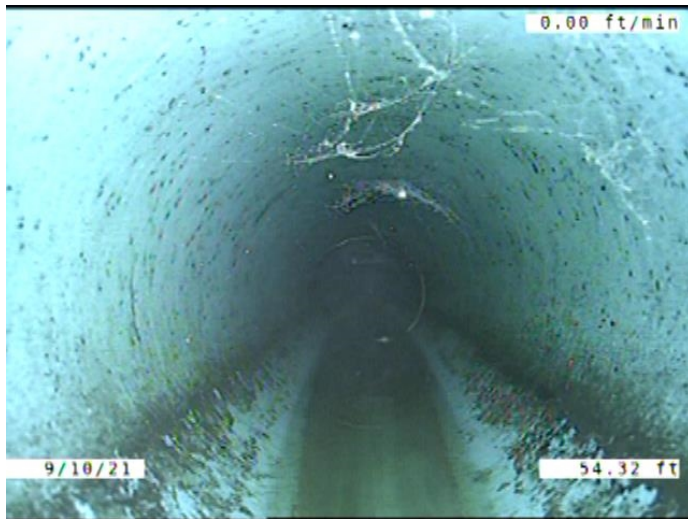
Code: **MWLS**  
Description: **Miscellaneous Water Level Sag**

Distance (ft): **54.3**  
Structural Grade: **2**  
O&M Grade: **0**  
Clock Start/From:  
Clock To:  
1st Value:  
2nd Value:  
Value Percent: **5.000**  
Continuous Index: **S01**  
Within 8" of Joint: **NO**  
Remarks:

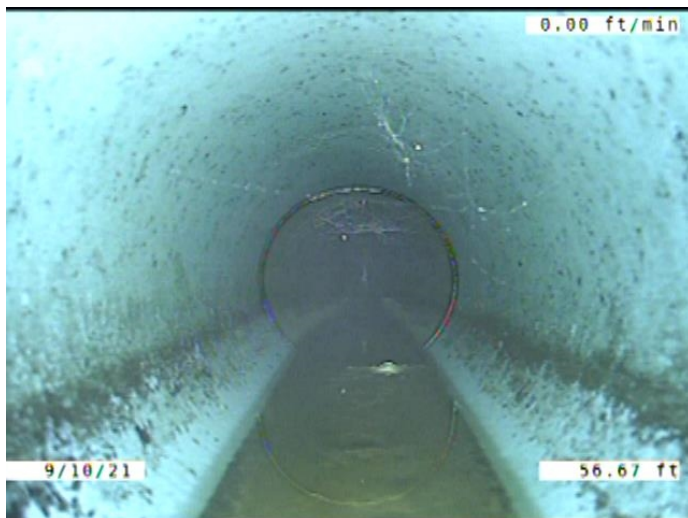
Code: **DSF**  
Description: **Deposits Settled Fine**

Distance (ft): **56.7**  
Structural Grade: **0**  
O&M Grade: **2**  
Clock Start/From: **5**  
Clock To: **7**  
1st Value:  
2nd Value:  
Value Percent: **5.000**  
Continuous Index: **S02**  
Within 8" of Joint: **YES**  
Remarks:

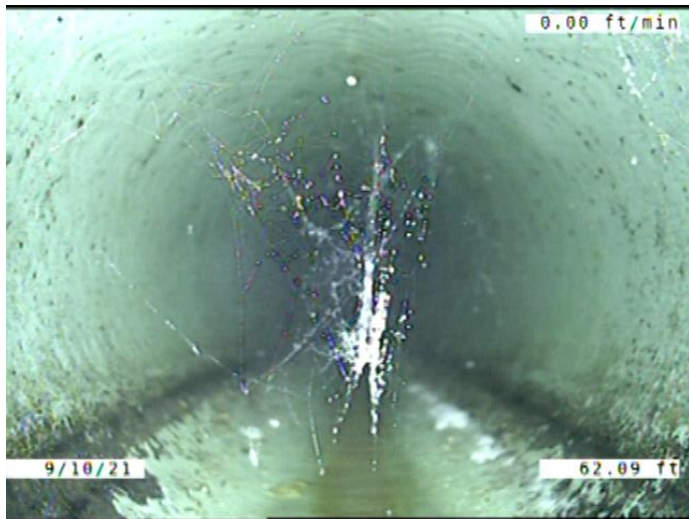
Code: **MWLS**  
 Description: **Miscellaneous Water Level Sag**

Distance (ft): **62.1**  
 Structural Grade: **2**  
 O&M Grade: **0**  
 Clock Start/From:  
 Clock To:  
 1st Value:  
 2nd Value:  
 Value Percent: **5.000**  
 Continuous Index: **F01**  
 Within 8" of Joint: **NO**  
 Remarks:

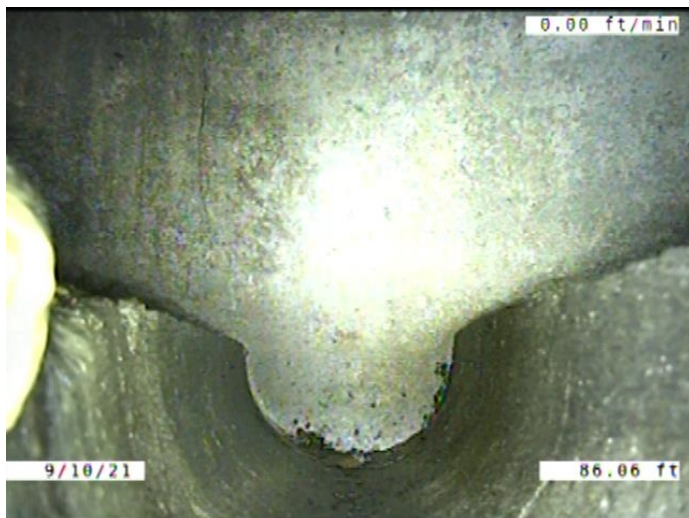
Code: **DSF**  
 Description: **Deposits Settled Fine**

Distance (ft): **86.1**  
 Structural Grade: **0**  
 O&M Grade: **2**  
 Clock Start/From: **5**  
 Clock To: **7**  
 1st Value:  
 2nd Value:  
 Value Percent: **5.000**  
 Continuous Index: **F02**  
 Within 8" of Joint: **YES**  
 Remarks:

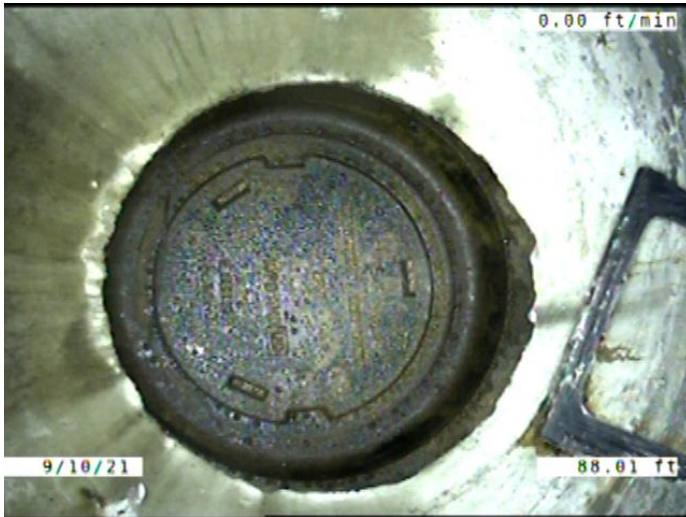
Code:	<b>AMH</b>
Description:	<b>Manhole</b>
Distance (ft):	<b>88.0</b>
Structural Grade:	<b>0</b>
O&M Grade:	<b>0</b>
Clock Start/From:	
Clock To:	
1st Value:	
2nd Value:	
Value Percent:	
Continuous Index:	
Within 8" of Joint:	<b>NO</b>
Remarks:	<b>M-404-028.1</b>
