Profile/Photo Observation Report

Street:	N CLARK ST	Flow Control:	Not Controlled
City:	Hobart, IN	Year Renewed:	
Location:	Light Highway	Tape/Media #:	
Purpose:	Not Known	Dia/Height:	12"
Use:	Sanitary	Material:	VCP
Drain Area:	NA	Lining:	
Category:	NA		
Comment:

Location Details:		Direction of Survey:	Downstream
US MH:	M-404-029	DS MH:	M-404-030
		Total Length Surveyed (ft):	173.9

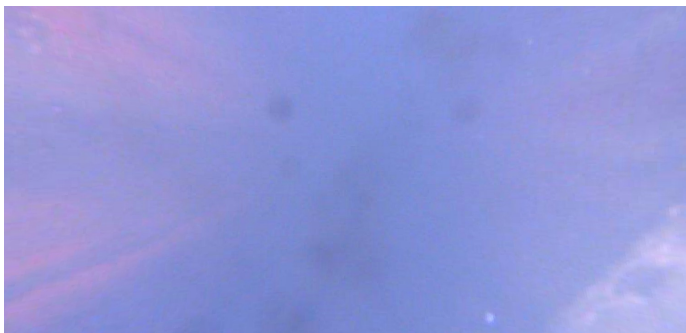
Code: **MCU**
Description: **Camera Underwater**

Distance (ft): **.0**
Structural Grade: **0**
O&M Grade: **4**
Clock Start/From:
Clock To:
1st Value:
2nd Value:
Value Percent:
Continuous Index: **S01**
Within 8" of Joint: **NO**
Remarks:

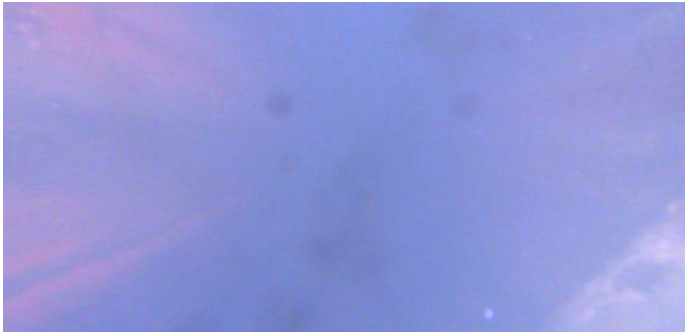
Code:	AMH
Description:	Manhole

Distance (ft):	.0
Structural Grade:	0
O&M Grade:	0
Clock Start/From:	
Clock To:	
1st Value:	
2nd Value:	
Value Percent:	
Continuous Index:	
Within 8" of Joint:	NO
Remarks:	M-404-029

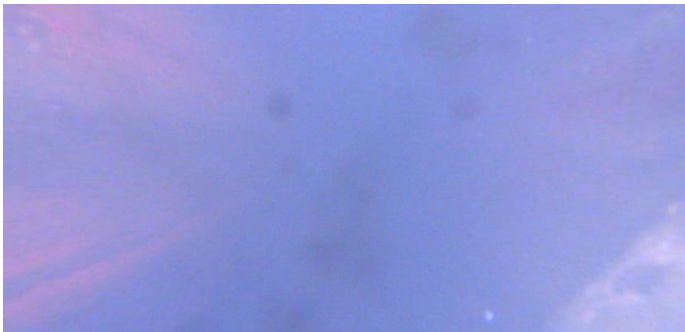
Code:	MWL
Description:	Water Level

Distance (ft):	.0
Structural Grade:	0
O&M Grade:	0
Clock Start/From:	
Clock To:	
1st Value:	
2nd Value:	
Value Percent:	15.000
Continuous Index:	
Within 8" of Joint:	NO
Remarks:
