Date:	04/16/2018	Weather:		Coding:	PACP 6.0
Pipe Length (ft):	361.7	Owner:	NA	Pre Clean:	Not Known
P.O.#:		Surveyor:	Selasie Honu	PSR:	P-404-030-029
Customer:		Clean Date:	01/01/1900	Shape:	С
Street:	Summerlin	Flow Control:		Not Controlled	
City:	Hobart, IN		Year Renewed:		
Location:	Light Highway		Tape/Media #:		
Purpose:	Not Known		Dia/Height:	12"	
Use:	Sanitary		Material:	VCP	
Drain Area:	NA		Lining:		
Category:	NA				
Comment:					
Location Details:			Direction of Surv	ey: Downstream	
US MH: N	1-404-029	DS MH:	M-404-030	Total Length Surveyed (ft)	: <b>173.9</b>
D&M Index:	4.00	O&M Quick:	4F0	0 O&M Rating:	140.00
Structural Index:	0.00	Structural Qu	uick: 000		0.00
Overall Index:	4.00	Overall Quick			140.00

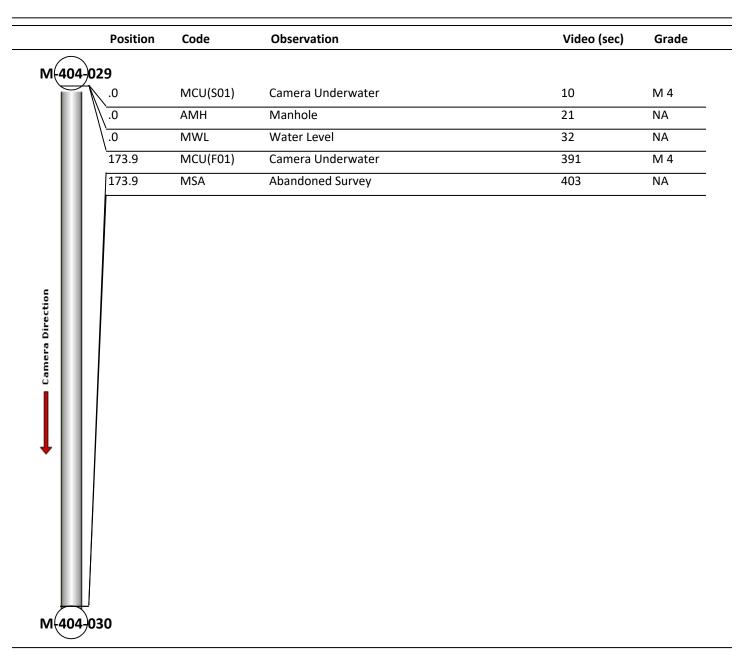
Code: Description:	MCU Camera Underwater
Distance (ft):	.0
Structural Grade:	0
O&M Grade:	4
Clock Start/From:	
Clock To:	
1st Value:	
2nd Value:	
Value Percent:	
Continuous Index:	S01
Within 8" of Joint:	NO
Remarks:
