Profile/Photo Observation Report

Date:	09/09/2021	Weather:		Coding:	PACP 7.0
Pipe Length (ft):	355.0	Owner:	City of Hobart	Pre Clean:	Light Cleaning
P.O.#:	YES502259	Surveyor:	S. Bucklin	PSR:	P-404-030-029
Customer:	City of Hobart	Clean Date:	09/09/2021	Shape:	C

Street:	North Clark Street	Flow Control:	Not Controlled
City:	Hobart, IN	Year Renewed:	
Location:	Local rural streets with light traffic, t	Tape/Media #:	
Purpose:	Routine Assessment	Dia/Height:	12"
Use:	Sanitary Sewage Pipe	Material:	VCP
Drain Area:		Lining:	None
Category:	NA		
Comment:			
Location Details:		Direction of Survey:	Upstream
US MH:	M-404-029	DS MH:	M-404-030
		Total Length Surveyed (ft):	355.0

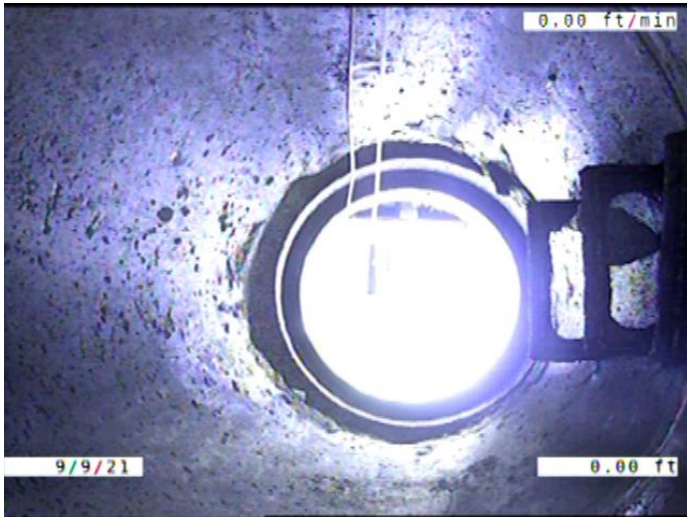
Code: **AMH**
 Description: **Manhole**

Distance (ft): **.0**
 Structural Grade: **0**
 O&M Grade: **0**
 Clock Start/From:
 Clock To:
 1st Value:
 2nd Value:
 Value Percent:
 Continuous Index:
 Within 8" of Joint: **NO**
 Remarks: **M-404-030**

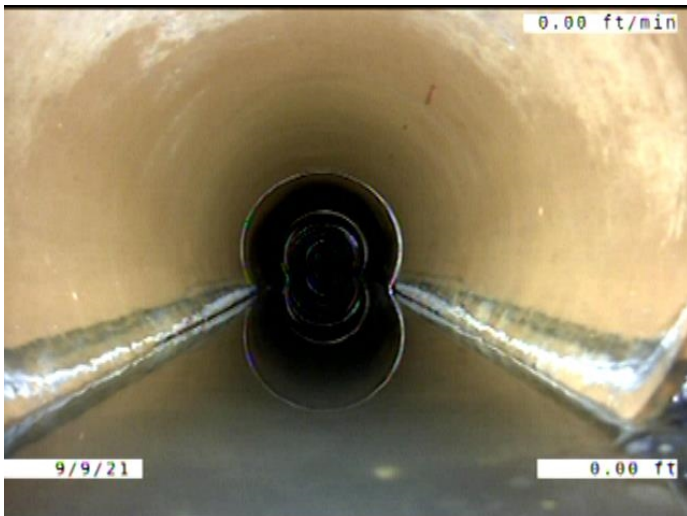
Code: **MWL**
 Description: **Miscellaneous Water Level**

Distance (ft): **.0**
 Structural Grade: **0**
 O&M Grade: **0**
 Clock Start/From:
 Clock To:
 1st Value:
 2nd Value:
 Value Percent: **5.000**
 Continuous Index:
 Within 8" of Joint: **NO**
 Remarks:

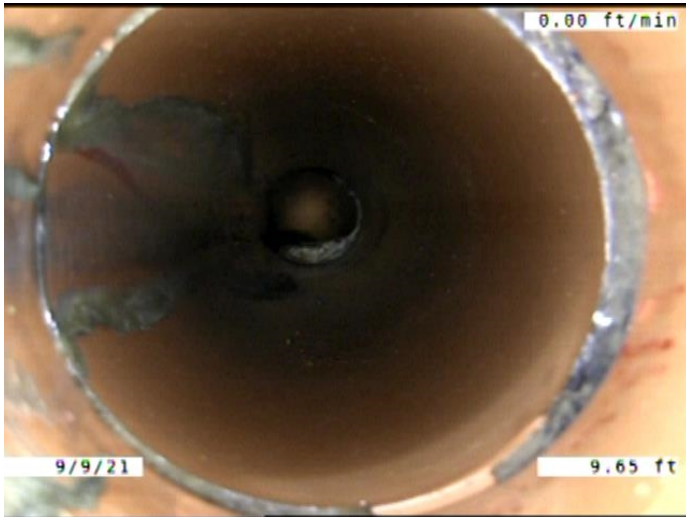
Code: **TF**
Description: **Tap Factory**

Distance (ft): **9.7**
Structural Grade: **0**
O&M Grade: **0**
Clock Start/From: **10**
Clock To:
1st Value: **4.000**
2nd Value:
Value Percent:
Continuous Index:
Within 8" of Joint: **YES**
Remarks:

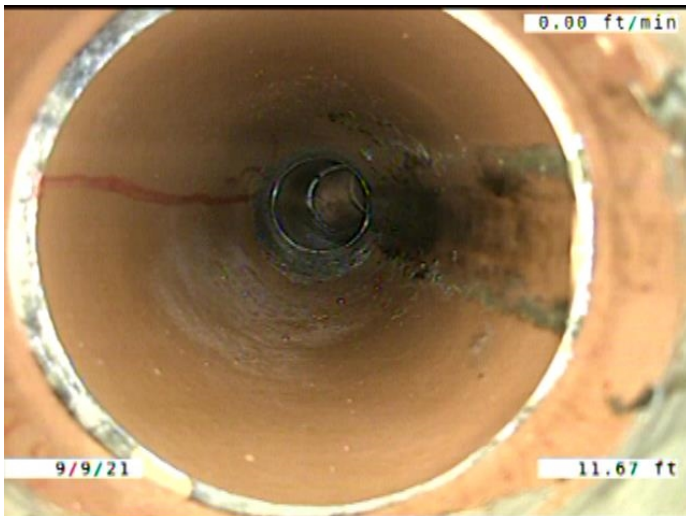
Code: **TF**
Description: **Tap Factory**

Distance (ft): **11.7**
Structural Grade: **0**
O&M Grade: **0**
Clock Start/From: **2**
Clock To:
1st Value: **4.000**
2nd Value:
Value Percent:
Continuous Index:
Within 8" of Joint: **YES**
Remarks: **CONSTANTLY RUNNING WATER**

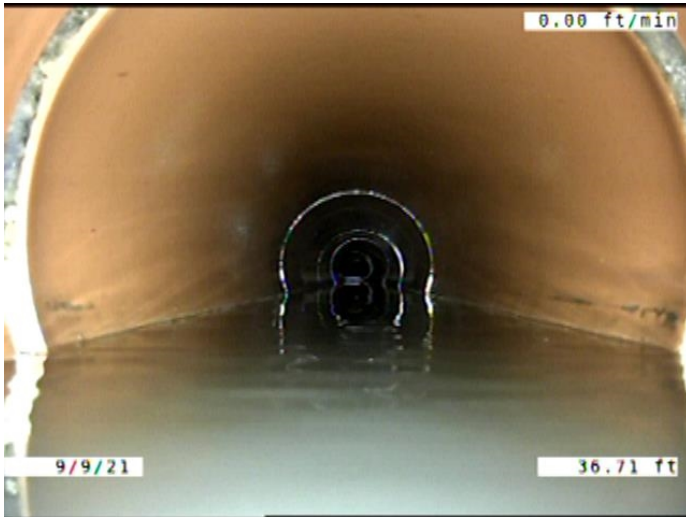
Code: **MWLS**
 Description: **Miscellaneous Water Level Sag**

Distance (ft): **36.2**
 Structural Grade: **2**
 O&M Grade: **0**
 Clock Start/From:
 Clock To:
 1st Value:
 2nd Value:
 Value Percent: **15.000**
 Continuous Index: **S01**
 Within 8" of Joint: **NO**
 Remarks:

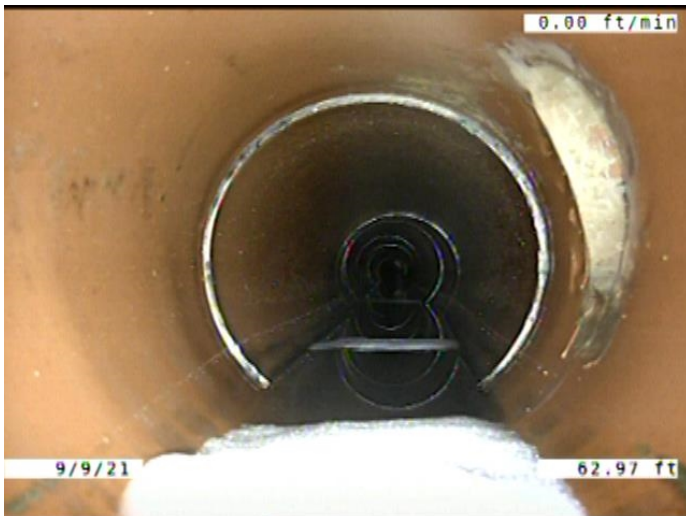
Code: **MWLS**
 Description: **Miscellaneous Water Level Sag**

Distance (ft): **63.0**
 Structural Grade: **2**
 O&M Grade: **0**
 Clock Start/From:
 Clock To:
 1st Value:
 2nd Value:
 Value Percent: **15.000**
 Continuous Index: **F01**
 Within 8" of Joint: **NO**
 Remarks:

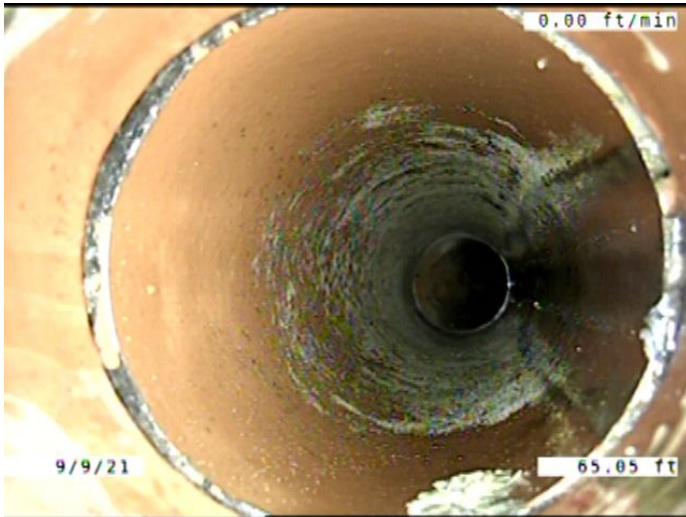
Code: **TF**
Description: **Tap Factory**

Distance (ft): **65.0**
Structural Grade: **0**
O&M Grade: **0**
Clock Start/From: **2**
Clock To:
1st Value: **4.000**
2nd Value:
Value Percent:
Continuous Index:
Within 8" of Joint: **YES**
Remarks:

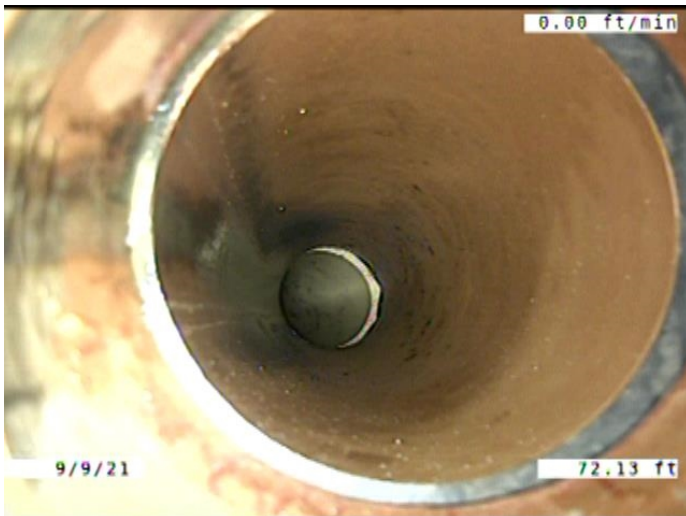
Code: **TF**
Description: **Tap Factory**

Distance (ft): **72.1**
Structural Grade: **0**
O&M Grade: **0**
Clock Start/From: **10**
Clock To:
1st Value: **4.000**
2nd Value:
Value Percent:
Continuous Index:
Within 8" of Joint: **YES**
Remarks:

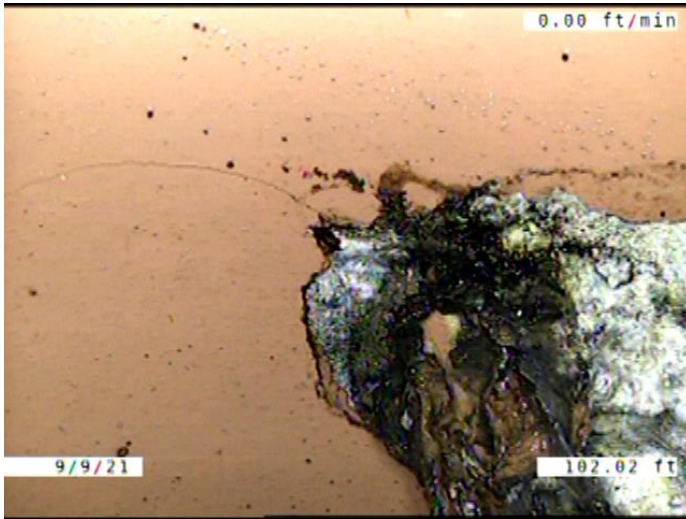
Code: **CS**
Description: **Crack Spiral**

Distance (ft): **102.0**
Structural Grade: **2**
O&M Grade: **0**
Clock Start/From: **11**
Clock To: **1**
1st Value:
2nd Value:
Value Percent:
Continuous Index:
Within 8" of Joint: **YES**
Remarks:

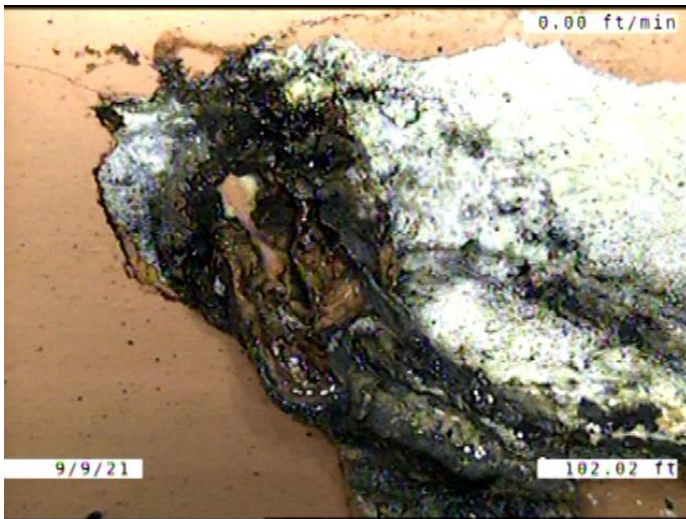
Code: **DAE**
Description: **Deposits Attached Encrustation**

Distance (ft): **102.0**
Structural Grade: **0**
O&M Grade: **2**
Clock Start/From: **1**
Clock To: **4**
1st Value:
2nd Value:
Value Percent: **5.000**
Continuous Index:
Within 8" of Joint: **YES**
Remarks:

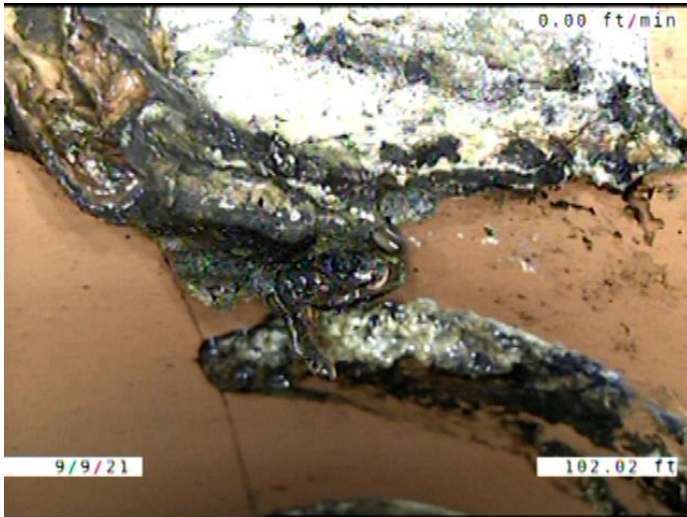
Code: **IDB**
Description: **Infiltration Dripper Barrel**

Distance (ft): **102.0**
Structural Grade: **0**
O&M Grade: **3**
Clock Start/From: **1**
Clock To: **2**
1st Value:
2nd Value:
Value Percent:
Continuous Index:
Within 8" of Joint: **NO**
Remarks:

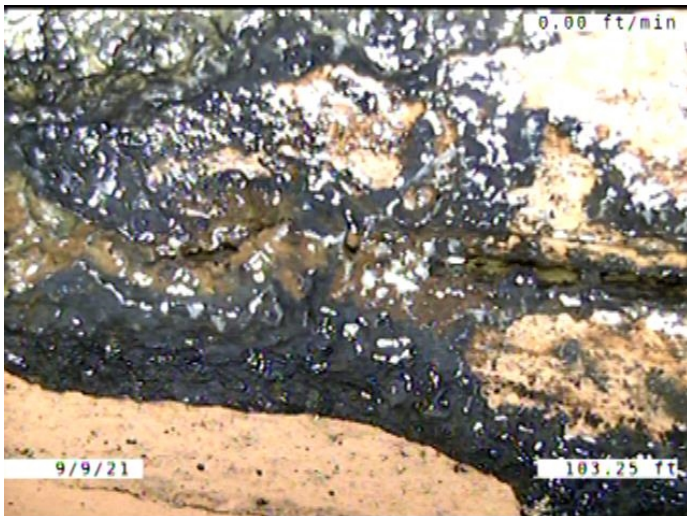
Code: **DAE**
Description: **Deposits Attached Encrustation**

Distance (ft): **103.3**
Structural Grade: **0**
O&M Grade: **2**
Clock Start/From: **10**
Clock To: **4**
1st Value:
2nd Value:
Value Percent: **5.000**
Continuous Index:
Within 8" of Joint: **YES**
Remarks:

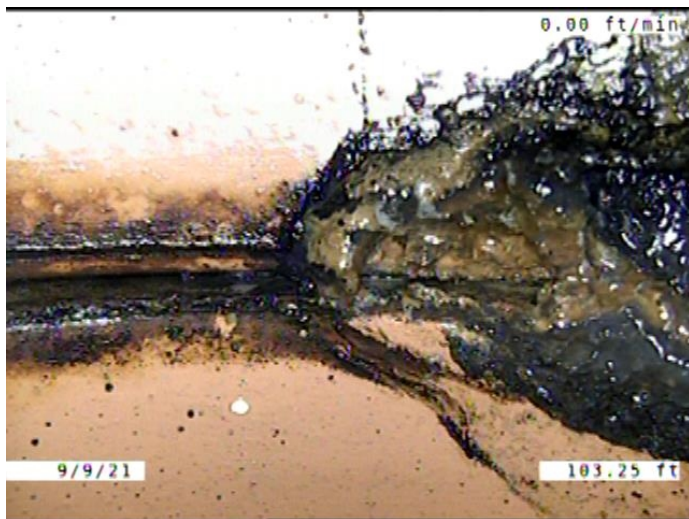
Code: **IRJ**
 Description: **Infiltration Runner Joint**

Distance (ft): **103.3**
 Structural Grade: **0**
 O&M Grade: **4**
 Clock Start/From: **1**
 Clock To:
 1st Value:
 2nd Value:
 Value Percent:
 Continuous Index:
 Within 8" of Joint: **YES**
 Remarks:

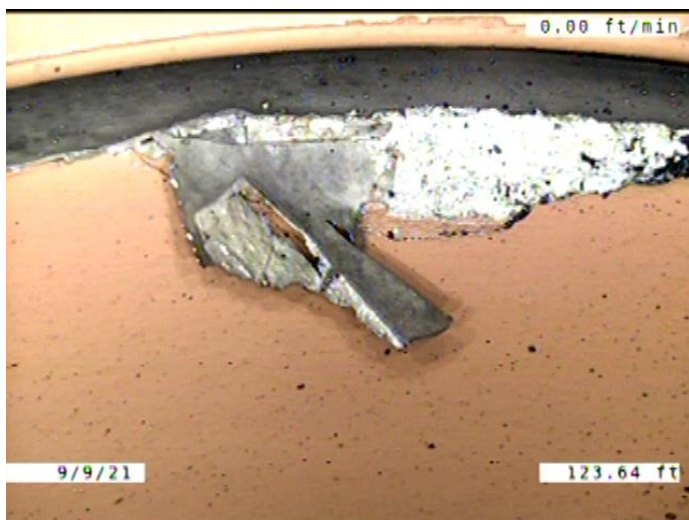
Code: **ISZ**
 Description: **Intruding Sealing Material Other**

Distance (ft): **123.6**
 Structural Grade: **0**
 O&M Grade: **2**
 Clock Start/From: **9**
 Clock To: **10**
 1st Value:
 2nd Value:
 Value Percent: **5.000**
 Continuous Index:
 Within 8" of Joint: **NO**
 Remarks: **JOINT SEALING MATERIAL BUT DOESNT LOOK TO HAVE ANY MISSIN**

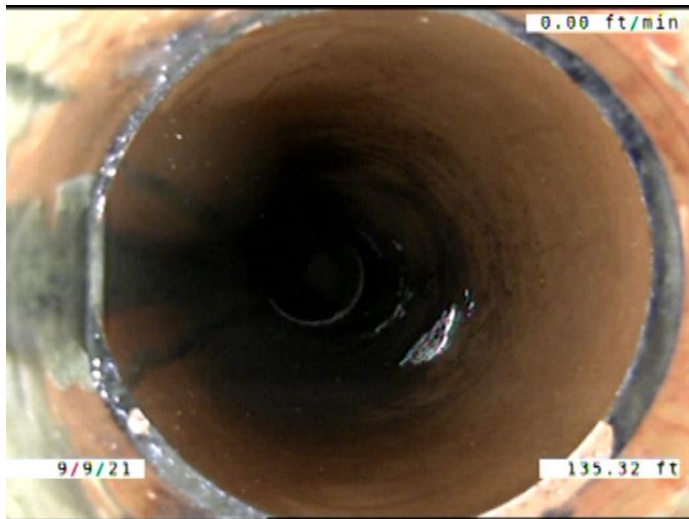
Code: **TF**
 Description: **Tap Factory**

Distance (ft): **135.3**
 Structural Grade: **0**
 O&M Grade: **0**
 Clock Start/From: **10**
 Clock To:
 1st Value: **4.000**
 2nd Value:
 Value Percent:
 Continuous Index:
 Within 8" of Joint: **YES**
 Remarks:

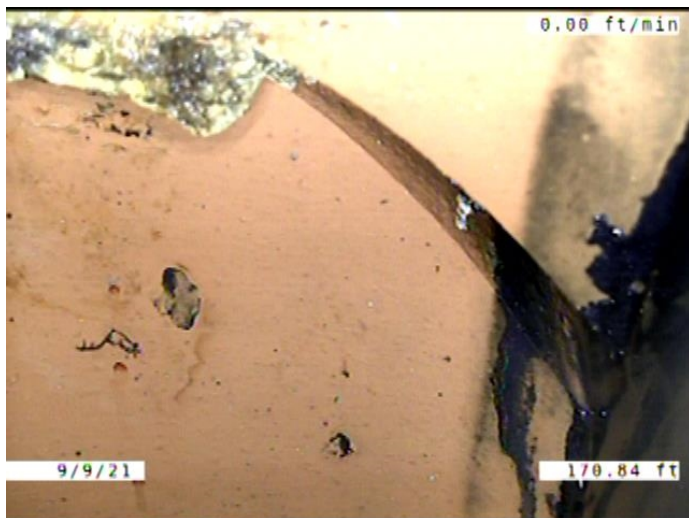
Code: **B**
 Description: **Broken**

Distance (ft): **170.8**
 Structural Grade: **4**
 O&M Grade: **0**
 Clock Start/From: **9**
 Clock To: **3**
 1st Value:
 2nd Value:
 Value Percent:
 Continuous Index:
 Within 8" of Joint: **YES**
 Remarks:

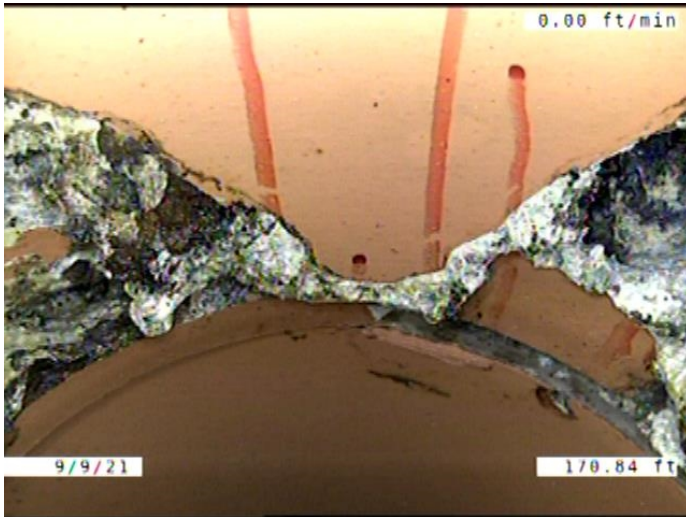
Code: **DAE**
 Description: **Deposits Attached Encrustation**

Distance (ft): **170.8**
 Structural Grade: **0**
 O&M Grade: **2**
 Clock Start/From: **10**
 Clock To: **2**
 1st Value:
 2nd Value:
 Value Percent: **5.000**
 Continuous Index:
 Within 8" of Joint: **YES**
 Remarks:

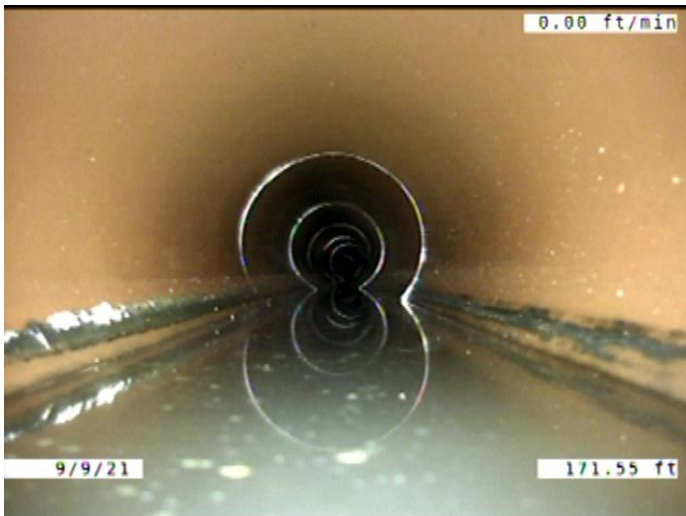
Code: **MWLS**
 Description: **Miscellaneous Water Level Sag**

Distance (ft): **171.5**
 Structural Grade: **2**
 O&M Grade: **0**
 Clock Start/From:
 Clock To:
 1st Value:
 2nd Value:
 Value Percent: **10.000**
 Continuous Index: **S02**
 Within 8" of Joint: **NO**
 Remarks:

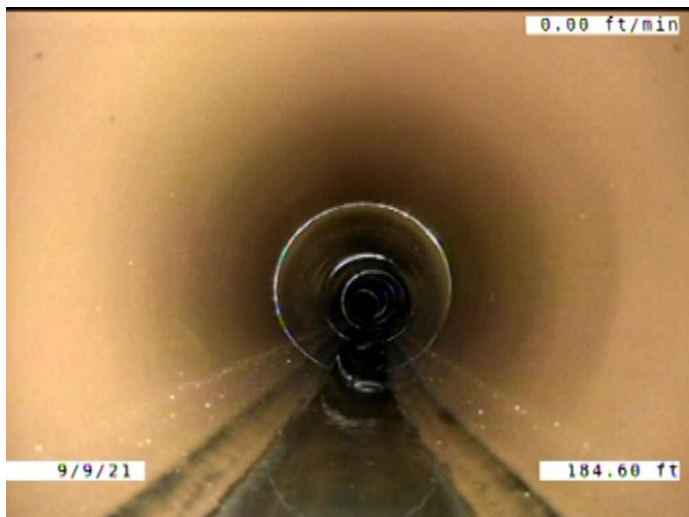
Code: **MWLS**
Description: **Miscellaneous Water Level Sag**

Distance (ft): **184.6**
Structural Grade: **2**
O&M Grade: **0**
Clock Start/From:
Clock To:
1st Value:
2nd Value:
Value Percent: **10.000**
Continuous Index: **F02**
Within 8" of Joint: **NO**
Remarks:

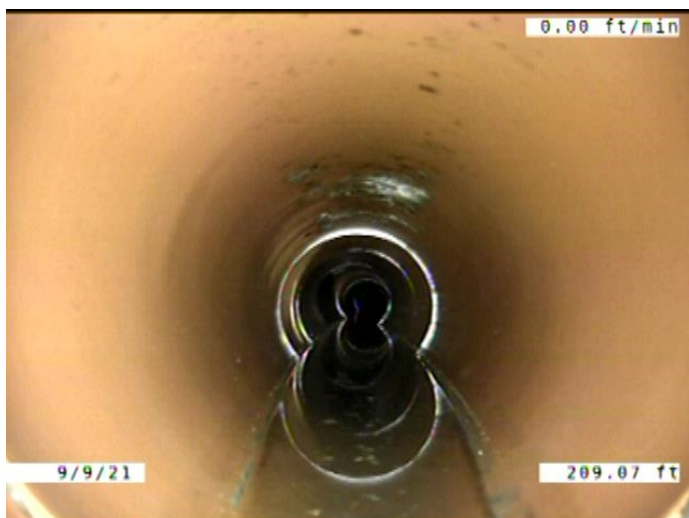
Code: **MWLS**
Description: **Miscellaneous Water Level Sag**

Distance (ft): **209.1**
Structural Grade: **2**
O&M Grade: **0**
Clock Start/From:
Clock To:
1st Value:
2nd Value:
Value Percent: **10.000**
Continuous Index: **S03**
Within 8" of Joint: **NO**
Remarks:

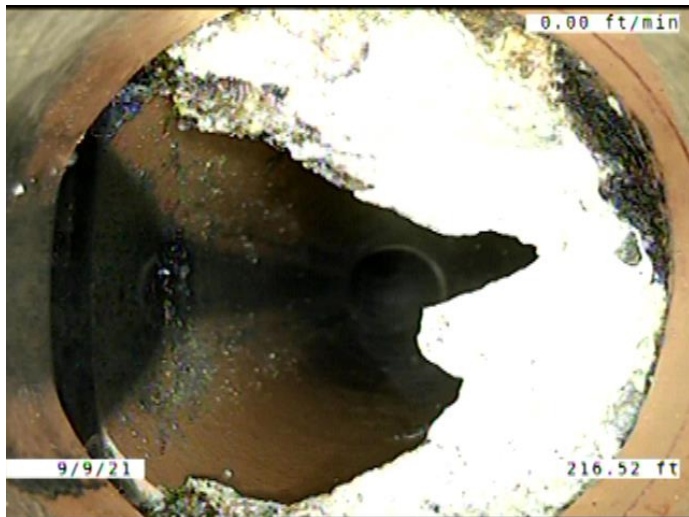
Code: **TF**
 Description: **Tap Factory**

Distance (ft): **216.5**
 Structural Grade: **0**
 O&M Grade: **0**
 Clock Start/From: **10**
 Clock To:
 1st Value: **4.000**
 2nd Value:
 Value Percent:
 Continuous Index:
 Within 8" of Joint: **YES**
 Remarks: **FIRST JOINT BACK HAS ENCRUSTATION**

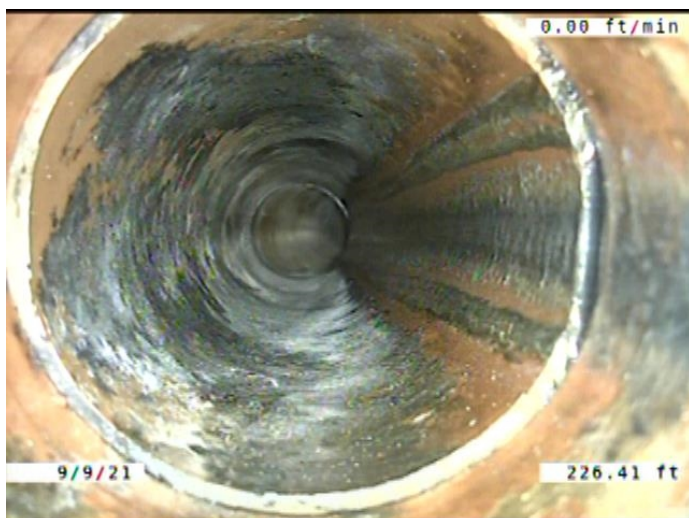
Code: **TF**
 Description: **Tap Factory**

Distance (ft): **226.4**
 Structural Grade: **0**
 O&M Grade: **0**
 Clock Start/From: **3**
 Clock To:
 1st Value: **4.000**
 2nd Value:
 Value Percent:
 Continuous Index:
 Within 8" of Joint: **YES**
 Remarks:

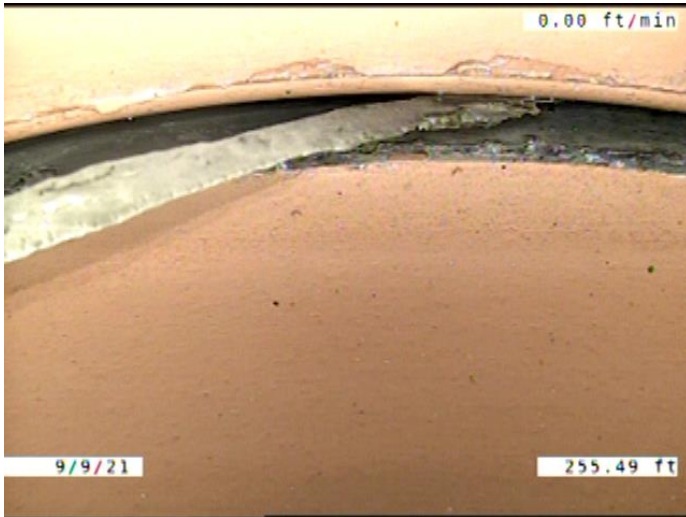
Code: **ISSRH**
 Description: **Intruding Sealing Material Sealing Ring Hanging**

Distance (ft): **255.5**
 Structural Grade: **0**
 O&M Grade: **2**
 Clock Start/From: **8**
 Clock To: **10**
 1st Value:
 2nd Value:
 Value Percent: **5.000**
 Continuous Index:
 Within 8" of Joint: **NO**
 Remarks:

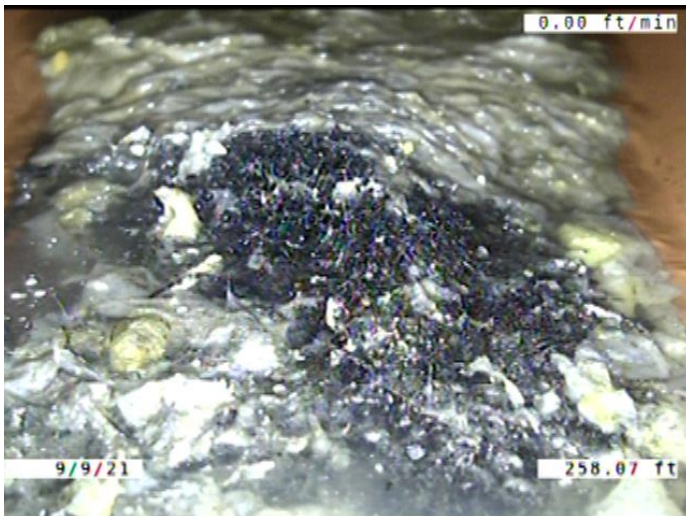
Code: **DSZ**
 Description: **Deposits Settled Other**

Distance (ft): **258.1**
 Structural Grade: **0**
 O&M Grade: **2**
 Clock Start/From: **5**
 Clock To: **7**
 1st Value:
 2nd Value:
 Value Percent: **5.000**
 Continuous Index:
 Within 8" of Joint: **YES**
 Remarks: **CUT ROOTS, TP AND SEWER DEBRIS**

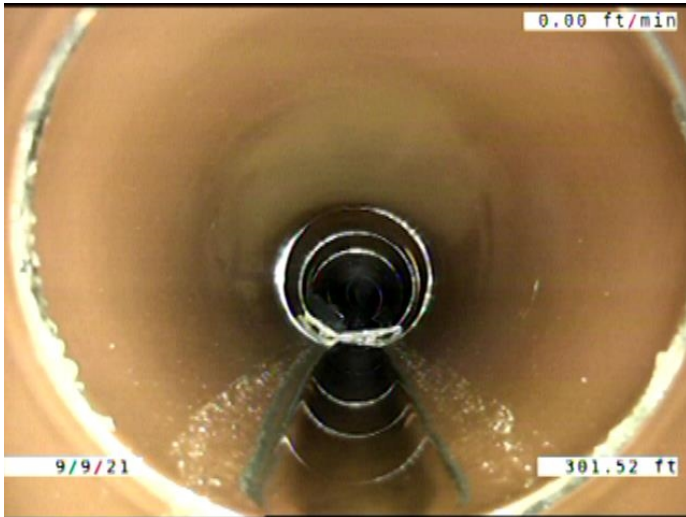
Code: **MWLS**
Description: **Miscellaneous Water Level Sag**

Distance (ft): **301.5**
Structural Grade: **2**
O&M Grade: **0**
Clock Start/From:
Clock To:
1st Value:
2nd Value:
Value Percent: **10.000**
Continuous Index: **F03**
Within 8" of Joint: **NO**
Remarks:

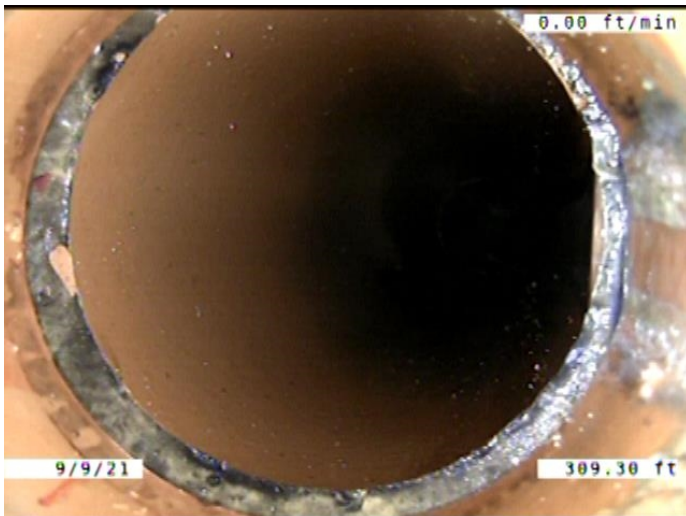
Code: **TF**
Description: **Tap Factory**

Distance (ft): **309.3**
Structural Grade: **0**
O&M Grade: **0**
Clock Start/From: **2**
Clock To:
1st Value: **4.000**
2nd Value:
Value Percent:
Continuous Index:
Within 8" of Joint: **YES**
Remarks:

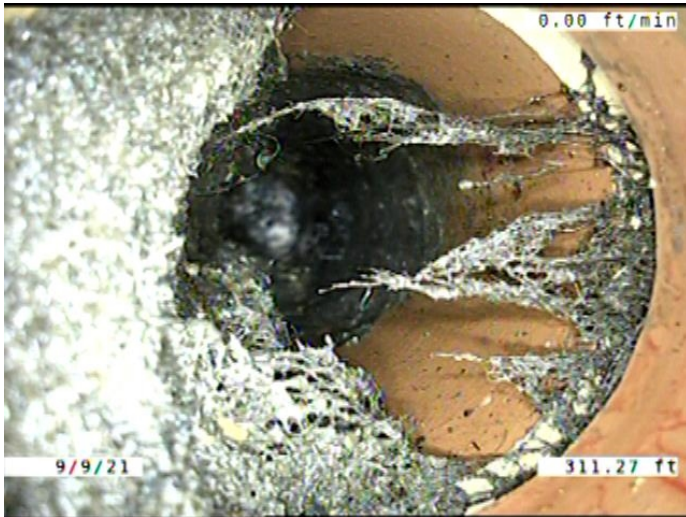
Code: **TF**
Description: **Tap Factory**

Distance (ft): **311.3**
Structural Grade: **0**
O&M Grade: **0**
Clock Start/From: **9**
Clock To:
1st Value: **4.000**
2nd Value:
Value Percent:
Continuous Index:
Within 8" of Joint: **YES**
Remarks: **ROOTS GROWING IN THE TAP**

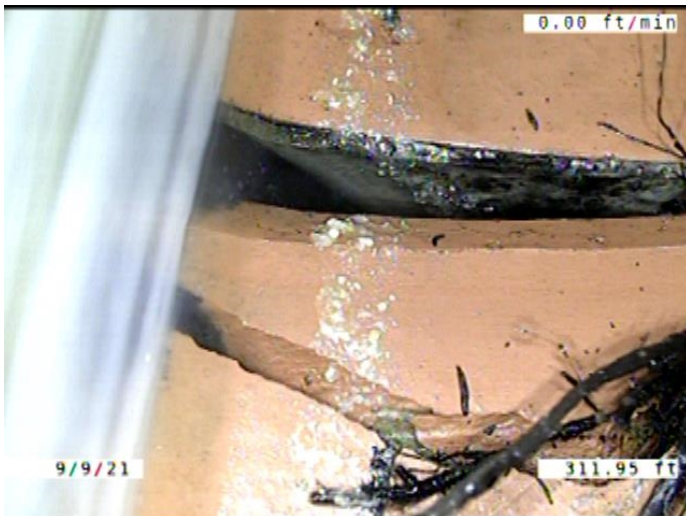
Code: **B**
Description: **Broken**

Distance (ft): **312.0**
Structural Grade: **4**
O&M Grade: **0**
Clock Start/From: **3**
Clock To: **5**
1st Value:
2nd Value:
Value Percent:
Continuous Index:
Within 8" of Joint: **YES**
Remarks:

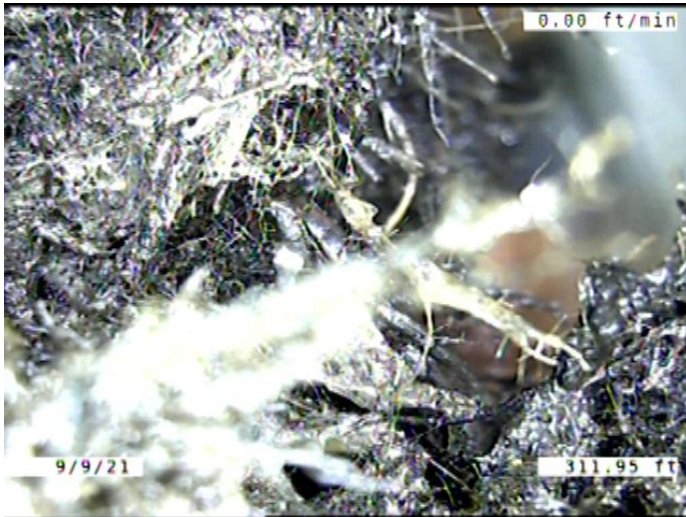
Code: **RMJ**
Description: **Roots Medium Joint**

Distance (ft): **312.0**
Structural Grade: **0**
O&M Grade: **3**
Clock Start/From: **7**
Clock To: **10**
1st Value:
2nd Value:
Value Percent: **5.000**
Continuous Index:
Within 8" of Joint: **YES**
Remarks:

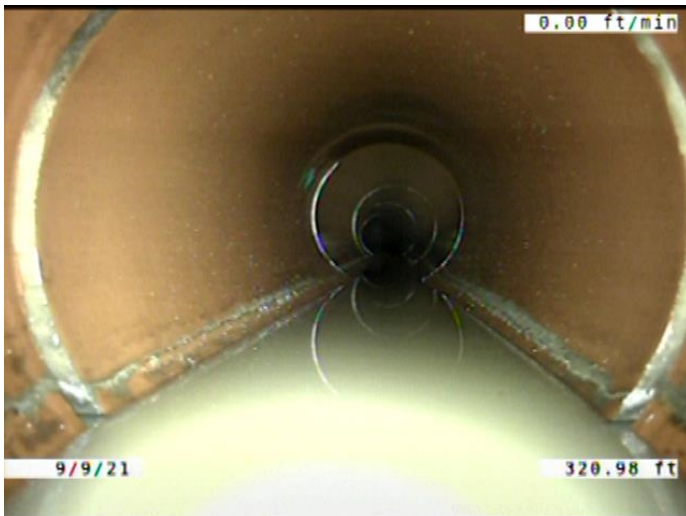
Code: **MWLS**
Description: **Miscellaneous Water Level Sag**

Distance (ft): **321.0**
Structural Grade: **2**
O&M Grade: **0**
Clock Start/From:
Clock To:
1st Value:
2nd Value:
Value Percent: **5.000**
Continuous Index:
Within 8" of Joint: **NO**
Remarks:

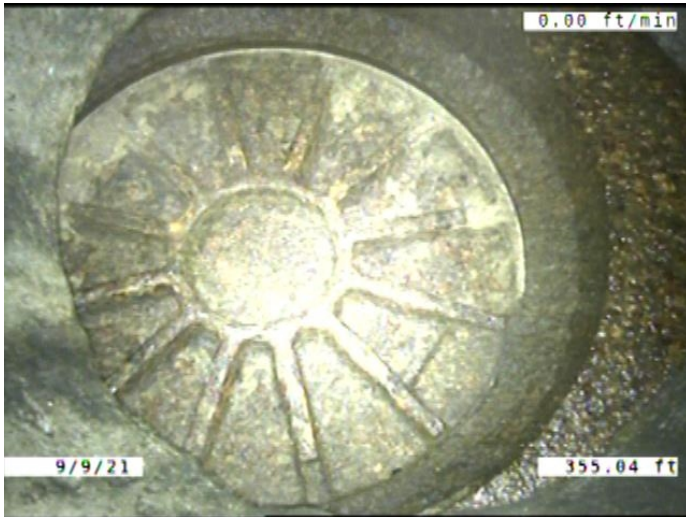
Code:	AMH
Description:	Manhole
Distance (ft):	355.0
Structural Grade:	0
O&M Grade:	0
Clock Start/From:	
Clock To:	
1st Value:	
2nd Value:	
Value Percent:	
Continuous Index:	
Within 8" of Joint:	NO
Remarks:	M-404-029
