## **Profile/Photo Observation Report**

Date: 09/09/2021 Weather: Coding: **PACP 7.0** Pipe Length (ft): 355.0 Owner: **City of Hobart** Pre Clean: **Light Cleaning** P.O.#: YES502259 Surveyor: S. Bucklin PSR: P-404-030-029

Street: North Clark Street Flow Control: Not Controlled

US MH: M-404-029 DS MH: M-404-030 Total Length Surveyed (ft): 355.0

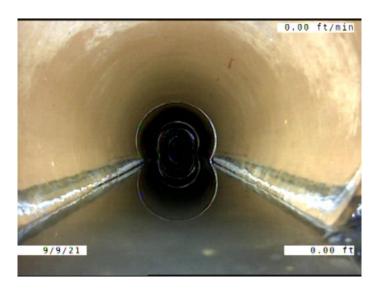
Code: MWL

Description: Miscellaneous Water Level

Value Percent: 5.000

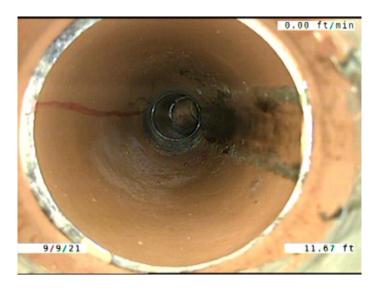
Code: **TF**

Description: Tap Factory

Remarks: CONSTANTLY RUNNING WATER

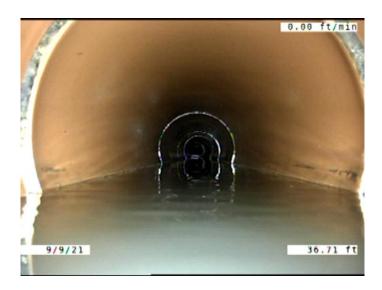
Code: MWLS

Description: Miscellaneous Water Level Sag

Distance (ft): 36.2
Structural Grade: 2
O&M Grade: 0

Value Percent: 15.000
Continuous Index: S01
Within 8" of Joint: NO

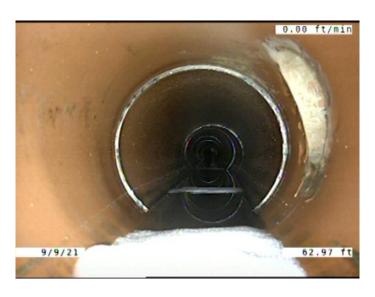
Code: MWLS

Description: Miscellaneous Water Level Sag

Distance (ft): 63.0
Structural Grade: 2
O&M Grade: 0

Value Percent: 15.000
Continuous Index: F01
Within 8" of Joint: NO

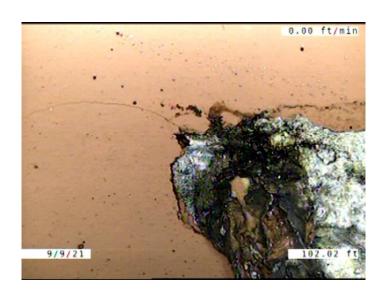
Code: CS

Description: Crack Spiral

Distance (ft): 102.0
Structural Grade: 2
O&M Grade: 0
Clock Start/From: 11
Clock To: 1

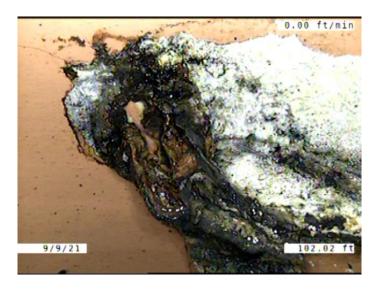
Code: DAE

Description: Deposits Attached Encrustation

Distance (ft): 102.0
Structural Grade: 0
O&M Grade: 2
Clock Start/From: 1
Clock To: 4
1st Value:

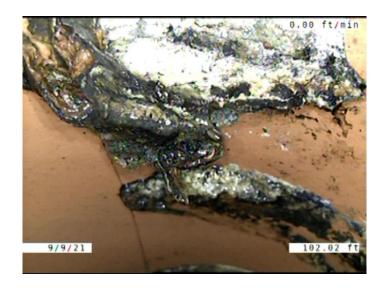
Code: IDB

Description: Infiltration Dripper Barrel

Distance (ft): 102.0
Structural Grade: 0
O&M Grade: 3

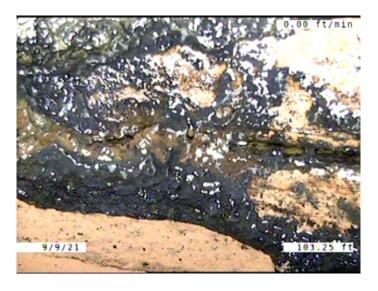
Code: DAE

Description: Deposits Attached Encrustation

Distance (ft): 103.3
Structural Grade: 0
O&M Grade: 2
Clock Start/From: 10
Clock To: 4
1st Value:

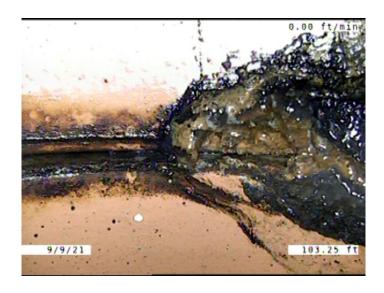
Code: IRJ

Description: Infiltration Runner Joint

Distance (ft): 103.3
Structural Grade: 0
O&M Grade: 4
Clock Start/From: 1

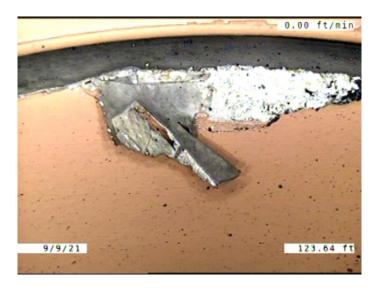
Code: ISZ

Description: Intruding Sealing Material Other

Distance (ft): 123.6
Structural Grade: 0
O&M Grade: 2
Clock Start/From: 9
Clock To: 10
1st Value:

Remarks: JOINT SEALING MATERIAL BUT

DOESNT LOOK TO HAVE ANY MISSIN

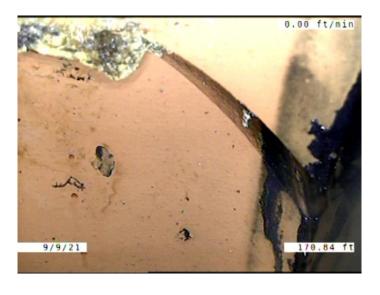
Code: B
Description: Broken

Distance (ft): 170.8

Structural Grade: 4

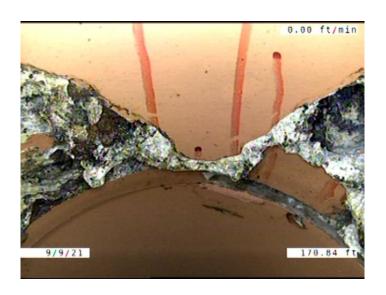
Code: DAE

Description: Deposits Attached Encrustation

Distance (ft): 170.8
Structural Grade: 0
O&M Grade: 2
Clock Start/From: 10
Clock To: 2

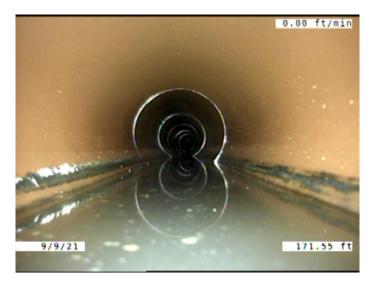
Code: MWLS

Description: Miscellaneous Water Level Sag

Distance (ft): 171.5
Structural Grade: 2
O&M Grade: 0

Value Percent: 10.000
Continuous Index: S02
Within 8" of Joint: NO

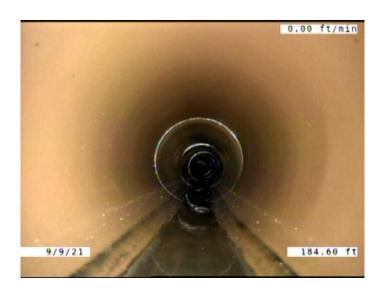
Code: MWLS

Description: Miscellaneous Water Level Sag

Distance (ft): 184.6
Structural Grade: 2
O&M Grade: 0

Value Percent: 10.000
Continuous Index: F02
Within 8" of Joint: NO

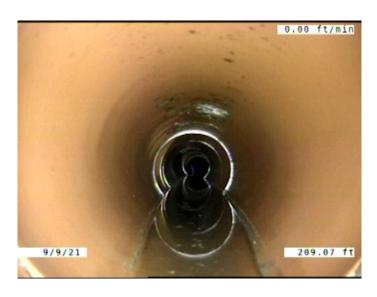
Code: MWLS

Description: Miscellaneous Water Level Sag

Distance (ft): 209.1
Structural Grade: 2
O&M Grade: 0

Value Percent: 10.000
Continuous Index: S03
Within 8" of Joint: NO

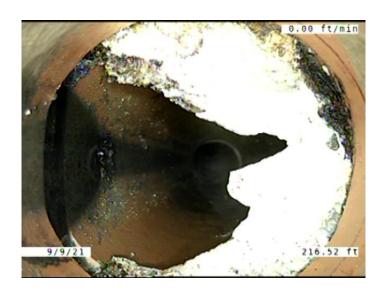
Description: Tap Factory

Distance (ft): 216.5
Structural Grade: 0
O&M Grade: 0
Clock Start/From: 10

Remarks: FIRST JOINT BACK HAS

**ENCRUSTATION**

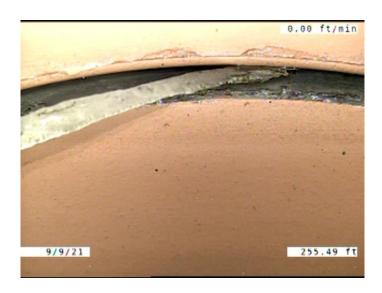
Code: ISSRH

Description: Intruding Sealing Material Sealing

**Ring Hanging**

Distance (ft): 255.5
Structural Grade: 0
O&M Grade: 2
Clock Start/From: 8
Clock To: 10

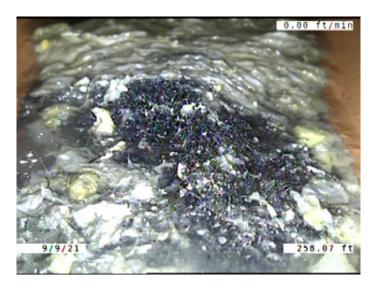
Code: DSZ

Description: Deposits Settled Other

Distance (ft): 258.1
Structural Grade: 0
O&M Grade: 2
Clock Start/From: 5
Clock To: 7
1st Value:

Remarks: CUT ROOTS, TP AND SEWER DEBRIS

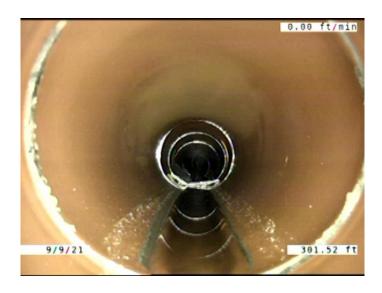
Code: MWLS

Description: Miscellaneous Water Level Sag

Distance (ft): 301.5
Structural Grade: 2
O&M Grade: 0

Value Percent: 10.000
Continuous Index: F03
Within 8" of Joint: NO

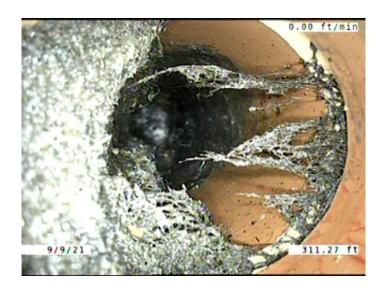
Description: Tap Factory

Distance (ft): 311.3
Structural Grade: 0
O&M Grade: 0
Clock Start/From: 9

Remarks: ROOTS GROWING IN THE TAP

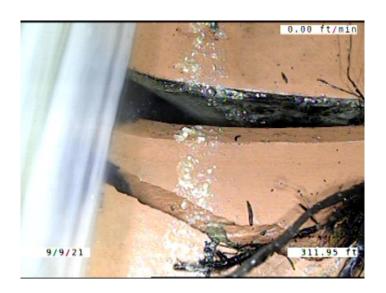
Code: B

Description: Broken

Distance (ft): 312.0
Structural Grade: 4

O&M Grade: 0
Clock Start/From: 3
Clock To: 5

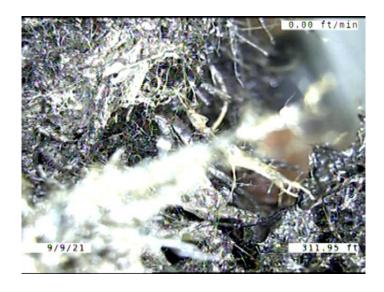
Code: RMJ

Description: Roots Medium Joint

Distance (ft): 312.0
Structural Grade: 0
O&M Grade: 3
Clock Start/From: 7
Clock To: 10

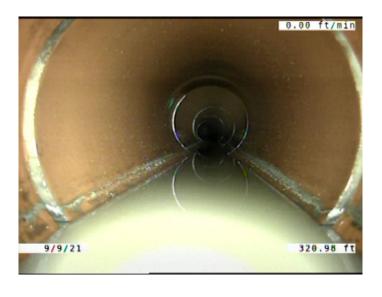
Code: MWLS

Description: Miscellaneous Water Level Sag

Distance (ft): 321.0
Structural Grade: 2
O&M Grade: 0

Value Percent: 5.000
