Profile/Photo Observation Report

Date:	04/07/2018	Weather:		Coding:	PACP 6.0
Pipe Length (ft):		Owner:	City of Hobart	Pre Clean:	No Pre-Cleaning
P.O.#:	17-1	Surveyor:	M. Pielacha	PSR:	M-404-032-M-404-031
Customer:	City of Hobart	Clean Date:		Shape:	C

Street:	Old Ridge Road	Flow Control:	Not Controlled
City:	Hobart, IN	Year Renewed:	
Location:	Light Highway	Tape/Media #:	DEP 17
Purpose:	Routine Assessment	Dia/Height:	18"
Use:	Sanitary	Material:	VCP
Drain Area:		Lining:	
Category:	NA		
Comment:			
Location Details:		Direction of Survey:	Downstream
US MH:	M-404-032	DS MH:	M-404-031
		Total Length Surveyed (ft):	41.6

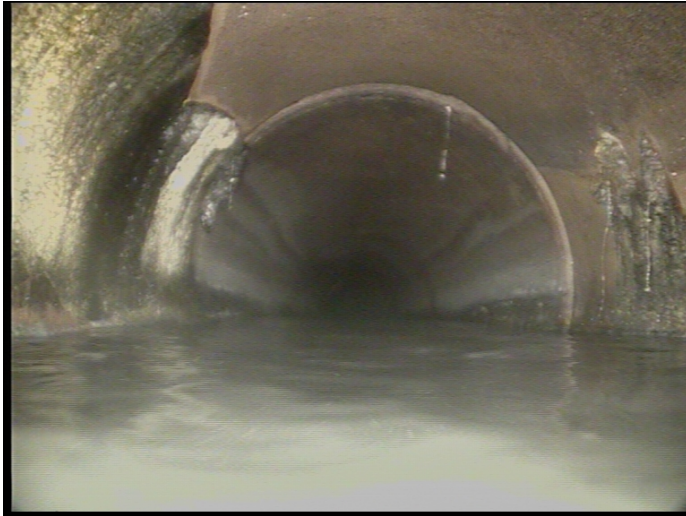
Code:	AMH
Description:	Manhole
Distance (ft):	.0
Structural Grade:	0
O&M Grade:	0
Clock Start/From:	
Clock To:	
1st Value:	
2nd Value:	
Value Percent:	
Continuous Index:	
Within 8" of Joint:	NO
Remarks:	M-404-032

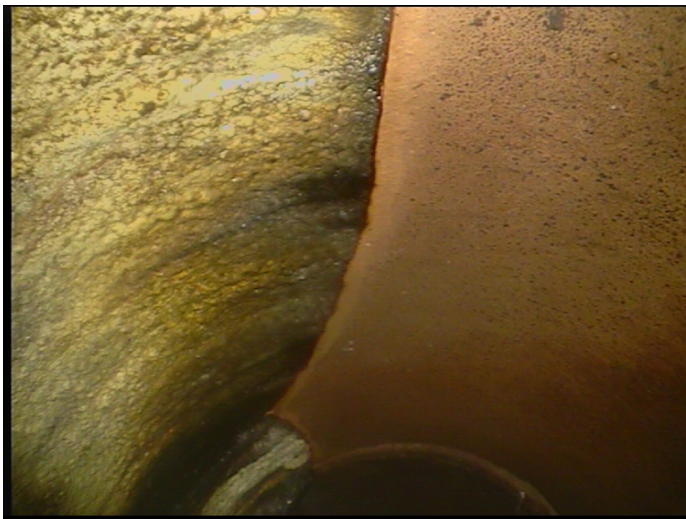
Code: **MWL**
Description: **Water Level**

Distance (ft): **.0**
Structural Grade: **0**
O&M Grade: **0**
Clock Start/From:
Clock To:
1st Value:
2nd Value:
Value Percent: **15.000**
Continuous Index:
Within 8" of Joint: **NO**
Remarks:

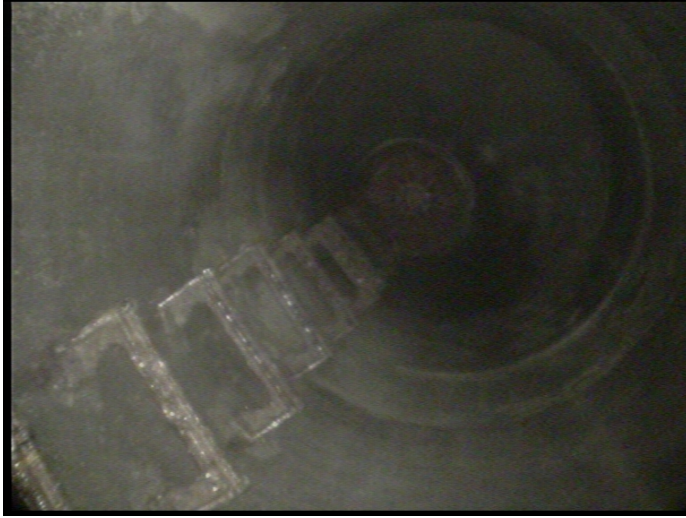
Code: **CL**
Description: **Crack Longitudinal**

Distance (ft): **.0**
Structural Grade: **2**
O&M Grade: **0**
Clock Start/From: **11**
Clock To:
1st Value:
2nd Value:
Value Percent:
Continuous Index:
Within 8" of Joint: **YES**
Remarks:
