Profile/Photo Observation Report

Date:	04/07/2018	Weather:		Coding:	PACP 6.0
Pipe Length (ft):		Owner:	City of Hobart	Pre Clean:	No Pre-Cleaning
P.O.#:	16-1	Surveyor:	M. Pielacha	PSR:	M-404-033-M-404-032
Customer:	City of Hobart	Clean Date:		Shape:	C

Street:	Old Ridge Road	Flow Control:	Not Controlled
City:	Hobart, IN	Year Renewed:	
Location:	Light Highway	Tape/Media #:	DEP 16
Purpose:	Routine Assessment	Dia/Height:	18"
Use:	Sanitary	Material:	VCP
Drain Area:		Lining:	
Category:	NA		
Comment:			
Location Details:		Direction of Survey:	Upstream
US MH:	M-404-033	DS MH:	M-404-032
		Total Length Surveyed (ft):	363.7

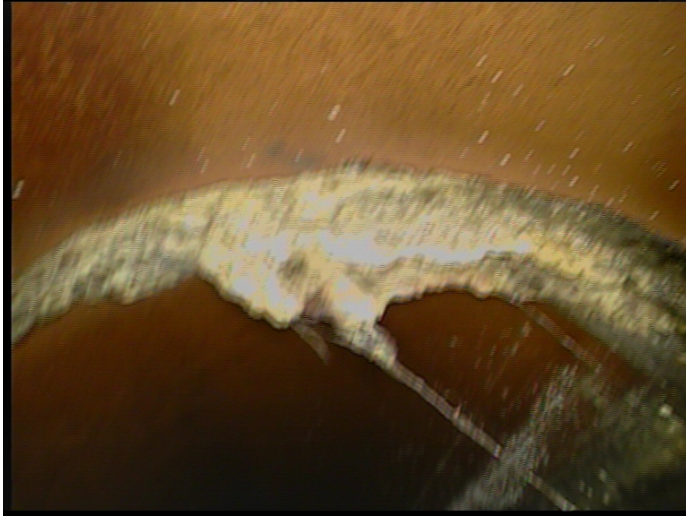
Code:	DAE
Description:	Deposits Attached Encrustation
Distance (ft):	44.1
Structural Grade:	0
O&M Grade:	2
Clock Start/From:	7
Clock To:	5
1st Value:	
2nd Value:	
Value Percent:	10.000
Continuous Index:	
Within 8" of Joint:	YES
Remarks:

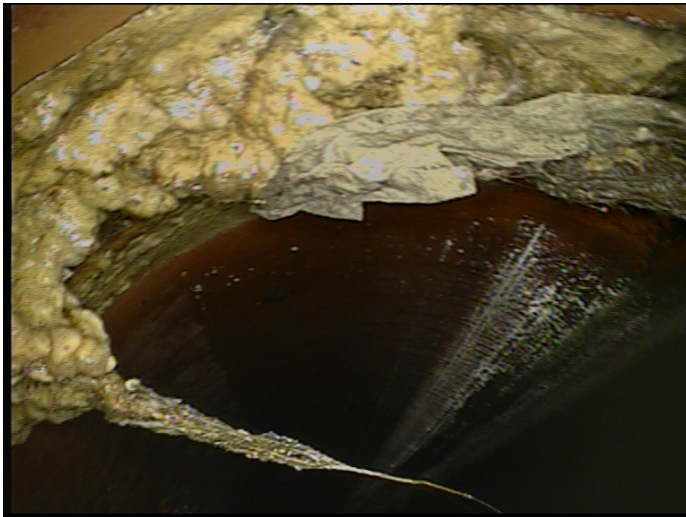
Code:	DAE
Description:	Deposits Attached Encrustation
Distance (ft):	96.2
Structural Grade:	0
O&M Grade:	2
Clock Start/From:	7
Clock To:	5
1st Value:	
2nd Value:	
Value Percent:	5.000
Continuous Index:	
Within 8" of Joint:	YES
Remarks:

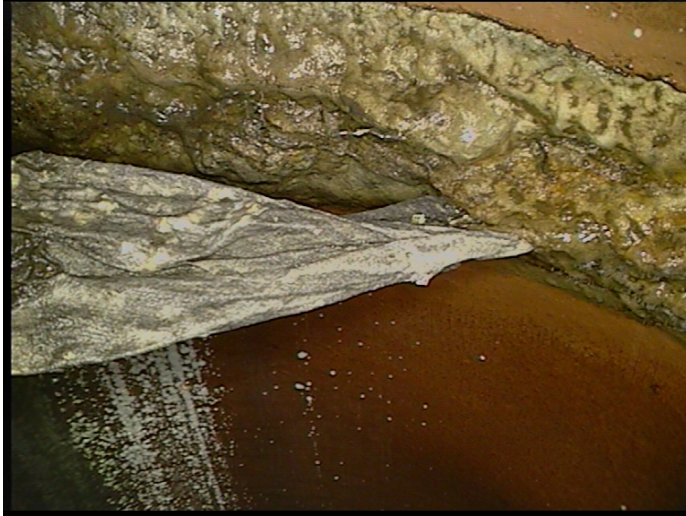
Code:	DAR
Description:	Deposits Attached Ragging
Distance (ft):	172.3
Structural Grade:	0
O&M Grade:	2
Clock Start/From:	11
Clock To:	
1st Value:	
2nd Value:	
Value Percent:	5.000
Continuous Index:	
Within 8" of Joint:	YES
Remarks:

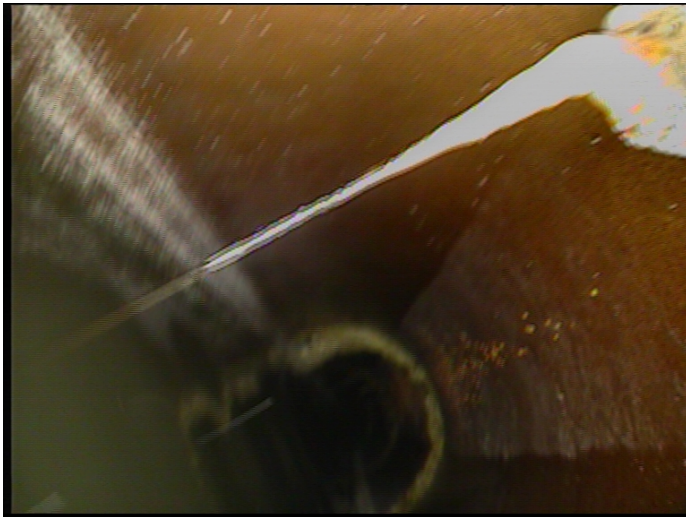
Code:	IR
Description:	Infil Runner
Distance (ft):	182.7
Structural Grade:	0
O&M Grade:	4
Clock Start/From:	11
Clock To:	
1st Value:	
2nd Value:	
Value Percent:	
Continuous Index:	
Within 8" of Joint:	YES
Remarks:

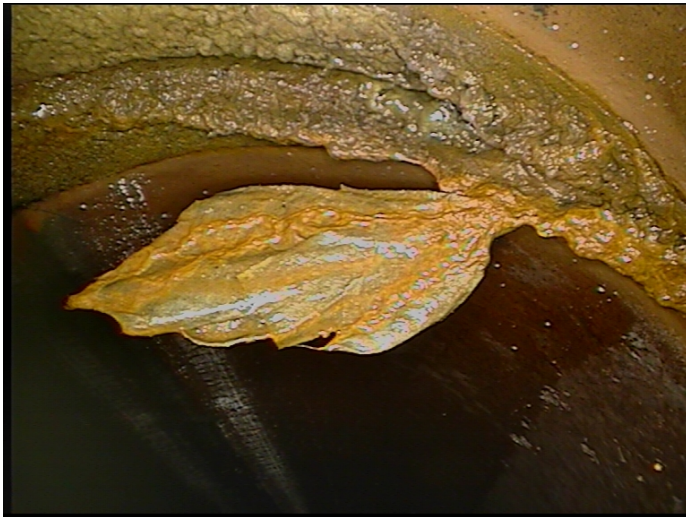
Code:	ID
Description:	Infil Dripper
Distance (ft):	246.2
Structural Grade:	0
O&M Grade:	3
Clock Start/From:	12
Clock To:	
1st Value:	
2nd Value:	
Value Percent:	
Continuous Index:	
Within 8" of Joint:	YES
Remarks:

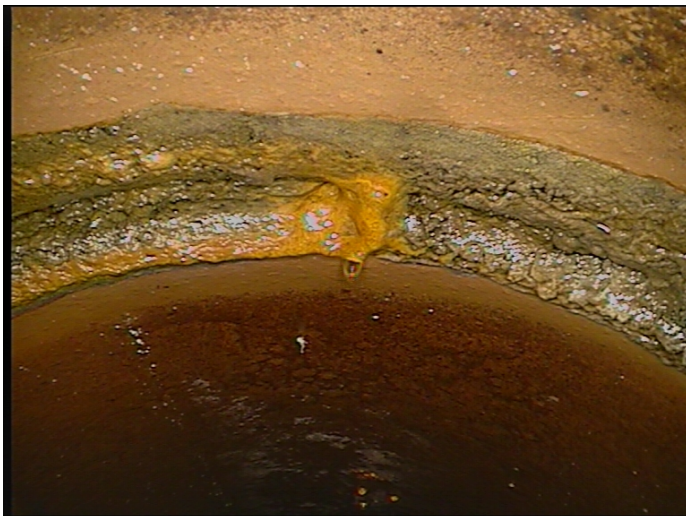
Code:	ID
Description:	Infil Dripper
Distance (ft):	292.5
Structural Grade:	0
O&M Grade:	3
Clock Start/From:	12
Clock To:	
1st Value:	
2nd Value:	
Value Percent:	
Continuous Index:	
Within 8" of Joint:	YES
Remarks:
