Profile/Photo Observation Report

Date:	04/07/2018	Weather:		Coding:	PACP 6.0
Pipe Length (ft):		Owner:	City of Hobart	Pre Clean:	No Pre-Cleaning
P.O.#:	16-1	Surveyor:	M. Pielacha	PSR:	M-404-033-M-404-032
Customer:	City of Hobart	Clean Date:		Shape:	C

Street:	Old Ridge Road	Flow Control:	Not Controlled
City:	Hobart, IN	Year Renewed:	
Location:	Light Highway	Tape/Media #:	DEP 16
Purpose:	Routine Assessment	Dia/Height:	18"
Use:	Sanitary	Material:	VCP
Drain Area:		Lining:	
Category:	NA		
Comment:			
Location Details:		Direction of Survey:	Upstream
US MH:	M-404-033	DS MH:	M-404-032
		Total Length Surveyed (ft):	363.7

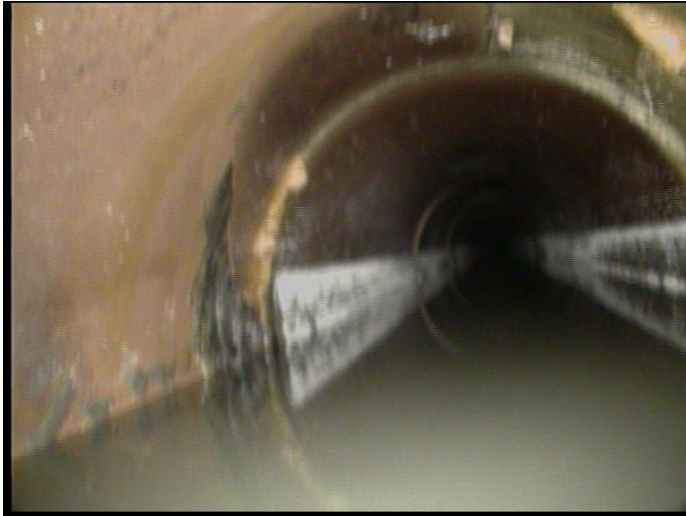
Code: **MWL**
Description: **Water Level**

Distance (ft): **.0**
Structural Grade: **0**
O&M Grade: **0**
Clock Start/From:
Clock To:
1st Value:
2nd Value:
Value Percent: **15.000**
Continuous Index:
Within 8" of Joint: **NO**
Remarks:

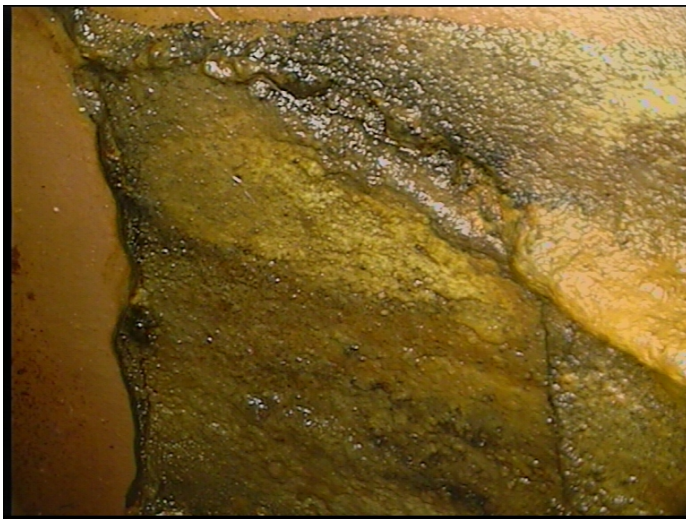
Code: **FM**
Description: **Fracture Multiple**

Distance (ft): **.0**
Structural Grade: **4**
O&M Grade: **0**
Clock Start/From: **12**
Clock To: **2**
1st Value:
2nd Value:
Value Percent:
Continuous Index:
Within 8" of Joint: **YES**
Remarks:

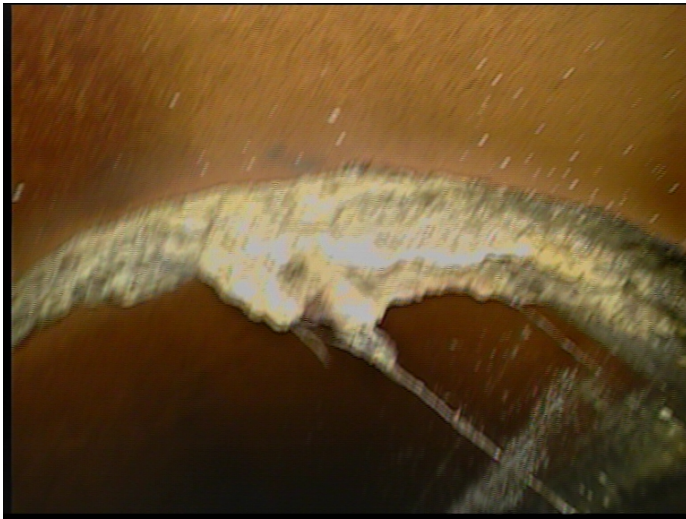
Code:	DAE
Description:	Deposits Attached Encrustation
Distance (ft):	44.1
Structural Grade:	0
O&M Grade:	2
Clock Start/From:	7
Clock To:	5
1st Value:	
2nd Value:	
Value Percent:	10.000
Continuous Index:	
Within 8" of Joint:	YES
Remarks:

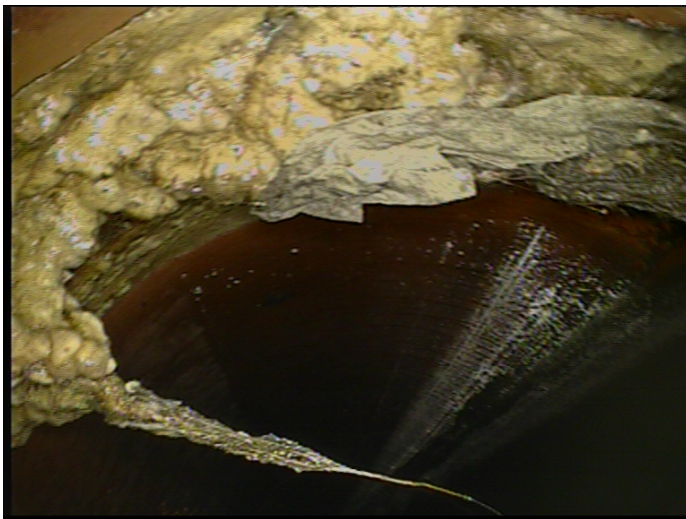
Code:	DAE
Description:	Deposits Attached Encrustation
Distance (ft):	96.2
Structural Grade:	0
O&M Grade:	2
Clock Start/From:	7
Clock To:	5
1st Value:	
2nd Value:	
Value Percent:	5.000
Continuous Index:	
Within 8" of Joint:	YES
Remarks:

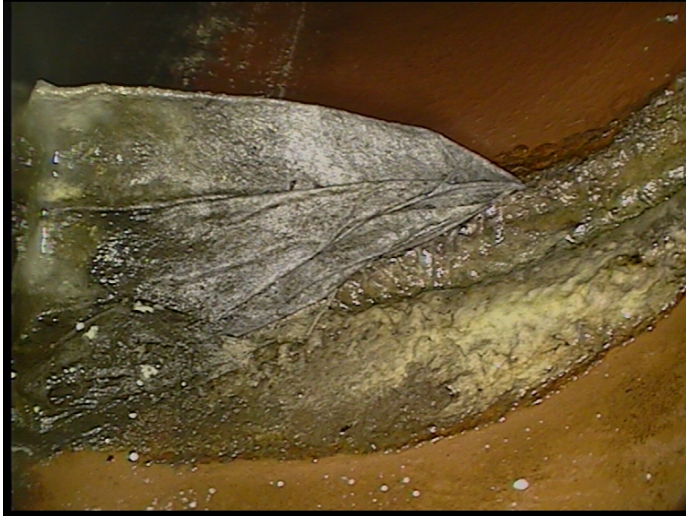
Code: **DAR**
Description: **Deposits Attached Ragging**

Distance (ft): **141.9**
Structural Grade: **0**
O&M Grade: **2**
Clock Start/From: **3**
Clock To: **4**
1st Value:
2nd Value:
Value Percent: **5.000**
Continuous Index:
Within 8" of Joint: **YES**
Remarks:

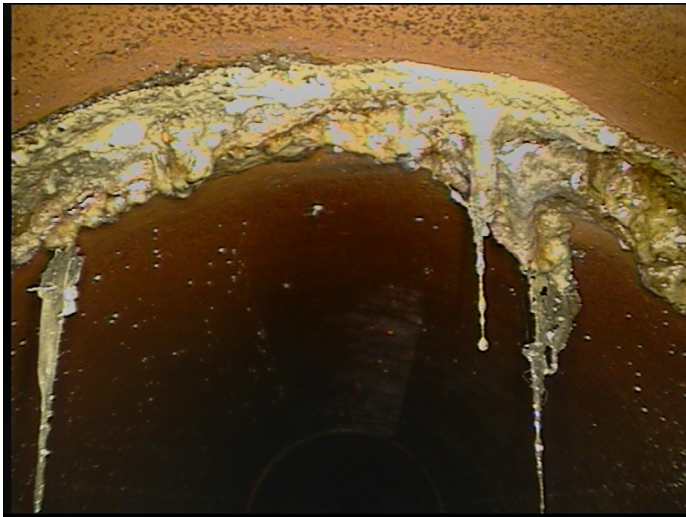
Code: **DAE**
Description: **Deposits Attached Encrustation**

Distance (ft): **146.5**
Structural Grade: **0**
O&M Grade: **2**
Clock Start/From: **7**
Clock To: **5**
1st Value:
2nd Value:
Value Percent: **5.000**
Continuous Index:
Within 8" of Joint: **YES**
Remarks:

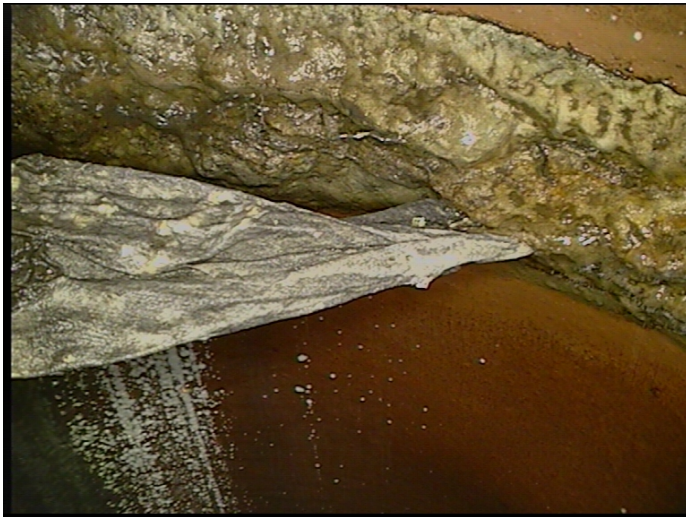
Code:	DAR
Description:	Deposits Attached Ragging
Distance (ft):	172.3
Structural Grade:	0
O&M Grade:	2
Clock Start/From:	11
Clock To:	
1st Value:	
2nd Value:	
Value Percent:	5.000
Continuous Index:	
Within 8" of Joint:	YES
Remarks:

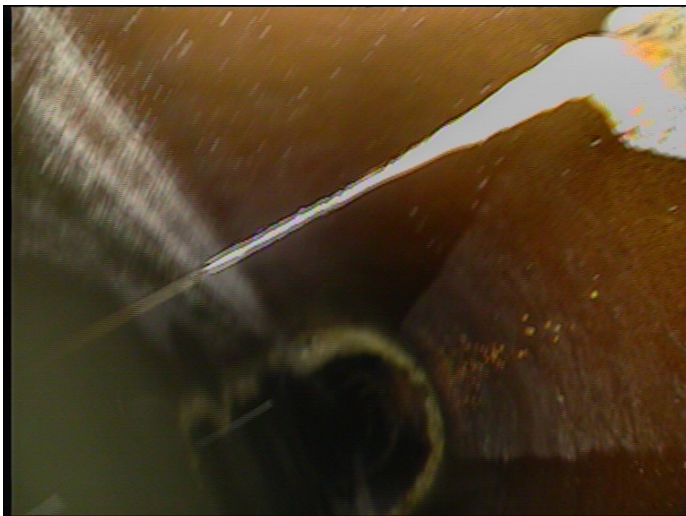
Code:	IR
Description:	Infil Runner
Distance (ft):	182.7
Structural Grade:	0
O&M Grade:	4
Clock Start/From:	11
Clock To:	
1st Value:	
2nd Value:	
Value Percent:	
Continuous Index:	
Within 8" of Joint:	YES
Remarks:

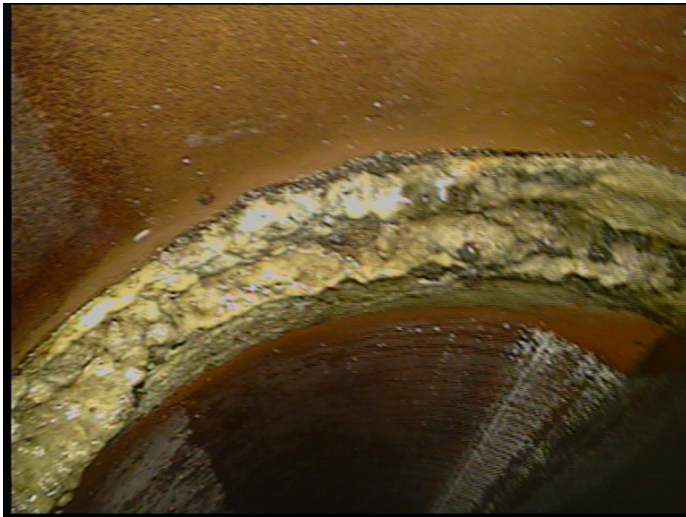
Code: **DAE**
Description: **Deposits Attached Encrustation**

Distance (ft): **187.3**
Structural Grade: **0**
O&M Grade: **2**
Clock Start/From: **7**
Clock To: **5**
1st Value:
2nd Value:
Value Percent: **5.000**
Continuous Index: **S01**
Within 8" of Joint: **YES**
Remarks:

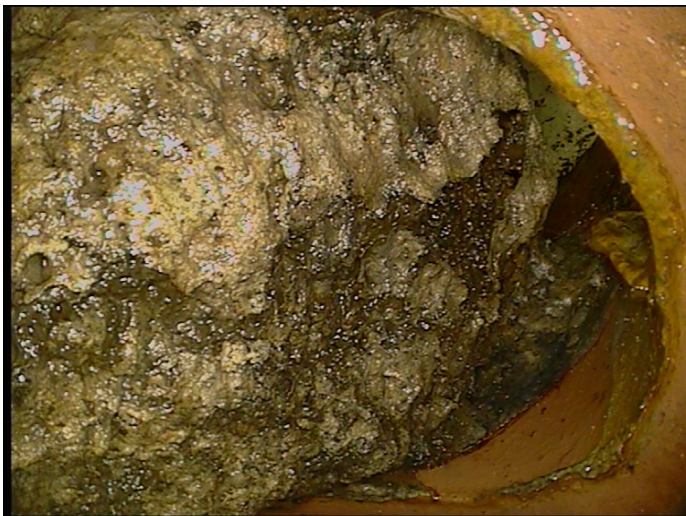
Code: **TFD**
Description: **Tap Factory Defective**

Distance (ft): **215.3**
Structural Grade: **0**
O&M Grade: **2**
Clock Start/From: **9**
Clock To:
1st Value: **4.000**
2nd Value:
Value Percent:
Continuous Index:
Within 8" of Joint: **NO**
Remarks: **Defective**

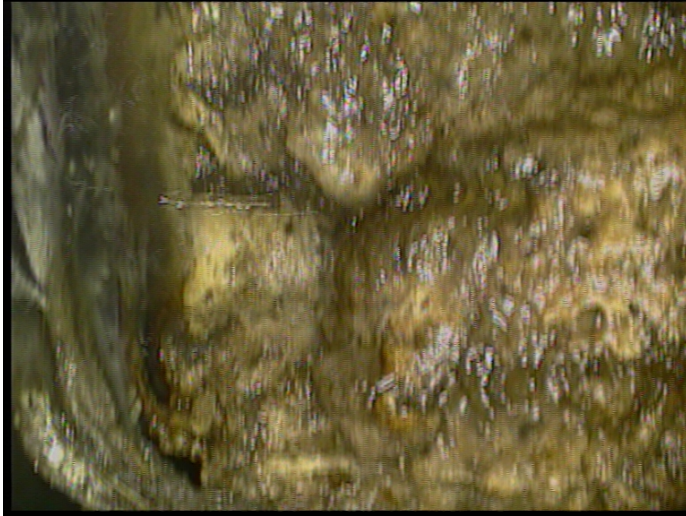
Code:	DAE
Description:	Deposits Attached Encrustation
Distance (ft):	215.3
Structural Grade:	0
O&M Grade:	2
Clock Start/From:	7
Clock To:	5
1st Value:	
2nd Value:	
Value Percent:	5.000
Continuous Index:	F01
Within 8" of Joint:	NO
Remarks:

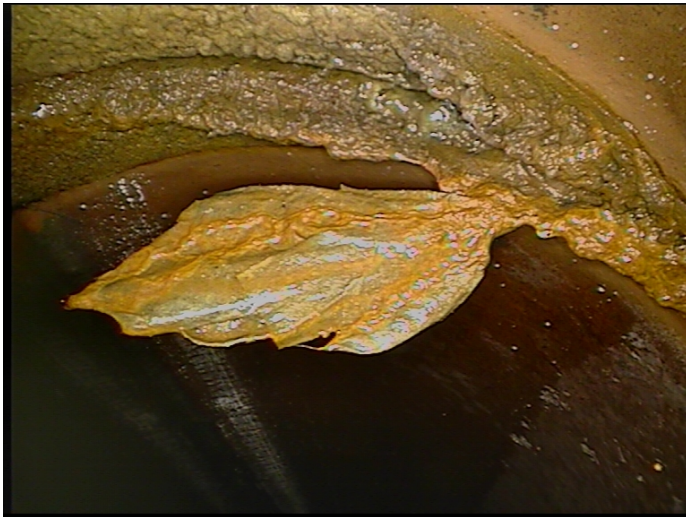
Code:	DAE
Description:	Deposits Attached Encrustation
Distance (ft):	246.2
Structural Grade:	0
O&M Grade:	2
Clock Start/From:	7
Clock To:	12
1st Value:	
2nd Value:	
Value Percent:	5.000
Continuous Index:	
Within 8" of Joint:	NO
Remarks:

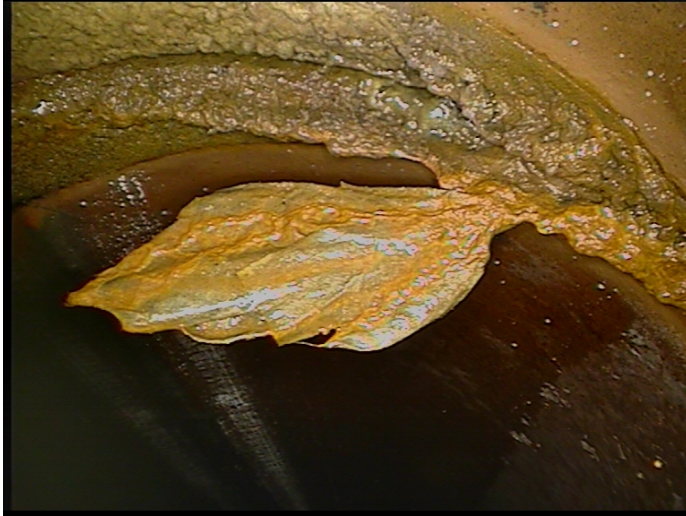
Code:	ID
Description:	Infil Dripper
Distance (ft):	246.2
Structural Grade:	0
O&M Grade:	3
Clock Start/From:	12
Clock To:	
1st Value:	
2nd Value:	
Value Percent:	
Continuous Index:	
Within 8" of Joint:	YES
Remarks:

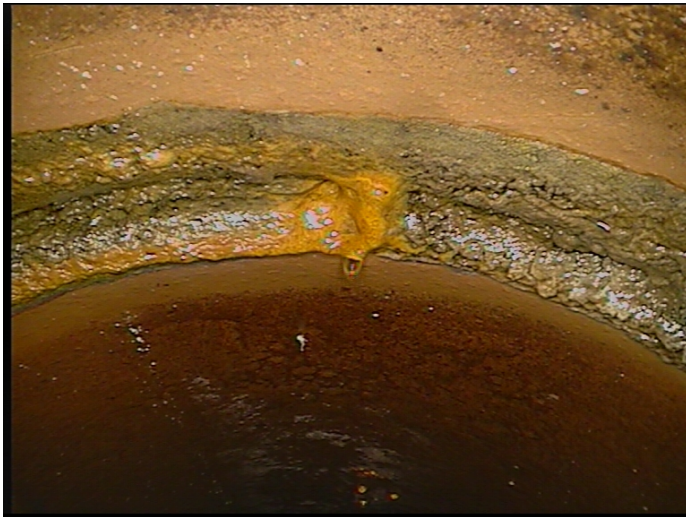
Code:	ID
Description:	Infil Dripper
Distance (ft):	292.5
Structural Grade:	0
O&M Grade:	3
Clock Start/From:	12
Clock To:	
1st Value:	
2nd Value:	
Value Percent:	
Continuous Index:	
Within 8" of Joint:	YES
Remarks:

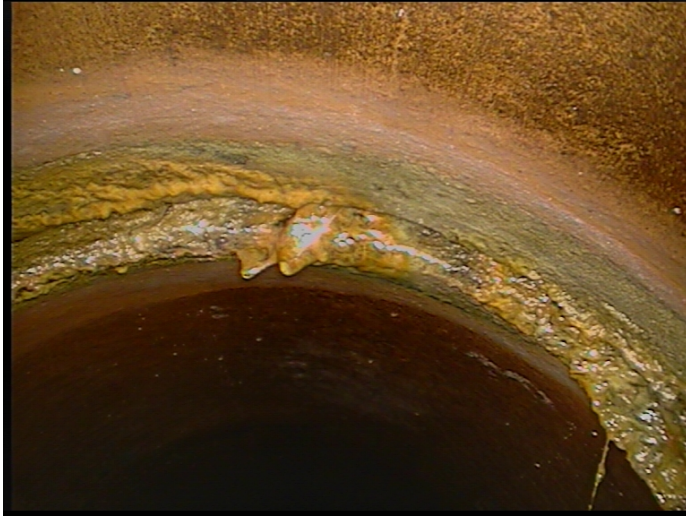
Code: **ID**
Description: **Infil Dripper**

Distance (ft): **302.3**
Structural Grade: **0**
O&M Grade: **3**
Clock Start/From: **12**
Clock To:
1st Value:
2nd Value:
Value Percent:
Continuous Index:
Within 8" of Joint: **YES**
Remarks:
