Profile/Photo Observation Report

Date:	04/10/2018	Weather:		Coding:	PACP 6.0
Pipe Length (ft):	117.4	Owner:	NA	Pre Clean:	Not Known
P.O.#:		Surveyor:	Mark Ruby	PSR:	P-404-037-036
Customer:		Clean Date:	01/01/1900	Shape:	C

Street:	DEARBORN ST	Flow Control:	Not Controlled
City:	Hobart, IN	Year Renewed:	
Location:	Other	Tape/Media #:	
Purpose:	Not Known	Dia/Height:	10"
Use:	Sanitary	Material:	PVC
Drain Area:	NA	Lining:	
Category:	NA		
Comment:

Location Details:		Direction of Survey:	Downstream
US MH:	M-404-037	DS MH:	M-404-036
		Total Length Surveyed (ft):	115.3

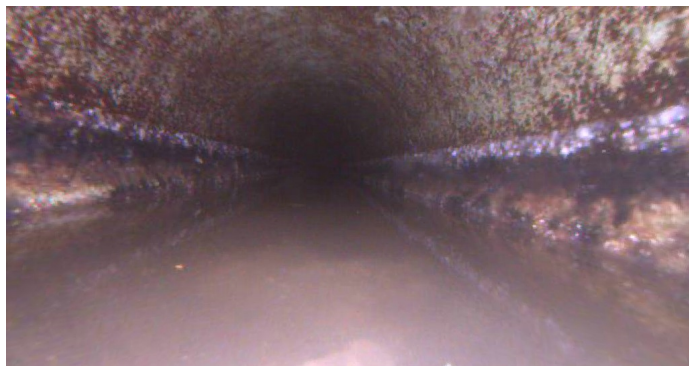
Code: **AMH**
Description: **Manhole**

Distance (ft): **.0**
Structural Grade: **0**
O&M Grade: **0**
Clock Start/From:
Clock To:
1st Value:
2nd Value:
Value Percent:
Continuous Index:
Within 8" of Joint: **NO**
Remarks: **M-404-037**

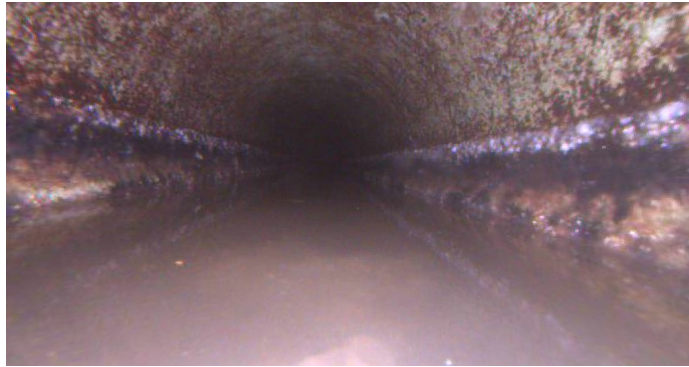
Code:	MWL
Description:	Water Level
Distance (ft):	.0
Structural Grade:	0
O&M Grade:	0
Clock Start/From:	
Clock To:	
1st Value:	
2nd Value:	
Value Percent:	10.000
Continuous Index:	
Within 8" of Joint:	NO
Remarks:

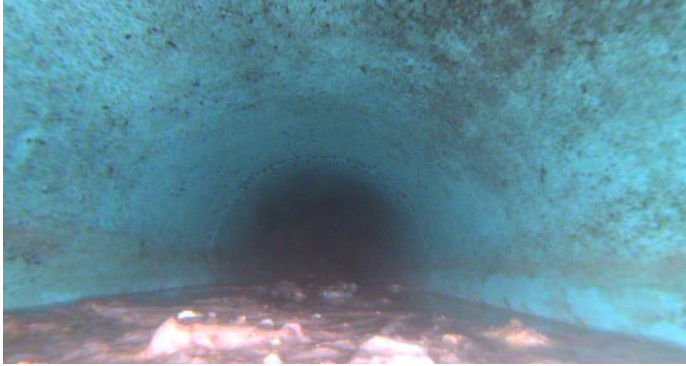
Code:	MWL
Description:	Water Level
Distance (ft):	54.7
Structural Grade:	0
O&M Grade:	0
Clock Start/From:	
Clock To:	
1st Value:	
2nd Value:	
Value Percent:	15.000
Continuous Index:	
Within 8" of Joint:	NO
Remarks:

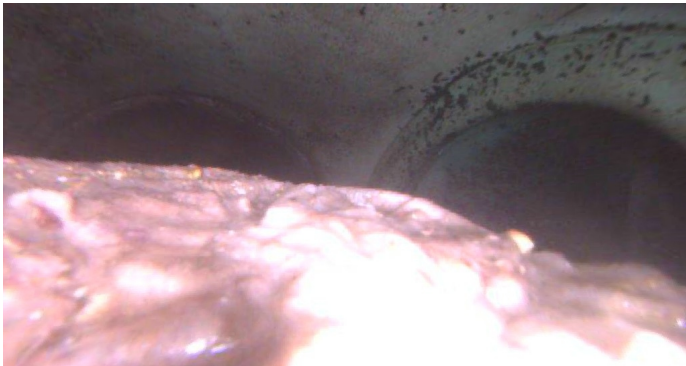
Code:	TF
Description:	Tap Factory
Distance (ft):	68.6
Structural Grade:	0
O&M Grade:	0
Clock Start/From:	4
Clock To:	
1st Value:	4.000
2nd Value:	
Value Percent:	
Continuous Index:	
Within 8" of Joint:	
Remarks:

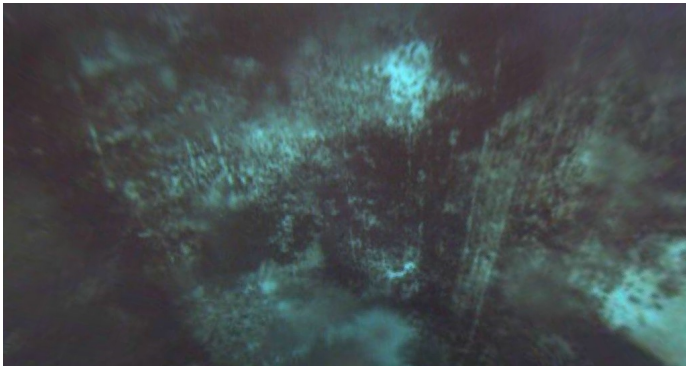
Code: **MCU**
Description: **Camera Underwater**

Distance (ft): **104.2**
Structural Grade: **0**
O&M Grade: **4**
Clock Start/From:
Clock To:
1st Value:
2nd Value:
Value Percent:
Continuous Index: **F01**
Within 8" of Joint: **NO**
Remarks:
