Profile/Photo Observation Report

Date:	04/10/2018	Weather:		Coding:	PACP 6.0
Pipe Length (ft):	117.4	Owner:	NA	Pre Clean:	Not Known
P.O.#:		Surveyor:	Mark Ruby	PSR:	P-404-037-036
Customer:		Clean Date:	01/01/1900	Shape:	C

Street:	W 40th ave	Flow Control:	Not Controlled
City:	Hobart, IN	Year Renewed:	
Location:	Other	Tape/Media #:	
Purpose:	Not Known	Dia/Height:	10"
Use:	Sanitary	Material:	PVC
Drain Area:	NA	Lining:	
Category:	NA		
Comment:

Location Details:		Direction of Survey:	Downstream
US MH:	M-404-037	DS MH:	M-404-036
		Total Length Surveyed (ft):	115.3

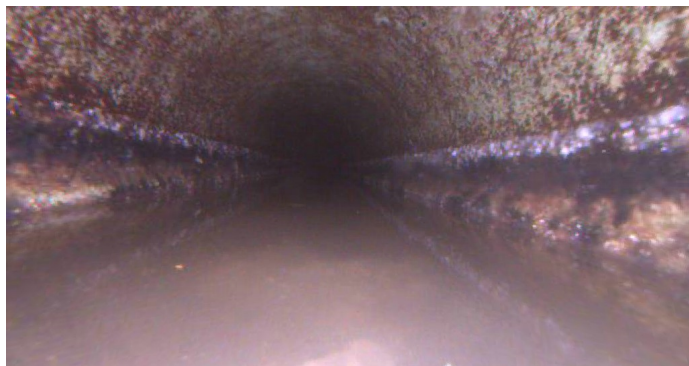
Code: **AMH**
 Description: **Manhole**

Distance (ft): **.0**
 Structural Grade: **0**
 O&M Grade: **0**
 Clock Start/From:
 Clock To:
 1st Value:
 2nd Value:
 Value Percent:
 Continuous Index:
 Within 8" of Joint: **NO**
 Remarks: **M-404-037**

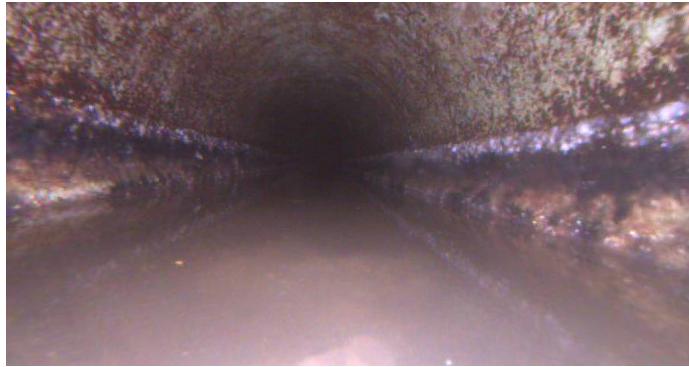
Code:	MWL
Description:	Water Level
Distance (ft):	.0
Structural Grade:	0
O&M Grade:	0
Clock Start/From:	
Clock To:	
1st Value:	
2nd Value:	
Value Percent:	10.000
Continuous Index:	
Within 8" of Joint:	NO
Remarks:

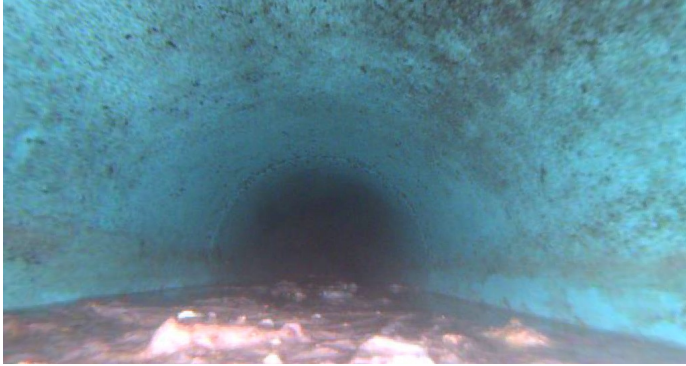
Code: **MWL**
Description: **Water Level**

Distance (ft): **54.7**
Structural Grade: **0**
O&M Grade: **0**
Clock Start/From:
Clock To:
1st Value:
2nd Value:
Value Percent: **15.000**
Continuous Index:
Within 8" of Joint: **NO**
Remarks:

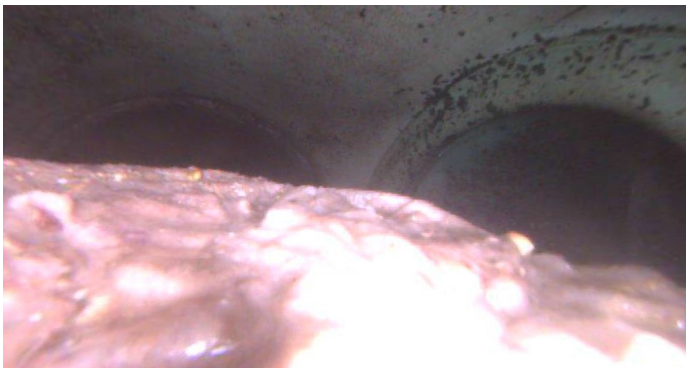
Code: **TF**
Description: **Tap Factory**

Distance (ft): **68.6**
Structural Grade: **0**
O&M Grade: **0**
Clock Start/From: **4**
Clock To:
1st Value: **4.000**
2nd Value:
Value Percent:
Continuous Index:
Within 8" of Joint:
Remarks:

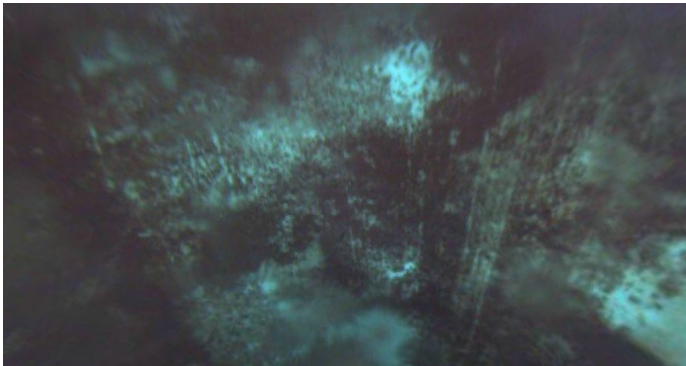
Code: **MCU**
Description: **Camera Underwater**

Distance (ft): **104.2**
Structural Grade: **0**
O&M Grade: **4**
Clock Start/From:
Clock To:
1st Value:
2nd Value:
Value Percent:
Continuous Index: **F01**
Within 8" of Joint: **NO**
Remarks:
