Profile/Photo Observation Report

Street:	DEARBORN ST	Flow Control:	Not Controlled
City:	Hobart, IN	Year Renewed:	
Location:	Other	Tape/Media #:	
Purpose:	Not Known	Dia/Height:	10"
Use:	Sanitary	Material:	PVC
Drain Area:	NA	Lining:	
Category:	NA		
Comment:

Location Details:		Direction of Survey:	Downstream
US MH:	M-404-038	DS MH:	M-404-037
		Total Length Surveyed (ft):	35.3

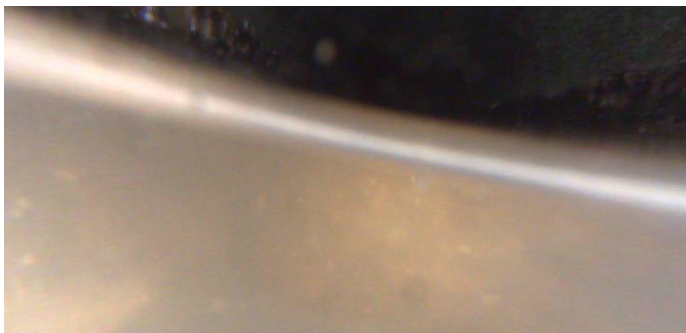
Code: **AMH**
Description: **Manhole**

Distance (ft): **.0**
Structural Grade: **0**
O&M Grade: **0**
Clock Start/From:
Clock To:
1st Value:
2nd Value:
Value Percent:
Continuous Index:
Within 8" of Joint: **NO**
Remarks: **M-404-038**

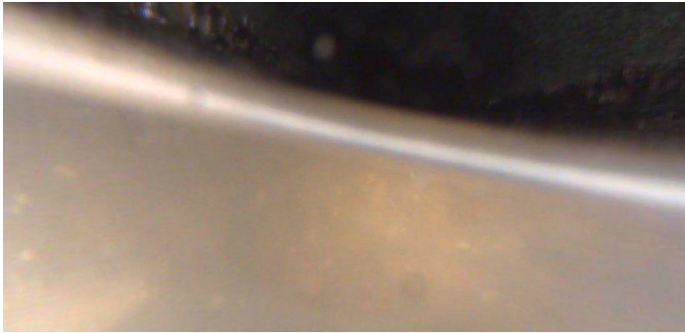
Code:	MWL
Description:	Water Level

Distance (ft):	.0
Structural Grade:	0
O&M Grade:	0
Clock Start/From:	
Clock To:	
1st Value:	
2nd Value:	
Value Percent:	15.000
Continuous Index:	
Within 8" of Joint:	NO
Remarks:

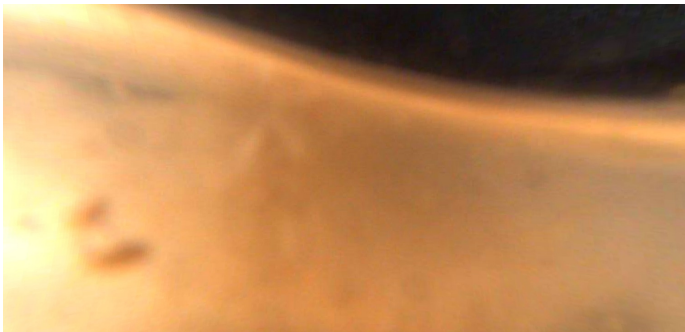
Code:	MCU
Description:	Camera Underwater

Distance (ft):	1.9
Structural Grade:	0
O&M Grade:	4
Clock Start/From:	
Clock To:	
1st Value:	
2nd Value:	
Value Percent:	
Continuous Index:	
Within 8" of Joint:	NO
Remarks:

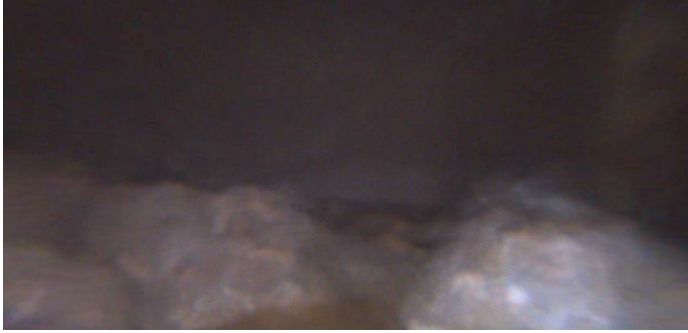
Code:	AMH
Description:	Manhole
Distance (ft):	35.3
Structural Grade:	0
O&M Grade:	0
Clock Start/From:	
Clock To:	
1st Value:	
2nd Value:	
Value Percent:	
Continuous Index:	
Within 8" of Joint:	NO
Remarks:	M-404-037
