Profile/Photo Observation Report

Date:	04/10/2018	Weather:		Coding:	PACP 6.0
Pipe Length (ft):	37.9	Owner:	NA	Pre Clean:	Not Known
P.O.#:		Surveyor:	Byrd Fitzgerald	PSR:	P-404-038-037
Customer:		Clean Date:	01/01/1900	Shape:	C

Street:	W 40th ave	Flow Control:	Not Controlled
City:	Hobart, IN	Year Renewed:	
Location:	Other	Tape/Media #:	
Purpose:	Not Known	Dia/Height:	10"
Use:	Sanitary	Material:	PVC
Drain Area:	NA	Lining:	
Category:	NA		
Comment:

Location Details:		Direction of Survey:	Downstream
US MH:	M-404-038	DS MH:	M-404-037
		Total Length Surveyed (ft):	35.3

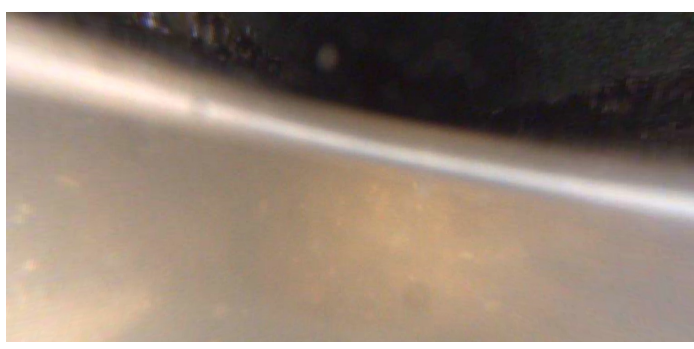
Code: **AMH**
Description: **Manhole**

Distance (ft): **.0**
Structural Grade: **0**
O&M Grade: **0**
Clock Start/From:
Clock To:
1st Value:
2nd Value:
Value Percent:
Continuous Index:
Within 8" of Joint: **NO**
Remarks: **M-404-038**

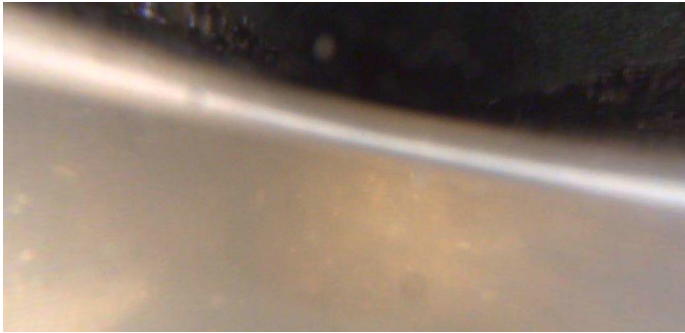
Code:	MWL
Description:	Water Level

Distance (ft):	.0
Structural Grade:	0
O&M Grade:	0
Clock Start/From:	
Clock To:	
1st Value:	
2nd Value:	
Value Percent:	15.000
Continuous Index:	
Within 8" of Joint:	NO
Remarks:

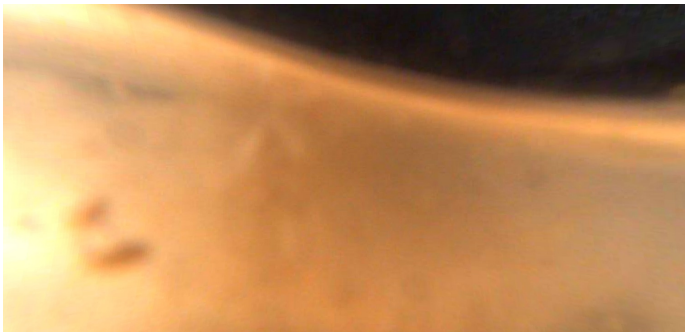
Code:	MCU
Description:	Camera Underwater

Distance (ft):	1.9
Structural Grade:	0
O&M Grade:	4
Clock Start/From:	
Clock To:	
1st Value:	
2nd Value:	
Value Percent:	
Continuous Index:	
Within 8" of Joint:	NO
Remarks:

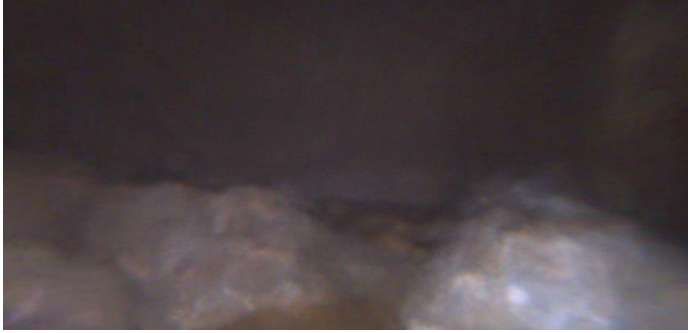
Code:	AMH
Description:	Manhole
Distance (ft):	35.3
Structural Grade:	0
O&M Grade:	0
Clock Start/From:	
Clock To:	
1st Value:	
2nd Value:	
Value Percent:	
Continuous Index:	
Within 8" of Joint:	NO
Remarks:	M-404-037
