## Profile/Photo Observation Report

Street:	<b>W 4TH PL &amp; S WABASH PL</b>	Flow Control:	<b>Not Controlled</b>
City:	<b>Hobart, IN</b>	Year Renewed:	
Location:	<b>Yard</b>	Tape/Media #:	
Purpose:	<b>Routine Assessment</b>	Dia/Height:	<b>10"</b>
Use:	<b>Sanitary</b>	Material:	<b>VCP</b>
Drain Area:	<b>NA</b>	Lining:	<b>Cured in Place</b>
Category:	<b>NA</b>		
Comment:	<b>Flow direction is marked wrong.</b>		
Location Details:		Direction of Survey:	<b>Downstream</b>
US MH:	<b>M-405-001</b>	DS MH:	<b>M-505-091</b>
		Total Length Surveyed (ft):	<b>155.1</b>

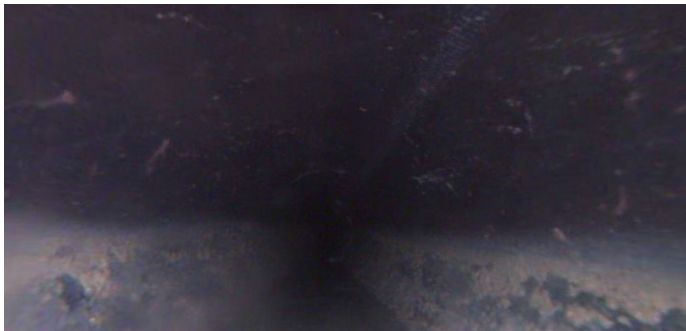
Code: **AMH**  
Description: **Manhole**

Distance (ft): **.0**  
Structural Grade: **0**  
O&M Grade: **0**  
Clock Start/From:  
Clock To:  
1st Value:  
2nd Value:  
Value Percent:  
Continuous Index:  
Within 8" of Joint: **NO**  
Remarks: **M-405-001**

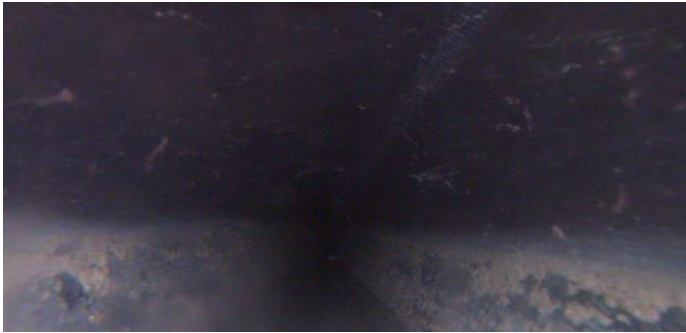
Code:	<b>MWL</b>
Description:	<b>Water Level</b>

Distance (ft):	<b>.0</b>
Structural Grade:	<b>0</b>
O&M Grade:	<b>0</b>
Clock Start/From:	
Clock To:	
1st Value:	
2nd Value:	
Value Percent:	<b>5.000</b>
Continuous Index:	
Within 8" of Joint:	<b>NO</b>
Remarks:

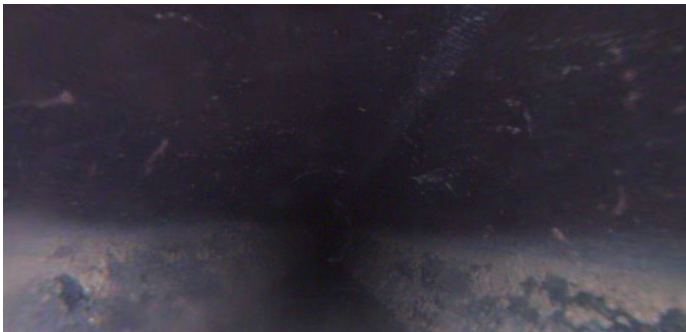
Code:	<b>DAGS</b>
Description:	<b>Deposits Attached Grease</b>

Distance (ft):	<b>.0</b>
Structural Grade:	<b>0</b>
O&M Grade:	<b>2</b>
Clock Start/From:	<b>8</b>
Clock To:	<b>4</b>
1st Value:	
2nd Value:	
Value Percent:	<b>5.000</b>
Continuous Index:	<b>S01</b>
Within 8" of Joint:	<b>NO</b>
Remarks:

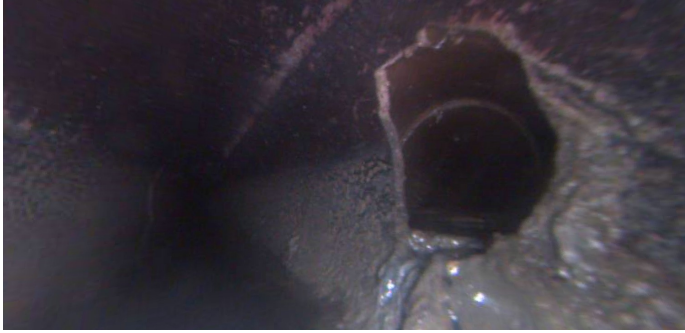
Code: **LFUC**  
Description: **Lining Failure Undercut Connection**

Distance (ft): **5.0**  
Structural Grade: **3**  
O&M Grade: **0**  
Clock Start/From: **3**  
Clock To:  
1st Value:  
2nd Value:  
Value Percent:  
Continuous Index:  
Within 8" of Joint: **NO**  
Remarks:

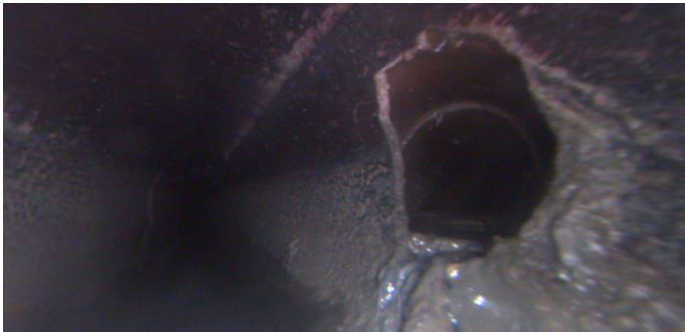
Code: **TFA**  
Description: **Tap Factory Active**

Distance (ft): **5.0**  
Structural Grade: **0**  
O&M Grade: **0**  
Clock Start/From: **3**  
Clock To:  
1st Value: **4.000**  
2nd Value:  
Value Percent:  
Continuous Index:  
Within 8" of Joint:  
Remarks:

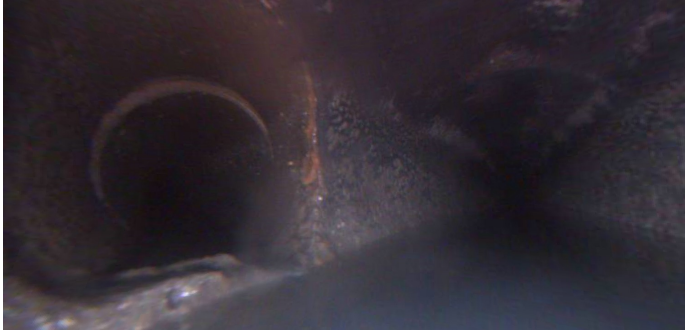
Code: **TFA**  
Description: **Tap Factory Active**

Distance (ft): **8.0**  
Structural Grade: **0**  
O&M Grade: **0**  
Clock Start/From: **9**  
Clock To:  
1st Value: **4.000**  
2nd Value:  
Value Percent:  
Continuous Index:  
Within 8" of Joint:  
Remarks:

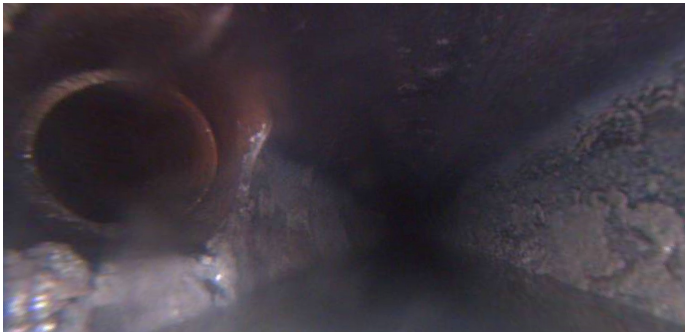
Code: **TFA**  
Description: **Tap Factory Active**

Distance (ft): **128.5**  
Structural Grade: **0**  
O&M Grade: **0**  
Clock Start/From: **9**  
Clock To:  
1st Value: **4.000**  
2nd Value:  
Value Percent:  
Continuous Index:  
Within 8" of Joint:  
Remarks:

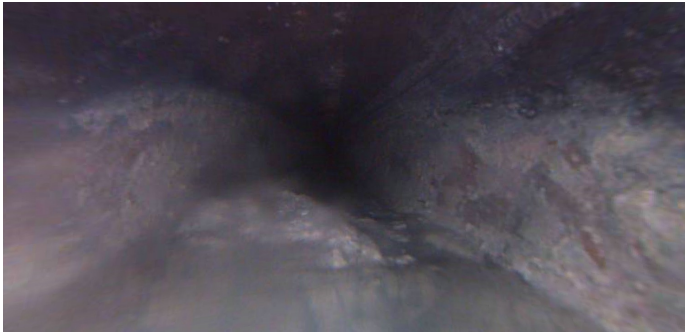
Code: **OBZ**  
Description: **Obstacle Other**

Distance (ft): **153.2**  
Structural Grade: **0**  
O&M Grade: **2**  
Clock Start/From: **6**  
Clock To: **8**  
1st Value:  
2nd Value:  
Value Percent: **10.000**  
Continuous Index:  
Within 8" of Joint: **NO**  
Remarks: **MISC**

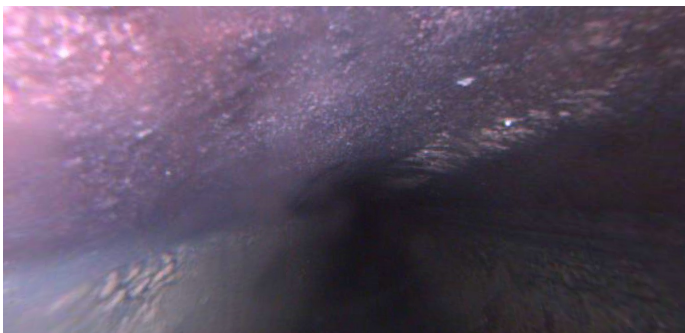
Code: **MSA**  
Description: **Abandoned Survey**

Distance (ft): **155.1**  
Structural Grade: **0**  
O&M Grade: **0**  
Clock Start/From:  
Clock To:  
1st Value:  
2nd Value:  
Value Percent:  
Continuous Index:  
Within 8" of Joint: **NO**  
Remarks: **DEBRIS UNDER WATER**

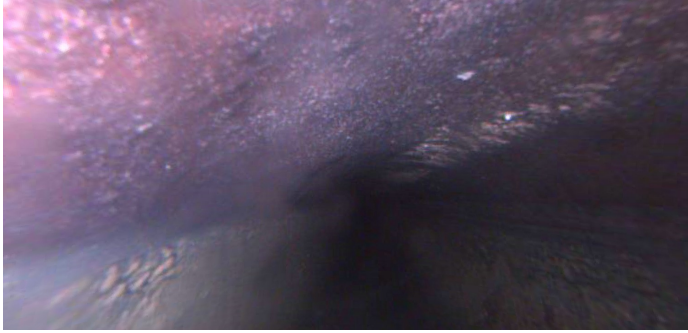
Code:	<b>DAGS</b>
Description:	<b>Deposits Attached Grease</b>
Distance (ft):	<b>155.1</b>
Structural Grade:	<b>0</b>
O&M Grade:	<b>2</b>
Clock Start/From:	<b>8</b>
Clock To:	<b>4</b>
1st Value:	
2nd Value:	
Value Percent:	<b>5.000</b>
Continuous Index:	<b>F01</b>
Within 8" of Joint:	<b>NO</b>
Remarks:
