Profile/Photo Observation Report

Date:	04/14/2018	Weather:		Coding:	PACP 6.0
Pipe Length (ft):	229.4	Owner:	NA	Pre Clean:	No Pre-Cleaning
P.O.#:		Surveyor:	Jen Costello	PSR:	P-505-091-001
Customer:		Clean Date:	01/01/1900	Shape:	C

Street:	FOXCROFT STREET	Flow Control:	Not Controlled
City:	Hobart, IN	Year Renewed:	
Location:	Yard	Tape/Media #:	
Purpose:	Routine Assessment	Dia/Height:	10"
Use:	Sanitary	Material:	VCP
Drain Area:	NA	Lining:	Cured in Place
Category:	NA		
Comment:	Flow direction is marked wrong.		
Location Details:		Direction of Survey:	Downstream
US MH:	M-405-001	DS MH:	M-505-091
		Total Length Surveyed (ft):	155.1

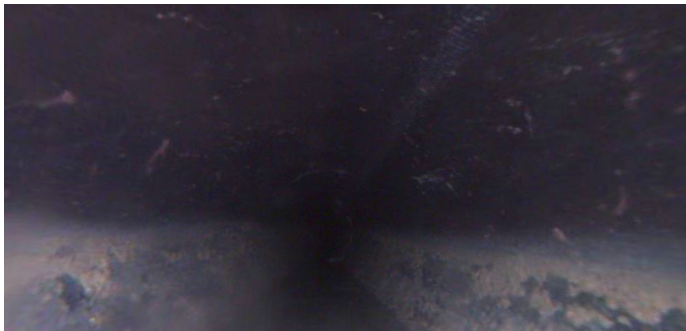
Code: **AMH**
Description: **Manhole**

Distance (ft): **.0**
Structural Grade: **0**
O&M Grade: **0**
Clock Start/From:
Clock To:
1st Value:
2nd Value:
Value Percent:
Continuous Index:
Within 8" of Joint: **NO**
Remarks: **M-405-001**

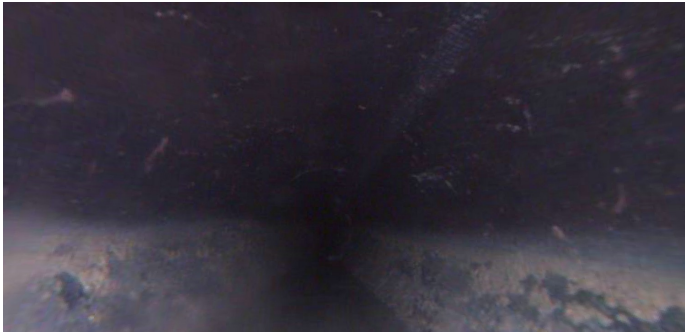
Code:	MWL
Description:	Water Level

Distance (ft):	.0
Structural Grade:	0
O&M Grade:	0
Clock Start/From:	
Clock To:	
1st Value:	
2nd Value:	
Value Percent:	5.000
Continuous Index:	
Within 8" of Joint:	NO
Remarks:

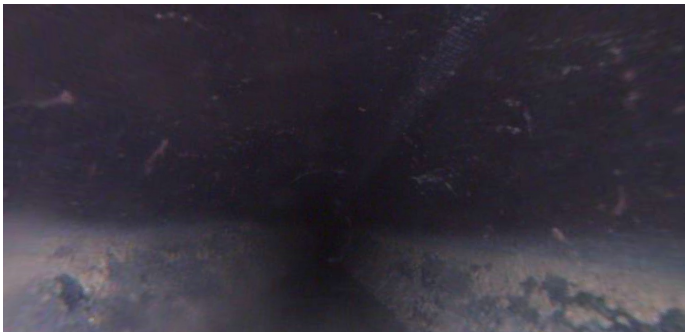
Code:	DAGS
Description:	Deposits Attached Grease

Distance (ft):	.0
Structural Grade:	0
O&M Grade:	2
Clock Start/From:	8
Clock To:	4
1st Value:	
2nd Value:	
Value Percent:	5.000
Continuous Index:	S01
Within 8" of Joint:	NO
Remarks:

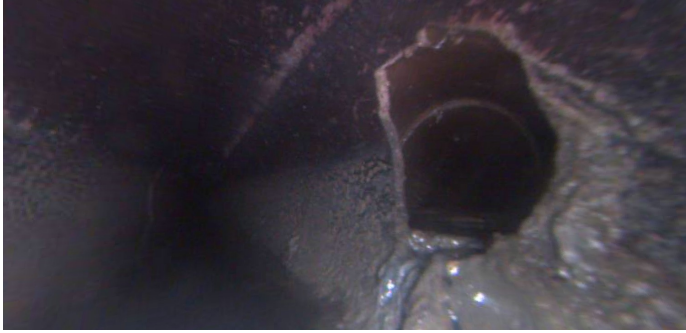
Code: **LFUC**
Description: **Lining Failure Undercut Connection**

Distance (ft): **5.0**
Structural Grade: **3**
O&M Grade: **0**
Clock Start/From: **3**
Clock To:
1st Value:
2nd Value:
Value Percent:
Continuous Index:
Within 8" of Joint: **NO**
Remarks:

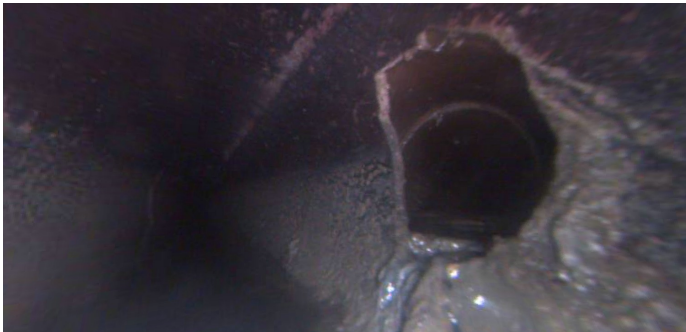
Code: **TFA**
Description: **Tap Factory Active**

Distance (ft): **5.0**
Structural Grade: **0**
O&M Grade: **0**
Clock Start/From: **3**
Clock To:
1st Value: **4.000**
2nd Value:
Value Percent:
Continuous Index:
Within 8" of Joint:
Remarks:

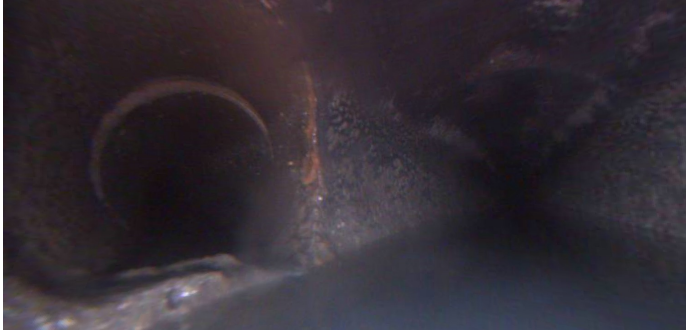
Code: **TFA**
Description: **Tap Factory Active**

Distance (ft): **8.0**
Structural Grade: **0**
O&M Grade: **0**
Clock Start/From: **9**
Clock To:
1st Value: **4.000**
2nd Value:
Value Percent:
Continuous Index:
Within 8" of Joint:
Remarks:

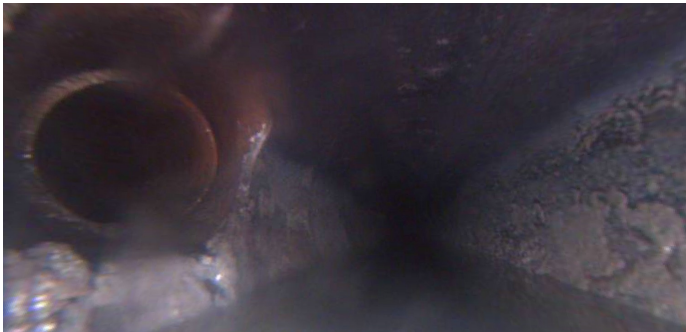
Code: **TFA**
Description: **Tap Factory Active**

Distance (ft): **128.5**
Structural Grade: **0**
O&M Grade: **0**
Clock Start/From: **9**
Clock To:
1st Value: **4.000**
2nd Value:
Value Percent:
Continuous Index:
Within 8" of Joint:
Remarks:

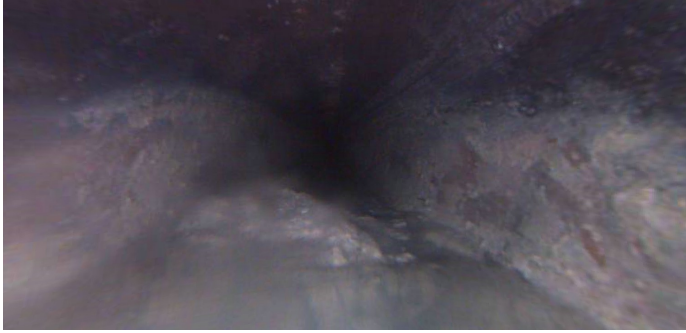
Code: **OBZ**
Description: **Obstacle Other**

Distance (ft): **153.2**
Structural Grade: **0**
O&M Grade: **2**
Clock Start/From: **6**
Clock To: **8**
1st Value:
2nd Value:
Value Percent: **10.000**
Continuous Index:
Within 8" of Joint: **NO**
Remarks: **MISC**

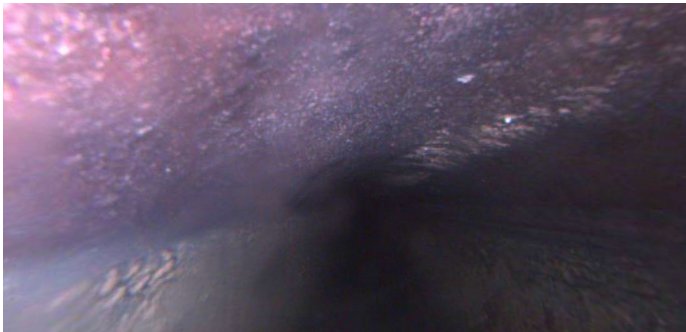
Code: **MSA**
Description: **Abandoned Survey**

Distance (ft): **155.1**
Structural Grade: **0**
O&M Grade: **0**
Clock Start/From:
Clock To:
1st Value:
2nd Value:
Value Percent:
Continuous Index:
Within 8" of Joint: **NO**
Remarks: **DEBRIS UNDER WATER**

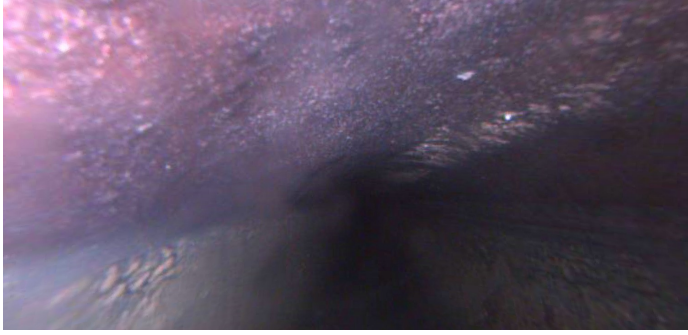
Code:	DAGS
Description:	Deposits Attached Grease
Distance (ft):	155.1
Structural Grade:	0
O&M Grade:	2
Clock Start/From:	8
Clock To:	4
1st Value:	
2nd Value:	
Value Percent:	5.000
Continuous Index:	F01
Within 8" of Joint:	NO
Remarks:
