Profile/Photo Observation Report

Date:	01/15/2022	Weather:		Coding:	PACP 7.0
Pipe Length (ft):	234.9	Owner:	City of Hobart	Pre Clean:	Light Cleaning
P.O.#:	YES502259	Surveyor:	S. Bucklin	PSR:	P-505-091-001
Customer:	City of Hobart	Clean Date:	01/13/2021	Shape:	C

Street:	West 4th Place	Flow Control:	Not Controlled
City:	Hobart, IN	Year Renewed:	
Location:	Local rural streets with light traffic, t	Tape/Media #:	
Purpose:	Routine Assessment	Dia/Height:	8"
Use:	Sanitary Sewage Pipe	Material:	VCP
Drain Area:		Lining:	Not Known
Category:	NA

Comment:		Direction of Survey:	Downstream
Location Details:			
US MH:	M-405-001	DS MH:	M-505-091
		Total Length Surveyed (ft):	234.9

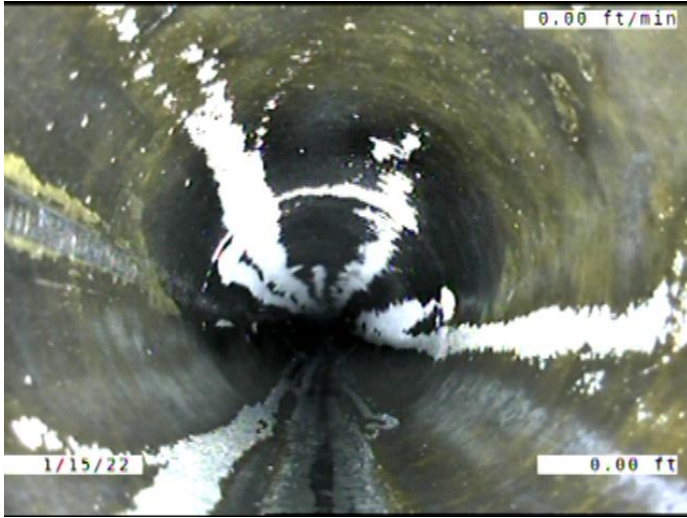
Code: **MWL**
Description: **Miscellaneous Water Level**

Distance (ft): **.0**
Structural Grade: **0**
O&M Grade: **0**
Clock Start/From:
Clock To:
1st Value:
2nd Value:
Value Percent: **5.000**
Continuous Index:
Within 8" of Joint: **NO**
Remarks:

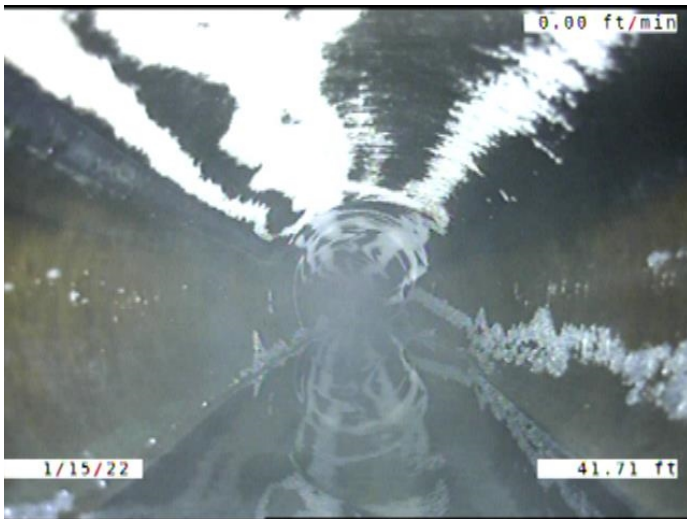
Code: **MWLS**
Description: **Miscellaneous Water Level Sag**

Distance (ft): **41.7**
Structural Grade: **2**
O&M Grade: **0**
Clock Start/From:
Clock To:
1st Value:
2nd Value:
Value Percent: **10.000**
Continuous Index: **S01**
Within 8" of Joint: **NO**
Remarks:

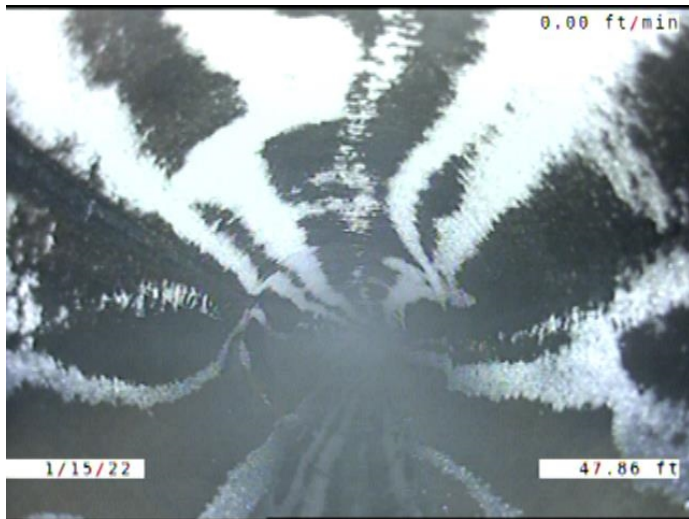
Code: **MWLS**
Description: **Miscellaneous Water Level Sag**

Distance (ft): **47.9**
Structural Grade: **2**
O&M Grade: **0**
Clock Start/From:
Clock To:
1st Value:
2nd Value:
Value Percent: **10.000**
Continuous Index: **F01**
Within 8" of Joint: **NO**
Remarks:

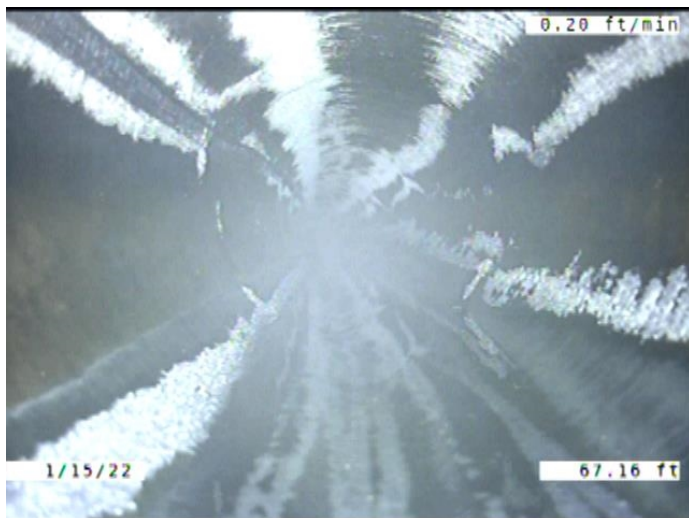
Code: **MWLS**
Description: **Miscellaneous Water Level Sag**

Distance (ft): **67.1**
Structural Grade: **2**
O&M Grade: **0**
Clock Start/From:
Clock To:
1st Value:
2nd Value:
Value Percent: **10.000**
Continuous Index: **S02**
Within 8" of Joint: **NO**
Remarks:

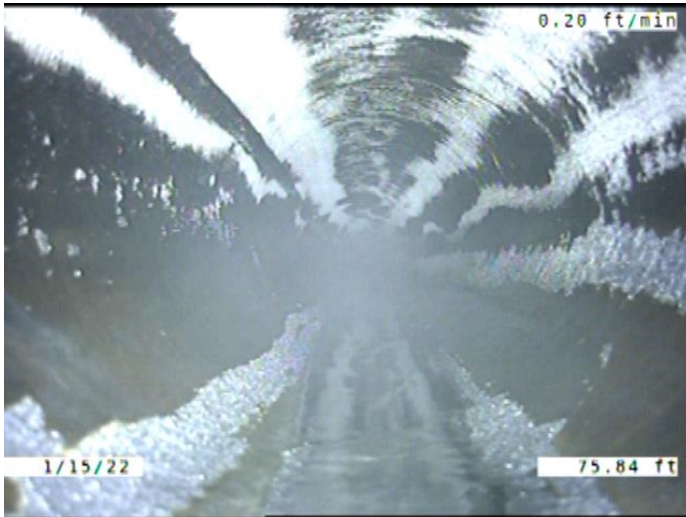
Code: **MWLS**
Description: **Miscellaneous Water Level Sag**

Distance (ft): **75.8**
Structural Grade: **2**
O&M Grade: **0**
Clock Start/From:
Clock To:
1st Value:
2nd Value:
Value Percent: **10.000**
Continuous Index: **F02**
Within 8" of Joint: **NO**
Remarks:

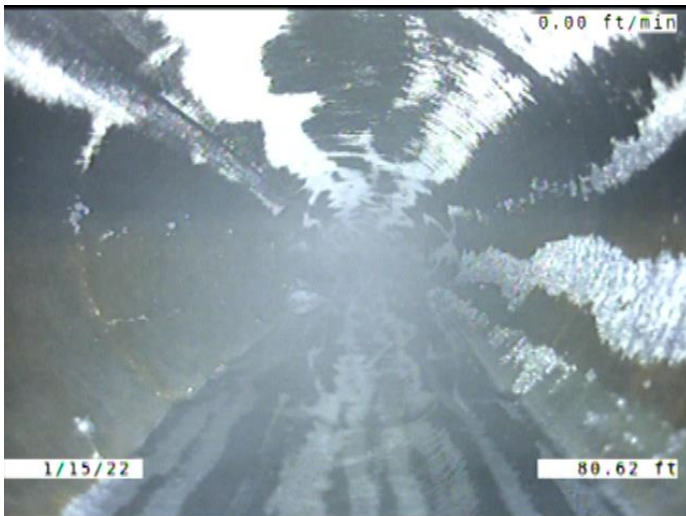
Code: **MWLS**
Description: **Miscellaneous Water Level Sag**

Distance (ft): **80.6**
Structural Grade: **2**
O&M Grade: **0**
Clock Start/From:
Clock To:
1st Value:
2nd Value:
Value Percent: **10.000**
Continuous Index: **S03**
Within 8" of Joint: **NO**
Remarks:

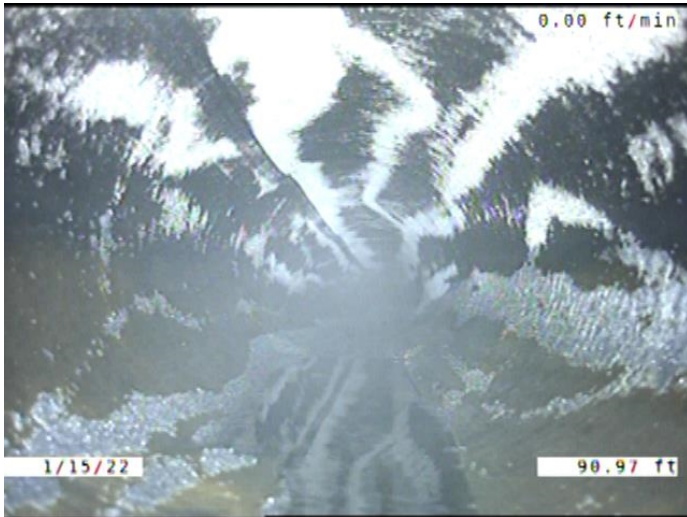
Code: **MWLS**
 Description: **Miscellaneous Water Level Sag**

Distance (ft): **91.0**
 Structural Grade: **2**
 O&M Grade: **0**
 Clock Start/From:
 Clock To:
 1st Value:
 2nd Value:
 Value Percent: **10.000**
 Continuous Index: **F03**
 Within 8" of Joint: **NO**
 Remarks:

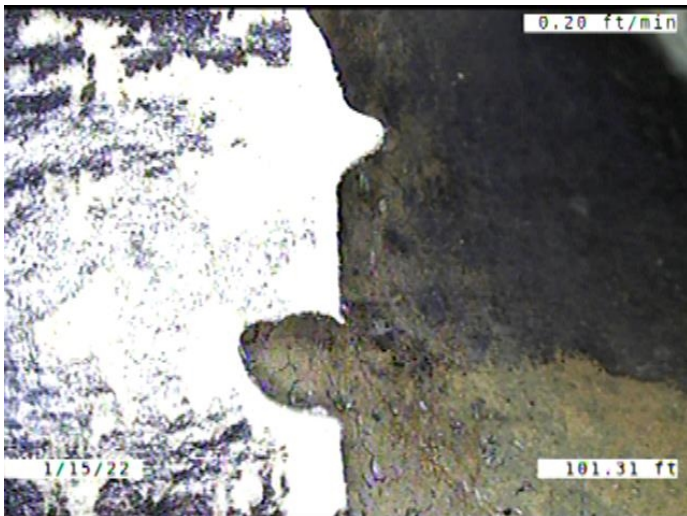
Code: **LFUC**
 Description: **Lining Feature Undercut Service**

Distance (ft): **101.3**
 Structural Grade: **3**
 O&M Grade: **0**
 Clock Start/From: **1**
 Clock To: **3**
 1st Value:
 2nd Value:
 Value Percent:
 Continuous Index:
 Within 8" of Joint: **NO**
 Remarks:

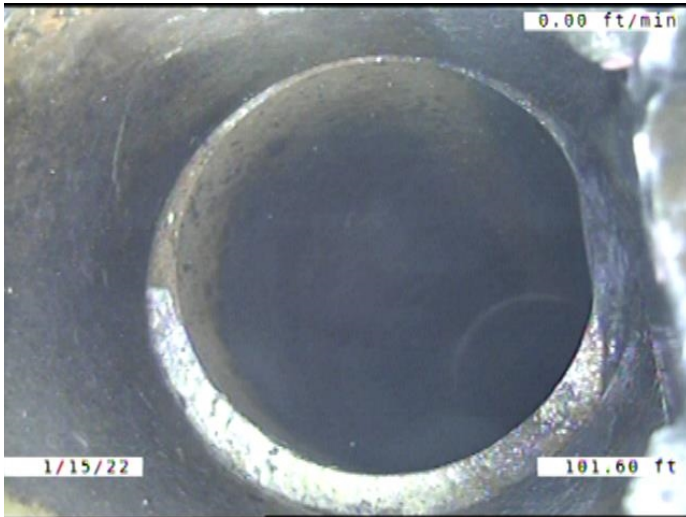
Code: **TB**
Description: **Tap Break-in/Hammer**

Distance (ft): **101.6**
Structural Grade: **0**
O&M Grade: **0**
Clock Start/From: **2**
Clock To:
1st Value: **4.000**
2nd Value:
Value Percent:
Continuous Index:
Within 8" of Joint: **YES**
Remarks: **CONSTANTLY RUNNING WATER.**

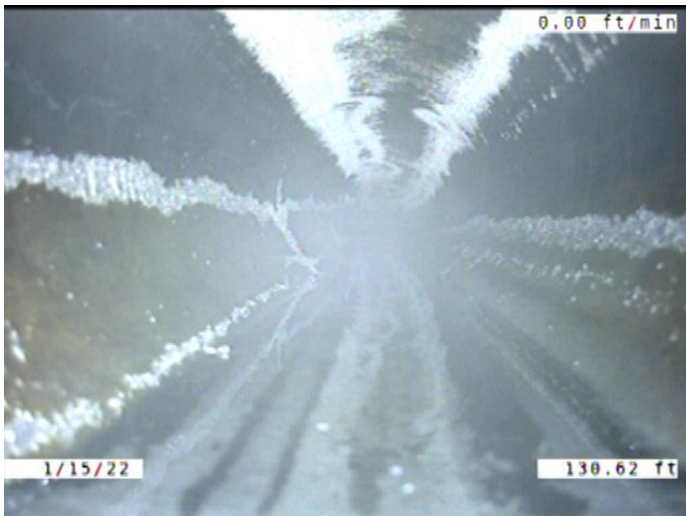
Code: **MWLS**
Description: **Miscellaneous Water Level Sag**

Distance (ft): **130.6**
Structural Grade: **2**
O&M Grade: **0**
Clock Start/From:
Clock To:
1st Value:
2nd Value:
Value Percent: **10.000**
Continuous Index: **S04**
Within 8" of Joint: **NO**
Remarks:

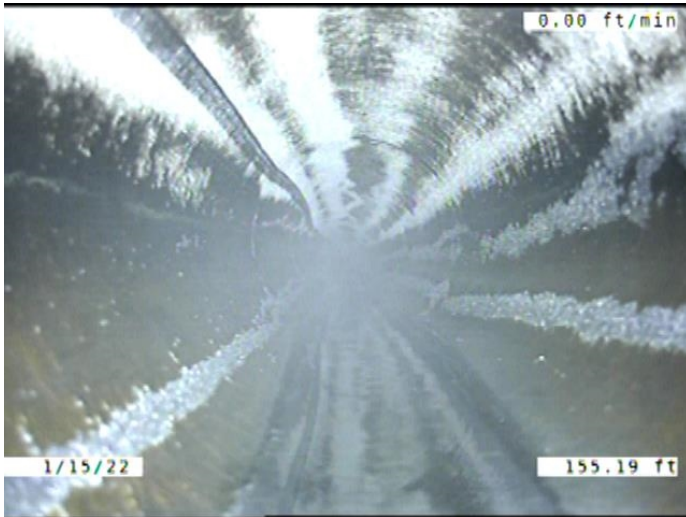
Code: **MWLS**
Description: **Miscellaneous Water Level Sag**

Distance (ft): **155.2**
Structural Grade: **2**
O&M Grade: **0**
Clock Start/From:
Clock To:
1st Value:
2nd Value:
Value Percent: **10.000**
Continuous Index: **F04**
Within 8" of Joint: **NO**
Remarks:

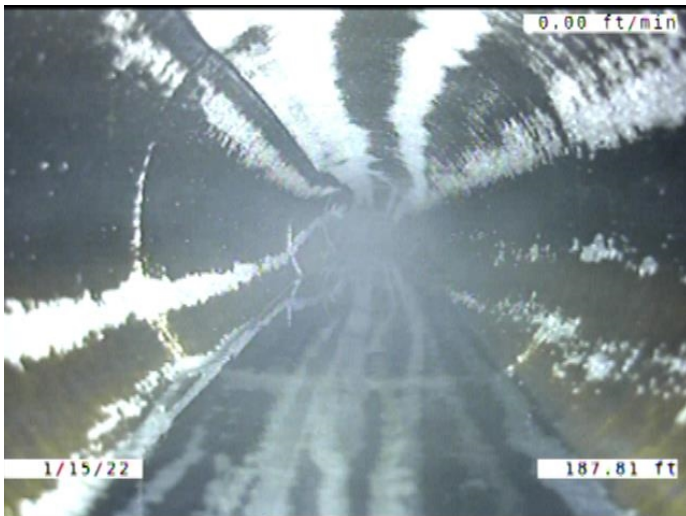
Code: **MWLS**
Description: **Miscellaneous Water Level Sag**

Distance (ft): **187.8**
Structural Grade: **2**
O&M Grade: **0**
Clock Start/From:
Clock To:
1st Value:
2nd Value:
Value Percent: **10.000**
Continuous Index: **S05**
Within 8" of Joint: **NO**
Remarks:

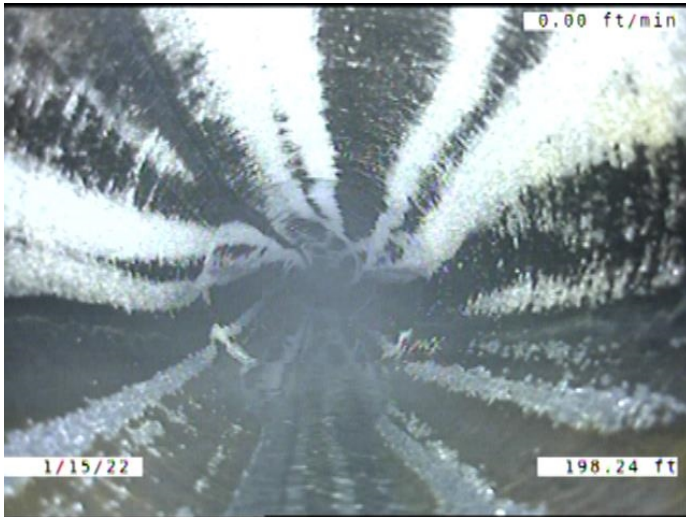
Code: **MWLS**
Description: **Miscellaneous Water Level Sag**

Distance (ft): **198.2**
Structural Grade: **2**
O&M Grade: **0**
Clock Start/From:
Clock To:
1st Value:
2nd Value:
Value Percent: **10.000**
Continuous Index: **F05**
Within 8" of Joint: **NO**
Remarks:

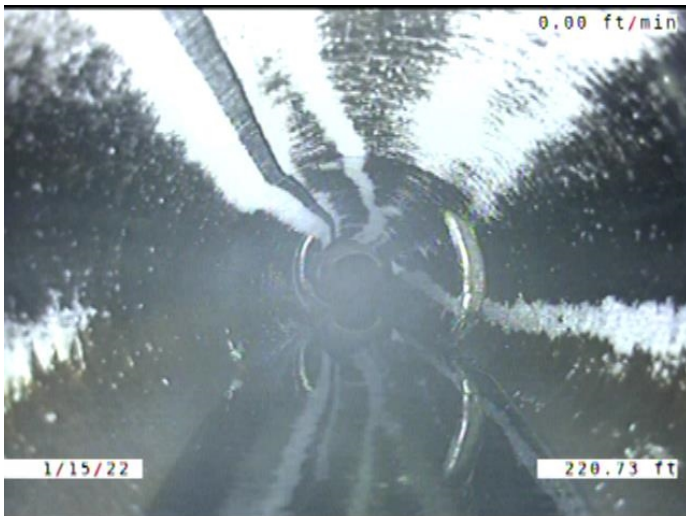
Code: **MWLS**
Description: **Miscellaneous Water Level Sag**

Distance (ft): **220.7**
Structural Grade: **2**
O&M Grade: **0**
Clock Start/From:
Clock To:
1st Value:
2nd Value:
Value Percent: **10.000**
Continuous Index: **S06**
Within 8" of Joint: **NO**
Remarks:

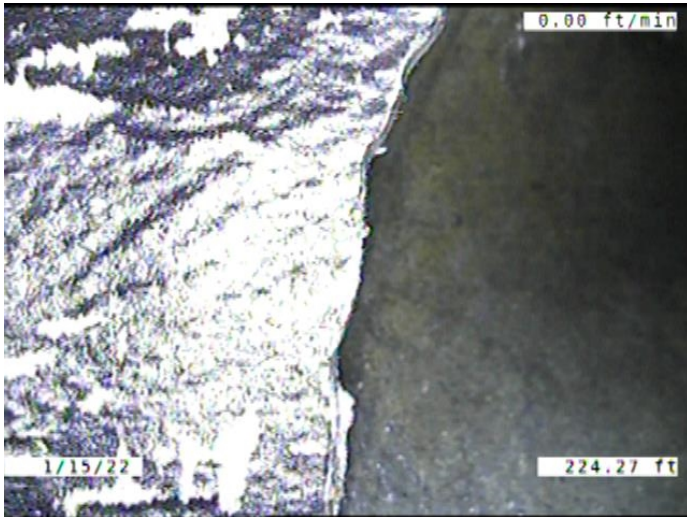
Code: **LFUC**
 Description: **Lining Feature Undercut Service**

Distance (ft): **224.3**
 Structural Grade: **3**
 O&M Grade: **0**
 Clock Start/From: **1**
 Clock To: **3**
 1st Value:
 2nd Value:
 Value Percent:
 Continuous Index:
 Within 8" of Joint: **NO**
 Remarks:

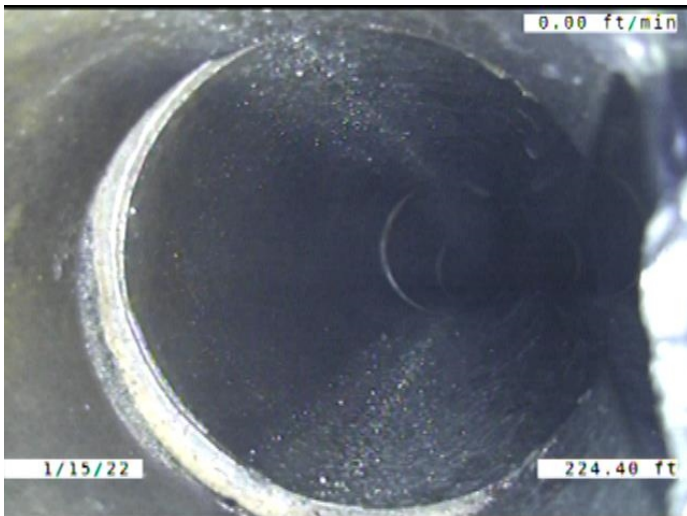
Code: **TB**
 Description: **Tap Break-in/Hammer**

Distance (ft): **224.4**
 Structural Grade: **0**
 O&M Grade: **0**
 Clock Start/From: **2**
 Clock To:
 1st Value: **4.000**
 2nd Value:
 Value Percent:
 Continuous Index:
 Within 8" of Joint: **YES**
 Remarks:

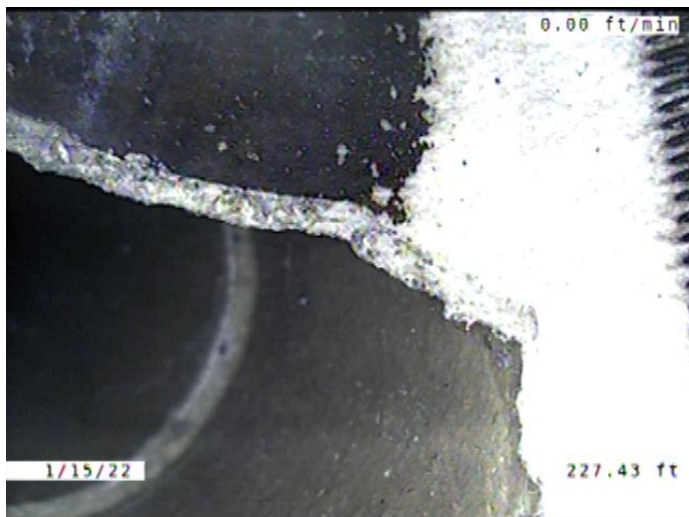
Code: **LFUC**
 Description: **Lining Feature Undercut Service**

Distance (ft): **227.4**
 Structural Grade: **3**
 O&M Grade: **0**
 Clock Start/From: **9**
 Clock To: **11**
 1st Value:
 2nd Value:
 Value Percent:
 Continuous Index:
 Within 8" of Joint: **NO**
 Remarks:

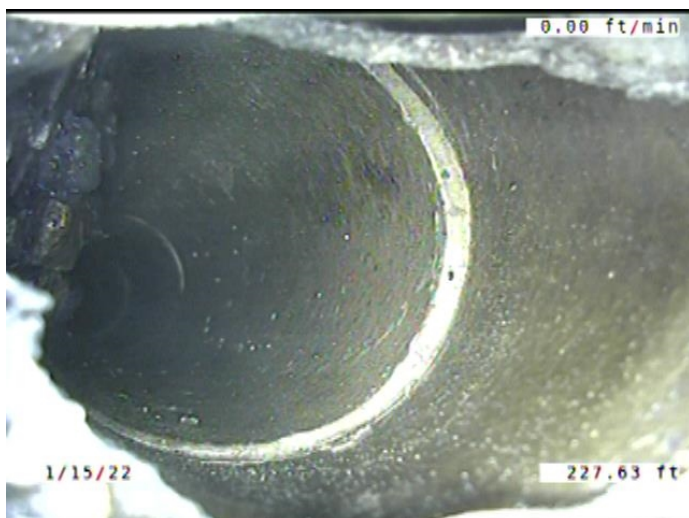
Code: **TB**
 Description: **Tap Break-in/Hammer**

Distance (ft): **227.6**
 Structural Grade: **0**
 O&M Grade: **0**
 Clock Start/From: **10**
 Clock To:
 1st Value: **4.000**
 2nd Value:
 Value Percent:
 Continuous Index:
 Within 8" of Joint: **YES**
 Remarks: **CONSTANTLY RUNNING WATER.**

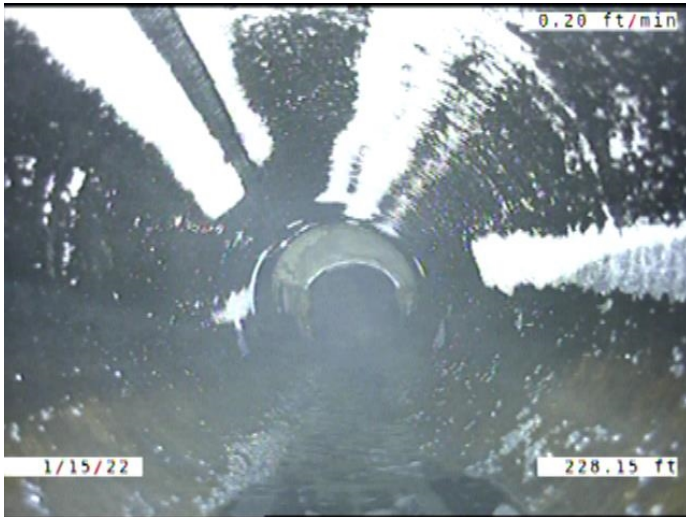
Code: **MWLS**
 Description: **Miscellaneous Water Level Sag**

Distance (ft): **228.1**
 Structural Grade: **2**
 O&M Grade: **0**
 Clock Start/From:
 Clock To:
 1st Value:
 2nd Value:
 Value Percent: **10.000**
 Continuous Index: **F06**
 Within 8" of Joint: **NO**
 Remarks:
