Profile/Photo Observation Report

Street:	W 4TH PL	Flow Control:	Not Controlled
City:	Hobart, IN	Year Renewed:	
Location:	Yard	Tape/Media #:	
Purpose:	Routine Assessment	Dia/Height:	10"
Use:	Sanitary	Material:	VCP
Drain Area:	NA	Lining:	Cured in Place
Category:	NA		
Comment:	Flow direction is marked wrong.		
Location Details:		Direction of Survey:	Upstream
US MH:	M-405-002	DS MH:	M-405-001
		Total Length Surveyed (ft):	191.0

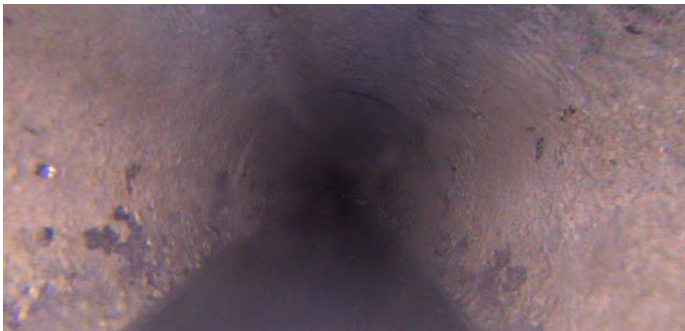
Code: **AMH**
Description: **Manhole**

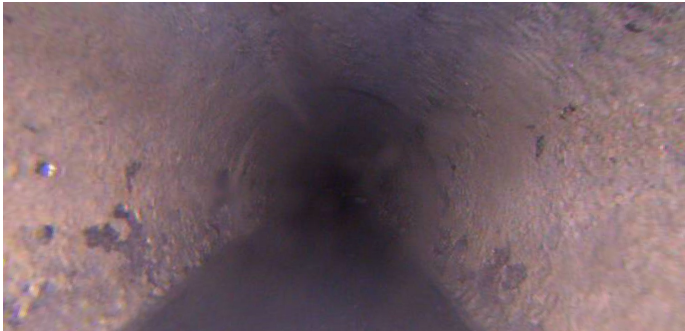
Code:	MWL
Description:	Water Level

Distance (ft):	.0
Structural Grade:	0
O&M Grade:	0
Clock Start/From:	
Clock To:	
1st Value:	
2nd Value:	
Value Percent:	5.000
Continuous Index:	
Within 8" of Joint:	NO
Remarks:

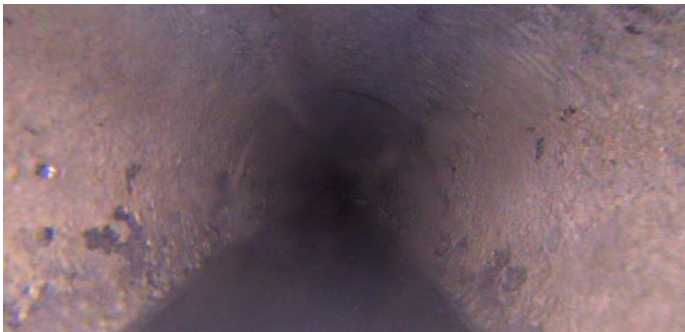
Code:	DAGS
Description:	Deposits Attached Grease

Distance (ft):	.0
Structural Grade:	0
O&M Grade:	2
Clock Start/From:	8
Clock To:	4
1st Value:	
2nd Value:	
Value Percent:	5.000
Continuous Index:	S01
Within 8" of Joint:	NO
Remarks:

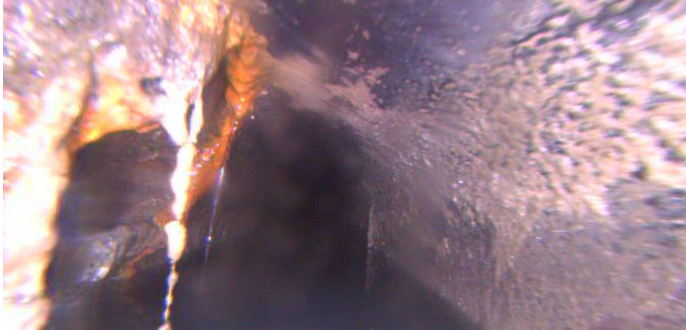
Code: **TBI**
Description: **Tap Break-in Intruding**

Distance (ft): **55.2**
Structural Grade: **0**
O&M Grade: **2**
Clock Start/From: **9**
Clock To:
1st Value: **4.000**
2nd Value: **1.000**
Value Percent:
Continuous Index:
Within 8" of Joint:
Remarks:

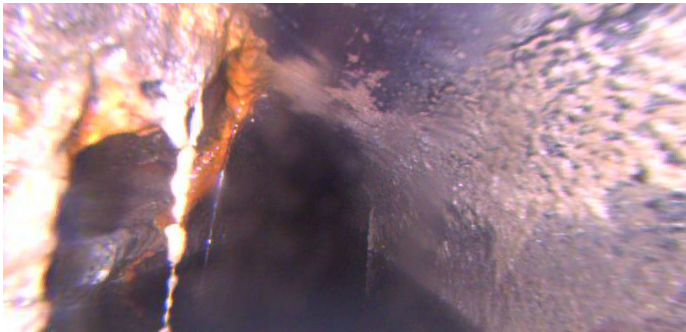
Code: **DAGS**
Description: **Deposits Attached Grease**

Distance (ft): **55.2**
Structural Grade: **0**
O&M Grade: **2**
Clock Start/From: **8**
Clock To: **10**
1st Value:
2nd Value:
Value Percent: **10.000**
Continuous Index:
Within 8" of Joint: **NO**
Remarks:

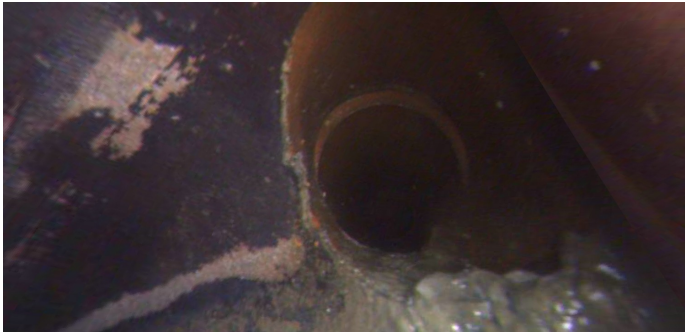
Code: **TFA**
Description: **Tap Factory Active**

Distance (ft): **154.9**
Structural Grade: **0**
O&M Grade: **0**
Clock Start/From: **10**
Clock To:
1st Value: **4.000**
2nd Value:
Value Percent:
Continuous Index:
Within 8" of Joint:
Remarks:

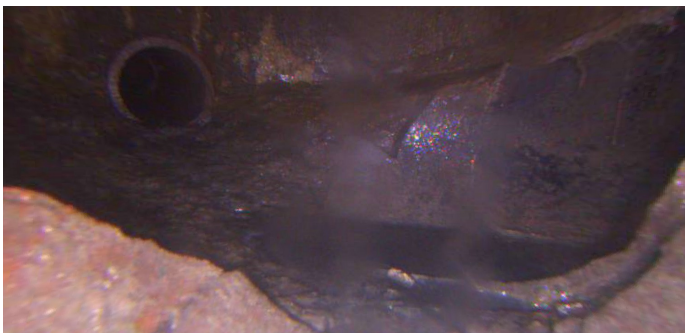
Code: **DAGS**
Description: **Deposits Attached Grease**

Distance (ft): **189.9**
Structural Grade: **0**
O&M Grade: **2**
Clock Start/From: **8**
Clock To: **4**
1st Value:
2nd Value:
Value Percent: **5.000**
Continuous Index: **F01**
Within 8" of Joint: **NO**
Remarks:

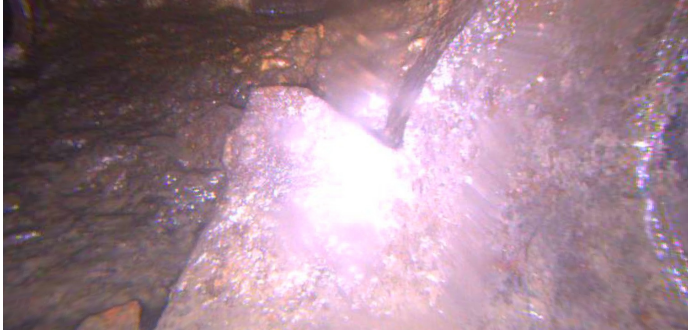
Code:	AMH
Description:	Manhole
Distance (ft):	191.0
Structural Grade:	0
O&M Grade:	0
Clock Start/From:	
Clock To:	
1st Value:	
2nd Value:	
Value Percent:	
Continuous Index:	
Within 8" of Joint:	NO
Remarks:	M-405-002
