Profile/Photo Observation Report

Date:	04/14/2018	Weather:		Coding:	PACP 6.0
Pipe Length (ft):	197.6	Owner:	NA	Pre Clean:	No Pre-Cleaning
P.O.#:		Surveyor:	Jen Costello	PSR:	P-405-001-002
Customer:		Clean Date:	01/01/1900	Shape:	C

Street:	FOXCROFT STREET	Flow Control:	Not Controlled
City:	Hobart, IN	Year Renewed:	
Location:	Yard	Tape/Media #:	
Purpose:	Routine Assessment	Dia/Height:	10"
Use:	Sanitary	Material:	VCP
Drain Area:	NA	Lining:	Cured in Place
Category:	NA		
Comment:	Flow direction is marked wrong.		
Location Details:		Direction of Survey:	Upstream
US MH:	M-405-002	DS MH:	M-405-001
		Total Length Surveyed (ft):	191.0

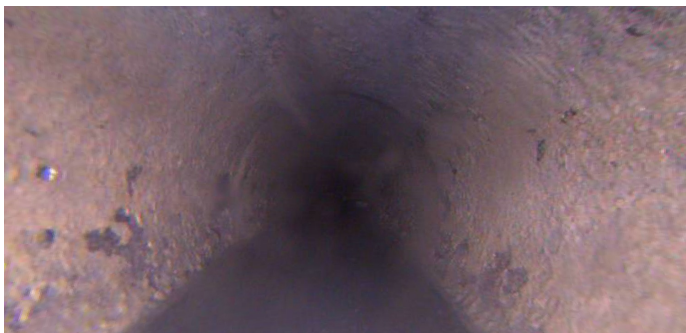
Code: **AMH**
Description: **Manhole**

Distance (ft): **.0**
Structural Grade: **0**
O&M Grade: **0**
Clock Start/From:
Clock To:
1st Value:
2nd Value:
Value Percent:
Continuous Index:
Within 8" of Joint: **NO**
Remarks: **M-405-001**

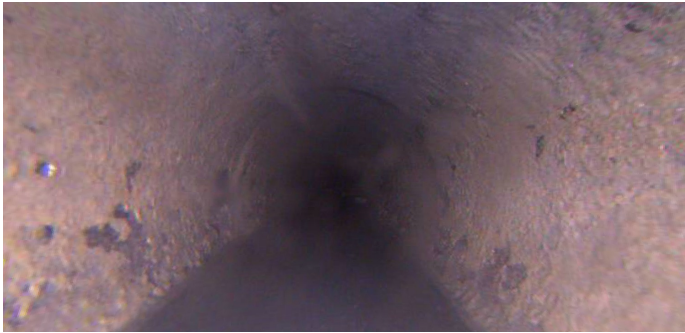
Code:	MWL
Description:	Water Level

Distance (ft):	.0
Structural Grade:	0
O&M Grade:	0
Clock Start/From:	
Clock To:	
1st Value:	
2nd Value:	
Value Percent:	5.000
Continuous Index:	
Within 8" of Joint:	NO
Remarks:

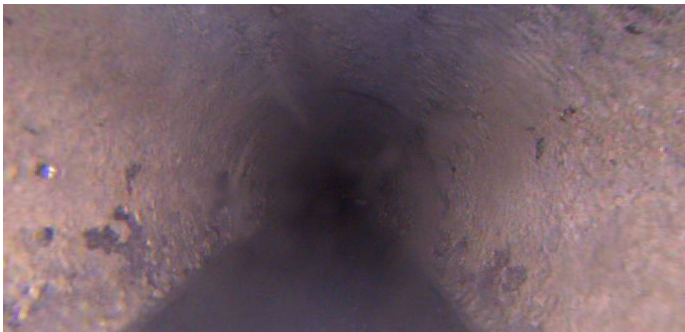
Code:	DAGS
Description:	Deposits Attached Grease

Distance (ft):	.0
Structural Grade:	0
O&M Grade:	2
Clock Start/From:	8
Clock To:	4
1st Value:	
2nd Value:	
Value Percent:	5.000
Continuous Index:	S01
Within 8" of Joint:	NO
Remarks:

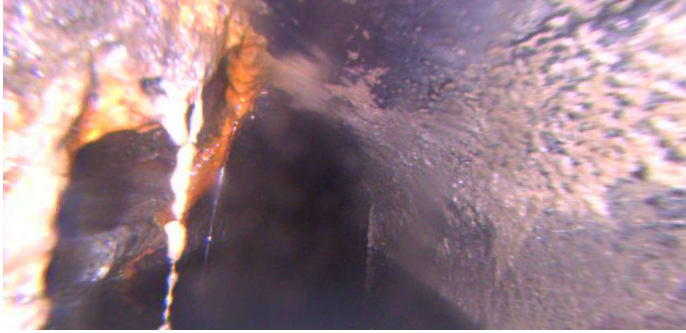
Code: **TBI**
Description: **Tap Break-in Intruding**

Distance (ft): **55.2**
Structural Grade: **0**
O&M Grade: **2**
Clock Start/From: **9**
Clock To:
1st Value: **4.000**
2nd Value: **1.000**
Value Percent:
Continuous Index:
Within 8" of Joint:
Remarks:

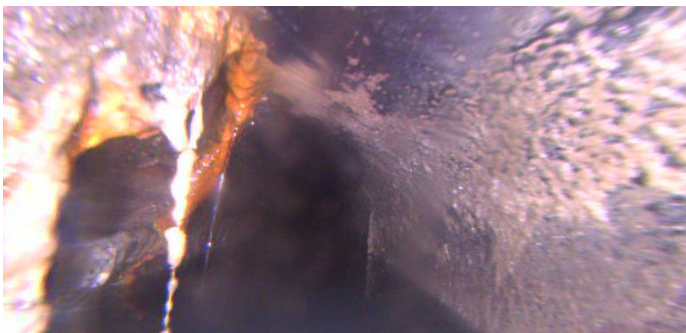
Code: **DAGS**
Description: **Deposits Attached Grease**

Distance (ft): **55.2**
Structural Grade: **0**
O&M Grade: **2**
Clock Start/From: **8**
Clock To: **10**
1st Value:
2nd Value:
Value Percent: **10.000**
Continuous Index:
Within 8" of Joint: **NO**
Remarks:

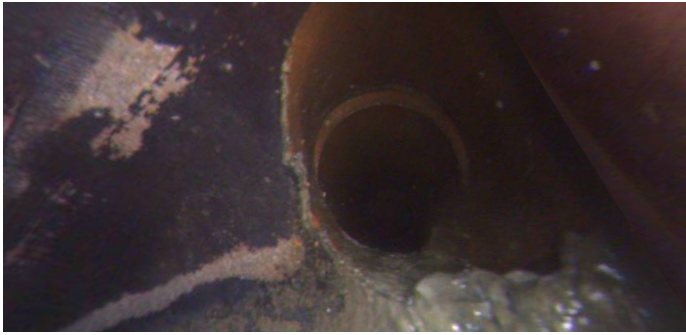
Code: **TFA**
Description: **Tap Factory Active**

Distance (ft): **154.9**
Structural Grade: **0**
O&M Grade: **0**
Clock Start/From: **10**
Clock To:
1st Value: **4.000**
2nd Value:
Value Percent:
Continuous Index:
Within 8" of Joint:
Remarks:

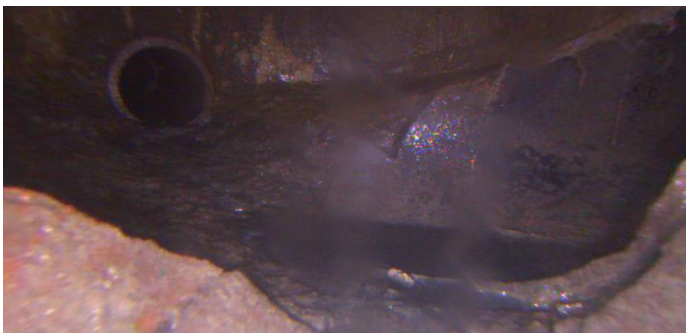
Code: **DAGS**
Description: **Deposits Attached Grease**

Distance (ft): **189.9**
Structural Grade: **0**
O&M Grade: **2**
Clock Start/From: **8**
Clock To: **4**
1st Value:
2nd Value:
Value Percent: **5.000**
Continuous Index: **F01**
Within 8" of Joint: **NO**
Remarks:

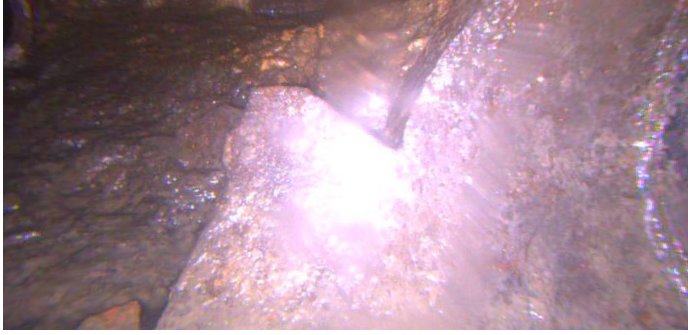
Code:	AMH
Description:	Manhole
Distance (ft):	191.0
Structural Grade:	0
O&M Grade:	0
Clock Start/From:	
Clock To:	
1st Value:	
2nd Value:	
Value Percent:	
Continuous Index:	
Within 8" of Joint:	NO
Remarks:	M-405-002
