## Profile/Photo Observation Report

Date:	<b>04/22/2018</b>	Weather:		Coding:	<b>PACP 6.0</b>
Pipe Length (ft):	<b>294.8</b>	Owner:	<b>NA</b>	Pre Clean:	<b>No Pre-Cleaning</b>
P.O.#:		Surveyor:	<b>Mark Ruby</b>	PSR:	<b>P-405-002.3-002.2</b>
Customer:		Clean Date:	<b>01/01/1900</b>	Shape:	<b>C</b>

Street:	<b>S WABASH ST</b>	Flow Control:	<b>Not Controlled</b>
City:	<b>Hobart, IN</b>	Year Renewed:	
Location:	<b>Light Highway</b>	Tape/Media #:	
Purpose:	<b>Routine Assessment</b>	Dia/Height:	<b>8"</b>
Use:	<b>Sanitary</b>	Material:	<b>PVC</b>
Drain Area:	<b>NA</b>	Lining:	
Category:	<b>NA</b>		
Comment:	<b>P_C at 241 ft CU/debris . Flow direction wrong</b>		
Location Details:		Direction of Survey:	<b>Downstream</b>
US MH:	<b>M-405-002.2</b>	DS MH:	<b>M-405-002.3</b>
		Total Length Surveyed (ft):	<b>242.9</b>

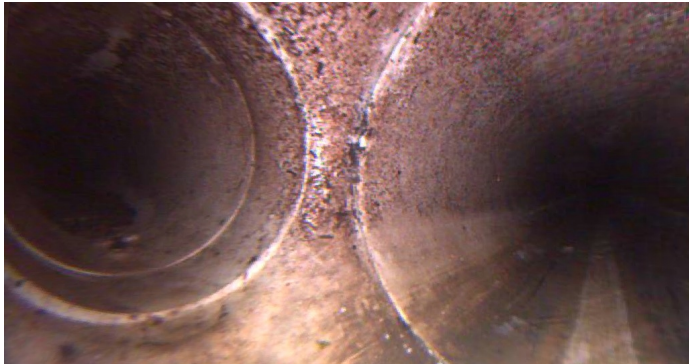
Code: **MWL**  
Description: **Water Level**

Distance (ft): **.0**  
Structural Grade: **0**  
O&M Grade: **0**  
Clock Start/From:  
Clock To:  
1st Value:  
2nd Value:  
Value Percent: **10.000**  
Continuous Index:  
Within 8" of Joint: **NO**  
Remarks:

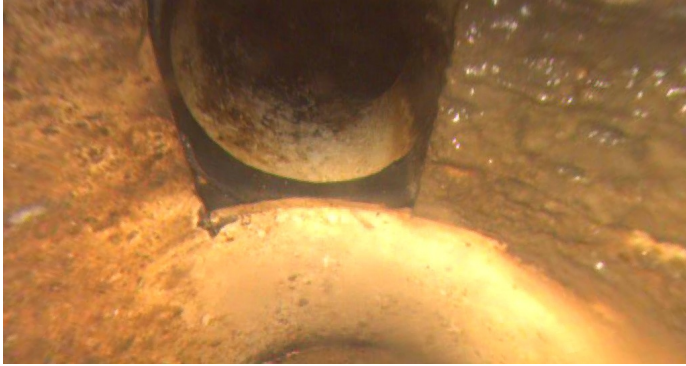
Code: **TS**  
Description: **Tap Saddle**

Distance (ft): **60.8**  
Structural Grade: **0**  
O&M Grade: **0**  
Clock Start/From: **12**  
Clock To:  
1st Value: **4.000**  
2nd Value:  
Value Percent:  
Continuous Index:  
Within 8" of Joint:  
Remarks:

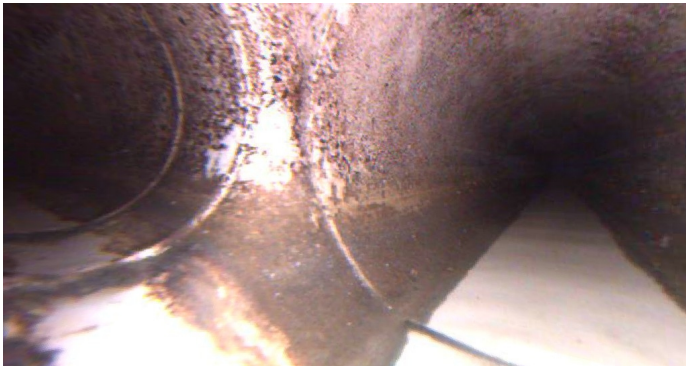
Code: **TF**  
Description: **Tap Factory**

Distance (ft): **106.9**  
Structural Grade: **0**  
O&M Grade: **0**  
Clock Start/From: **8**  
Clock To:  
1st Value: **4.000**  
2nd Value:  
Value Percent:  
Continuous Index:  
Within 8" of Joint:  
Remarks:

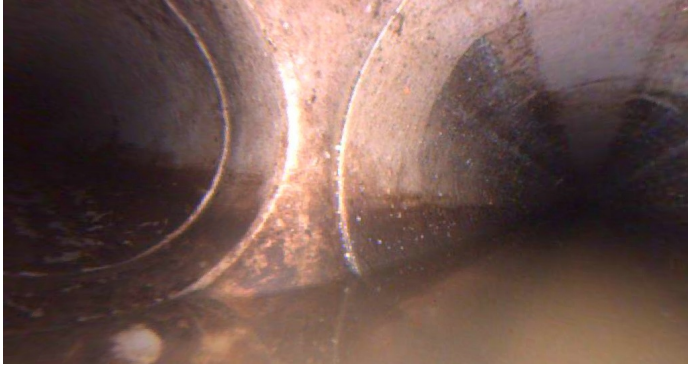
Code: **TF**  
Description: **Tap Factory**

Distance (ft): **181.9**  
Structural Grade: **0**  
O&M Grade: **0**  
Clock Start/From: **8**  
Clock To:  
1st Value: **4.000**  
2nd Value:  
Value Percent:  
Continuous Index:  
Within 8" of Joint:  
Remarks:

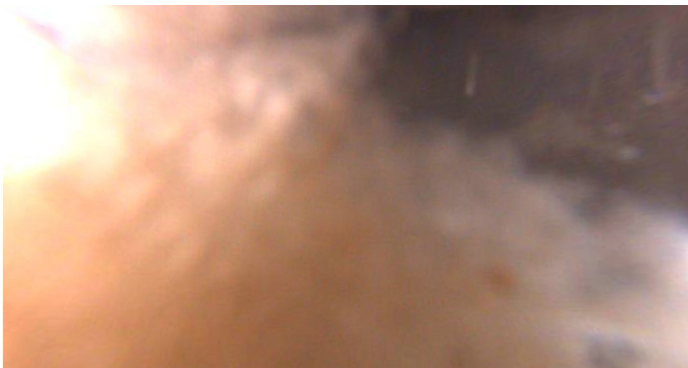
Code: **MCU**  
Description: **Camera Underwater**

Distance (ft): **215.8**  
Structural Grade: **0**  
O&M Grade: **4**  
Clock Start/From:  
Clock To:  
1st Value:  
2nd Value:  
Value Percent:  
Continuous Index:  
Within 8" of Joint: **NO**  
Remarks:
