## Profile/Photo Observation Report

Street:	<b>FOXCROFT STREET</b>	Flow Control:	<b>Not Controlled</b>
City:	<b>Hobart, IN</b>	Year Renewed:	
Location:	<b>Light Highway</b>	Tape/Media #:	
Purpose:	<b>Routine Assessment</b>	Dia/Height:	<b>8"</b>
Use:	<b>Sanitary</b>	Material:	<b>PVC</b>
Drain Area:	<b>NA</b>	Lining:	
Category:	<b>NA</b>		
Comment:	<b>P_C at 241 ft CU/debris . Flow direction wrong</b>		
Location Details:		Direction of Survey:	<b>Downstream</b>
US MH:	<b>M-405-002.2</b>	DS MH:	<b>M-405-002.3</b>
		Total Length Surveyed (ft):	<b>242.9</b>

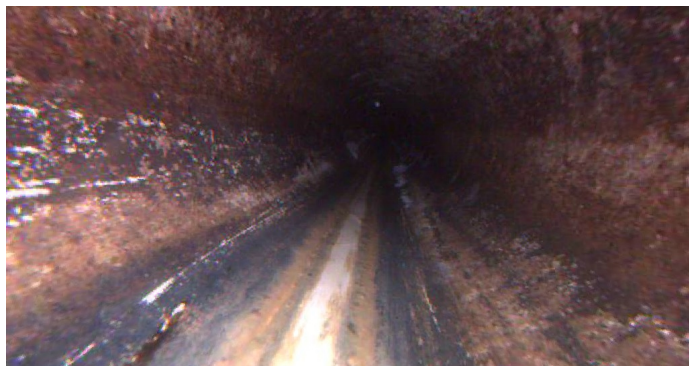
Code: **AMH**  
 Description: **Manhole**

Distance (ft): **.0**  
 Structural Grade: **0**  
 O&M Grade: **0**  
 Clock Start/From:  
 Clock To:  
 1st Value:  
 2nd Value:  
 Value Percent:  
 Continuous Index:  
 Within 8" of Joint: **NO**  
 Remarks: **M-405-002.2**

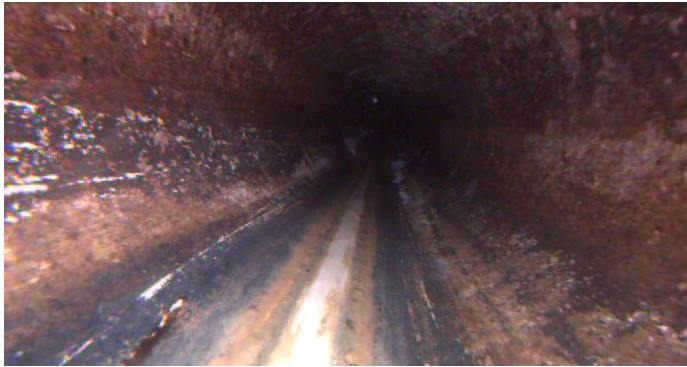
Code: **MWL**  
Description: **Water Level**

Distance (ft): **.0**  
Structural Grade: **0**  
O&M Grade: **0**  
Clock Start/From:  
Clock To:  
1st Value:  
2nd Value:  
Value Percent: **10.000**  
Continuous Index:  
Within 8" of Joint: **NO**  
Remarks:

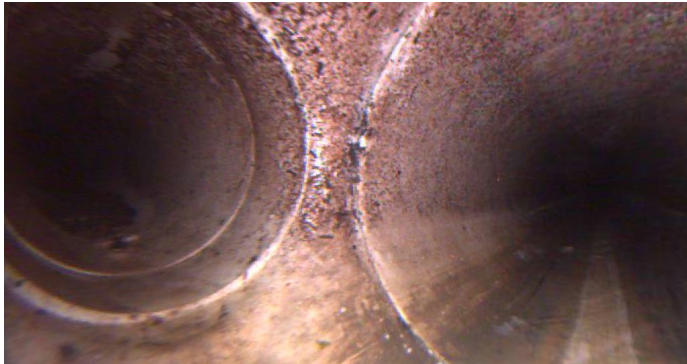
Code: **TF**  
Description: **Tap Factory**

Distance (ft): **33.9**  
Structural Grade: **0**  
O&M Grade: **0**  
Clock Start/From: **8**  
Clock To:  
1st Value: **4.000**  
2nd Value:  
Value Percent:  
Continuous Index:  
Within 8" of Joint:  
Remarks:

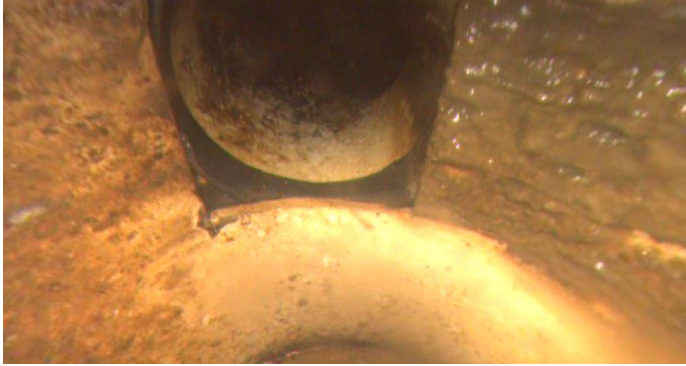
Code: **TS**  
Description: **Tap Saddle**

Distance (ft): **60.8**  
Structural Grade: **0**  
O&M Grade: **0**  
Clock Start/From: **12**  
Clock To:  
1st Value: **4.000**  
2nd Value:  
Value Percent:  
Continuous Index:  
Within 8" of Joint:  
Remarks:

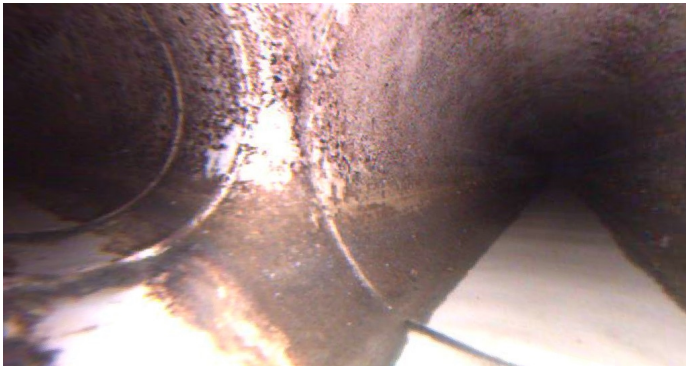
Code: **TF**  
Description: **Tap Factory**

Distance (ft): **106.9**  
Structural Grade: **0**  
O&M Grade: **0**  
Clock Start/From: **8**  
Clock To:  
1st Value: **4.000**  
2nd Value:  
Value Percent:  
Continuous Index:  
Within 8" of Joint:  
Remarks:

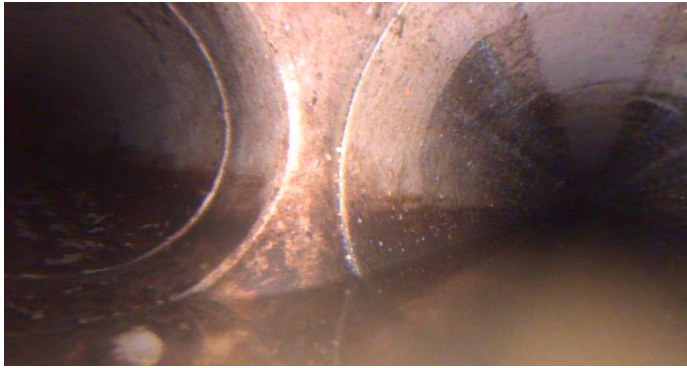
Code: **TF**  
Description: **Tap Factory**

Distance (ft): **181.9**  
Structural Grade: **0**  
O&M Grade: **0**  
Clock Start/From: **8**  
Clock To:  
1st Value: **4.000**  
2nd Value:  
Value Percent:  
Continuous Index:  
Within 8" of Joint:  
Remarks:

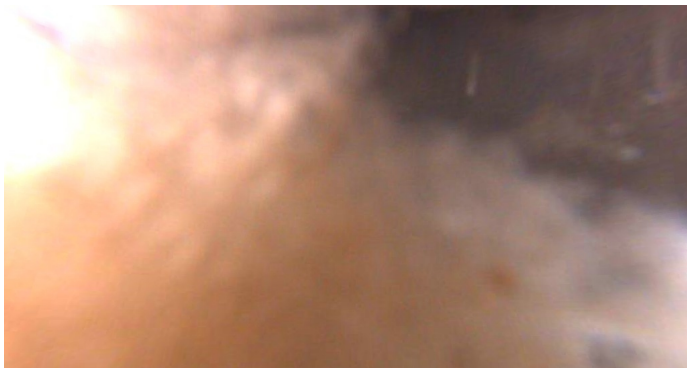
Code: **MCU**  
Description: **Camera Underwater**

Distance (ft): **215.8**  
Structural Grade: **0**  
O&M Grade: **4**  
Clock Start/From:  
Clock To:  
1st Value:  
2nd Value:  
Value Percent:  
Continuous Index:  
Within 8" of Joint: **NO**  
Remarks:
