## Profile/Photo Observation Report

Street:	<b>S WABASH ST</b>	Flow Control:	<b>Not Controlled</b>
City:	<b>Hobart, IN</b>	Year Renewed:	
Location:	<b>Yard</b>	Tape/Media #:	
Purpose:	<b>Routine Assessment</b>	Dia/Height:	<b>12"</b>
Use:	<b>Sanitary</b>	Material:	<b>VCP</b>
Drain Area:	<b>NA</b>	Lining:	
Category:	<b>NA</b>		
Comment:	<b>Flow direction is marked wrong.</b>

Location Details:		Direction of Survey:	<b>Downstream</b>
US MH:	<b>M-405-003</b>	DS MH:	<b>M-405-002</b>
		Total Length Surveyed (ft):	<b>60.0</b>

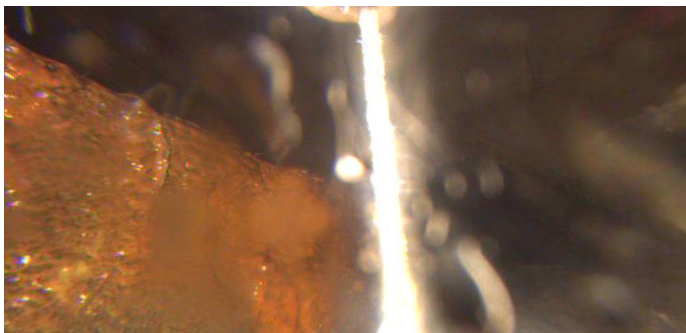
Code: **MGO**  
Description: **General Observation**

Distance (ft): **.0**  
Structural Grade: **0**  
O&M Grade: **0**  
Clock Start/From:  
Clock To:  
1st Value:  
2nd Value:  
Value Percent:  
Continuous Index:  
Within 8" of Joint: **NO**  
Remarks: **REAR CAMERA**

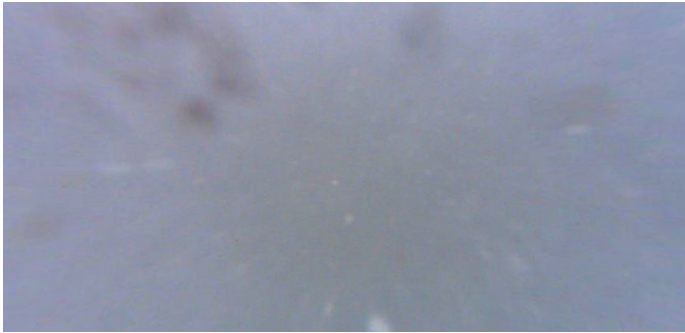
Code:	<b>AMH</b>
Description:	<b>Manhole</b>

Distance (ft):	<b>.0</b>
Structural Grade:	<b>0</b>
O&M Grade:	<b>0</b>
Clock Start/From:	
Clock To:	
1st Value:	
2nd Value:	
Value Percent:	
Continuous Index:	
Within 8" of Joint:	<b>NO</b>
Remarks:	<b>M-405-003</b>

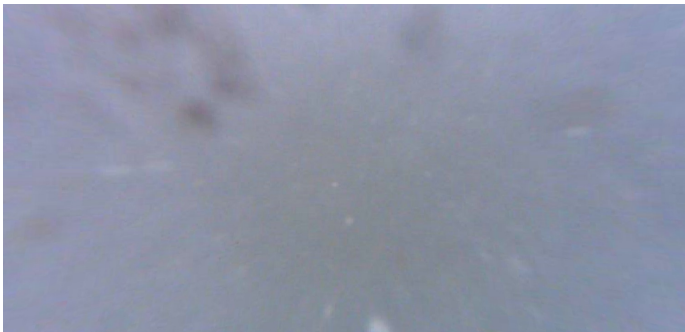
Code:	<b>MWL</b>
Description:	<b>Water Level</b>

Distance (ft):	<b>.0</b>
Structural Grade:	<b>0</b>
O&M Grade:	<b>0</b>
Clock Start/From:	
Clock To:	
1st Value:	
2nd Value:	
Value Percent:	<b>5.000</b>
Continuous Index:	
Within 8" of Joint:	<b>NO</b>
Remarks:	<b>M-405-002</b>

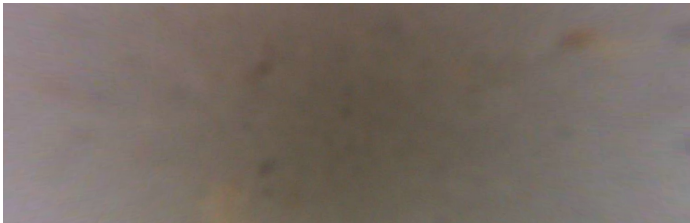
Code:	<b>MSA</b>
Description:	<b>Abandoned Survey</b>
Distance (ft):	<b>60.0</b>
Structural Grade:	<b>0</b>
O&M Grade:	<b>0</b>
Clock Start/From:	
Clock To:	
1st Value:	
2nd Value:	
Value Percent:	
Continuous Index:	
Within 8" of Joint:	<b>NO</b>
Remarks:	<b>camera underwater</b>
