Profile/Photo Observation Report

Street:	FOXCROFT STREET	Flow Control:	Not Controlled
City:	Hobart, IN	Year Renewed:	
Location:	Yard	Tape/Media #:	
Purpose:	Routine Assessment	Dia/Height:	12"
Use:	Sanitary	Material:	VCP
Drain Area:	NA	Lining:	
Category:	NA		
Comment:	Flow direction is marked wrong.		
Location Details:		Direction of Survey:	Downstream
US MH:	M-405-003	DS MH:	M-405-002
		Total Length Surveyed (ft):	60.0

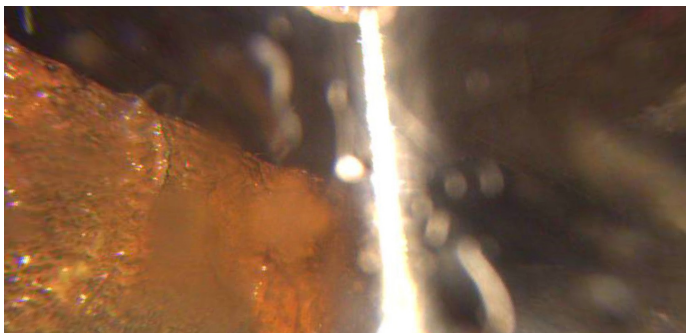
Code: **MGO**
Description: **General Observation**

Distance (ft): **.0**
Structural Grade: **0**
O&M Grade: **0**
Clock Start/From:
Clock To:
1st Value:
2nd Value:
Value Percent:
Continuous Index:
Within 8" of Joint: **NO**
Remarks: **REAR CAMERA**

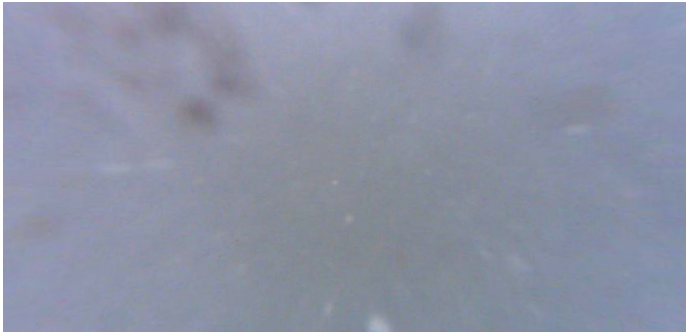
Code:	AMH
Description:	Manhole

Distance (ft):	.0
Structural Grade:	0
O&M Grade:	0
Clock Start/From:	
Clock To:	
1st Value:	
2nd Value:	
Value Percent:	
Continuous Index:	
Within 8" of Joint:	NO
Remarks:	M-405-003

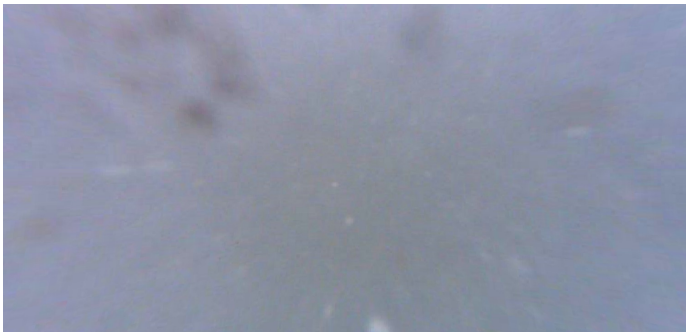
Code:	MWL
Description:	Water Level

Distance (ft):	.0
Structural Grade:	0
O&M Grade:	0
Clock Start/From:	
Clock To:	
1st Value:	
2nd Value:	
Value Percent:	5.000
Continuous Index:	
Within 8" of Joint:	NO
Remarks:	M-405-002

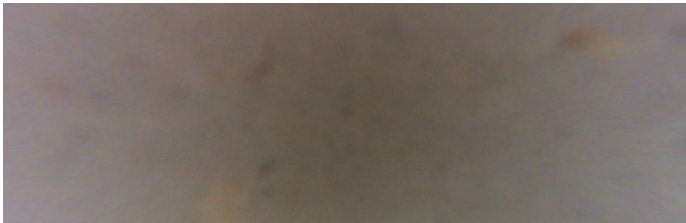
Code: **MSA**
Description: **Abandoned Survey**

Distance (ft): **60.0**
Structural Grade: **0**
O&M Grade: **0**
Clock Start/From:
Clock To:
1st Value:
2nd Value:
Value Percent:
Continuous Index:
Within 8" of Joint: **NO**
Remarks: **camera underwater**
