Profile/Photo Observation Report

Date:	01/16/2022	Weather:		Coding:	PACP 7.0
Pipe Length (ft):	212.8	Owner:	City of Hobart	Pre Clean:	Heavy Cleaning
P.O.#:	YES502259	Surveyor:	S. Bucklin	PSR:	P-405-002-003
Customer:	City of Hobart	Clean Date:	01/13/2021	Shape:	C

Street:	South Wabash Street	Flow Control:	Not Controlled
City:	Hobart, IN	Year Renewed:	
Location:	Easement/Right of Way	Tape/Media #:	
Purpose:	Routine Assessment	Dia/Height:	12"
Use:	Sanitary Sewage Pipe	Material:	VCP
Drain Area:		Lining:	Not Known
Category:	NA

Comment:		Direction of Survey:	Upstream
Location Details:			
US MH:	M-405-003	DS MH:	M-405-002
		Total Length Surveyed (ft):	212.8

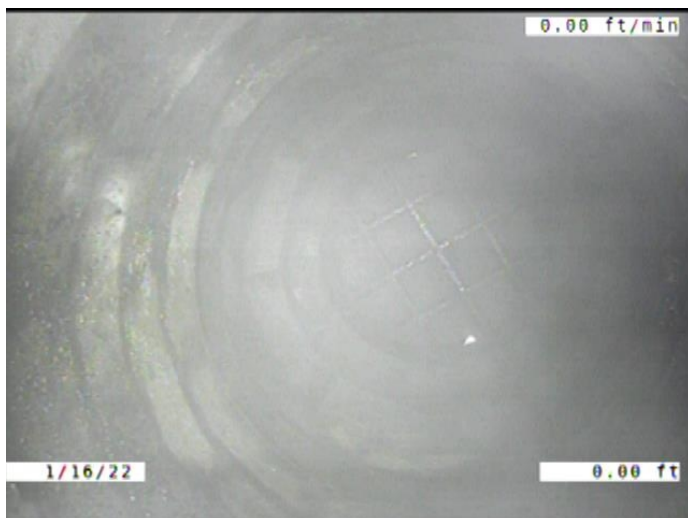
Code: **AMH**
 Description: **Manhole**

Distance (ft): **.0**
 Structural Grade: **0**
 O&M Grade: **0**
 Clock Start/From:
 Clock To:
 1st Value:
 2nd Value:
 Value Percent:
 Continuous Index:
 Within 8" of Joint: **NO**
 Remarks: **M-405-002**

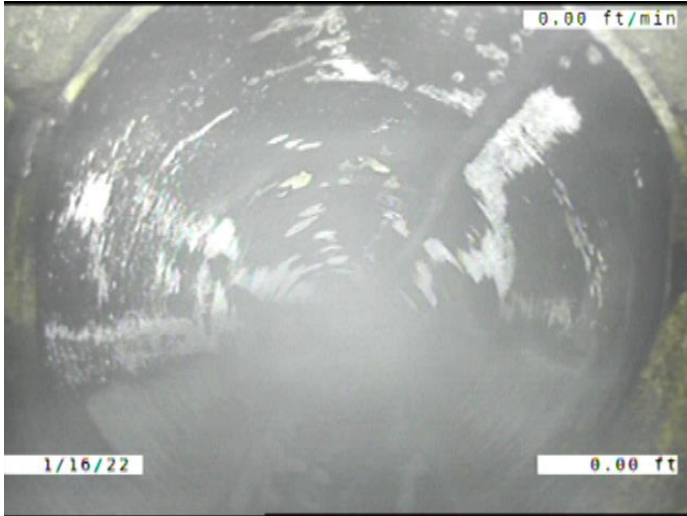
Code: **MWL**
Description: **Miscellaneous Water Level**

Distance (ft): **.0**
Structural Grade: **0**
O&M Grade: **0**
Clock Start/From:
Clock To:
1st Value:
2nd Value:
Value Percent: **5.000**
Continuous Index:
Within 8" of Joint: **NO**
Remarks:

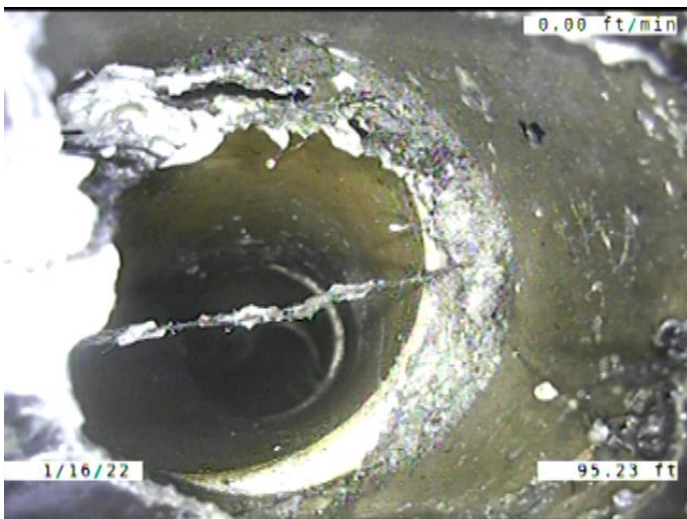
Code: **TB**
Description: **Tap Break-in/Hammer**

Distance (ft): **95.2**
Structural Grade: **0**
O&M Grade: **0**
Clock Start/From: **10**
Clock To:
1st Value: **4.000**
2nd Value:
Value Percent:
Continuous Index:
Within 8" of Joint: **NO**
Remarks: **LARGE OFFSET. ROOTS GROWING IN THE JOINTS AND INTO THE MAIN,**

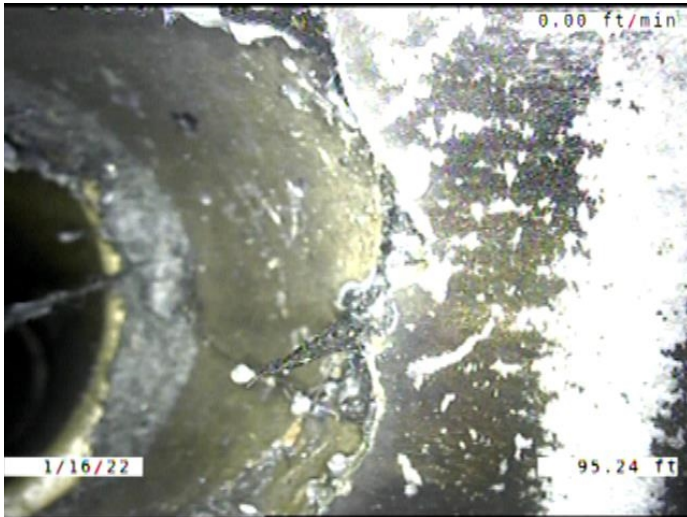
Code: **IWC**
 Description: **Infiltration Weeper Connection**

Distance (ft): **95.2**
 Structural Grade: **0**
 O&M Grade: **2**
 Clock Start/From: **11**
 Clock To:
 1st Value:
 2nd Value:
 Value Percent:
 Continuous Index:
 Within 8" of Joint: **NO**
 Remarks:

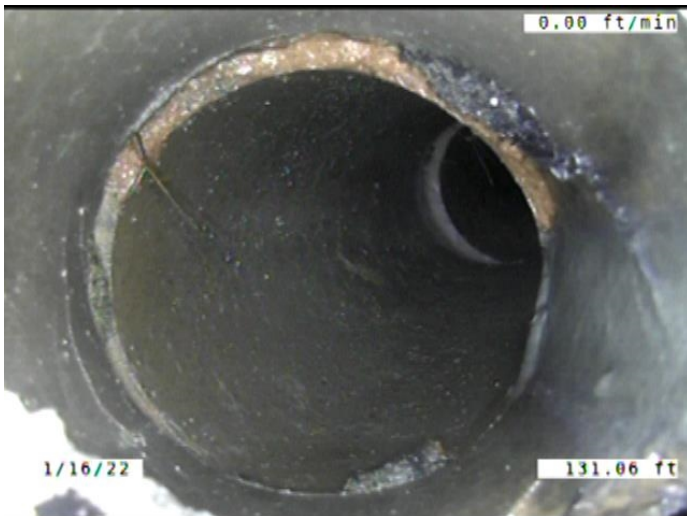
Code: **TB**
 Description: **Tap Break-in/Hammer**

Distance (ft): **131.1**
 Structural Grade: **0**
 O&M Grade: **0**
 Clock Start/From: **2**
 Clock To:
 1st Value: **4.000**
 2nd Value:
 Value Percent:
 Continuous Index:
 Within 8" of Joint: **NO**
 Remarks: **CONSTANTLY RUNNING WATER.
 ROOTS GROWING IN THE JOINTS**

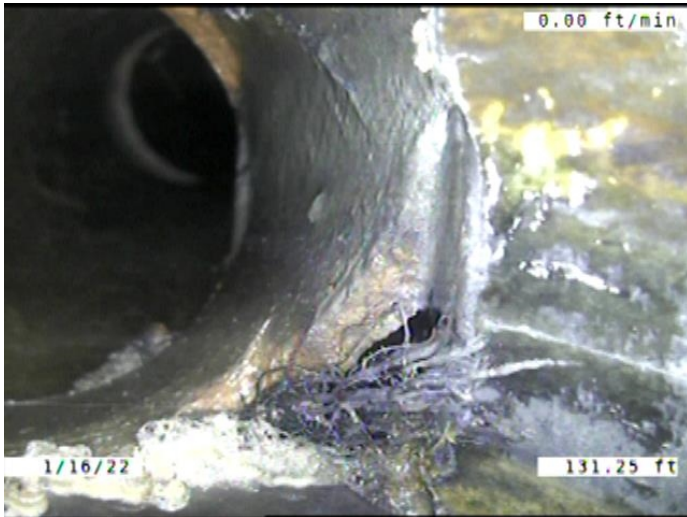
Code: **LFOC**
Description: **Lining Feature Overcut Service**

Distance (ft): **131.2**
Structural Grade: **3**
O&M Grade: **0**
Clock Start/From: **3**
Clock To:
1st Value:
2nd Value:
Value Percent:
Continuous Index:
Within 8" of Joint: **NO**
Remarks:

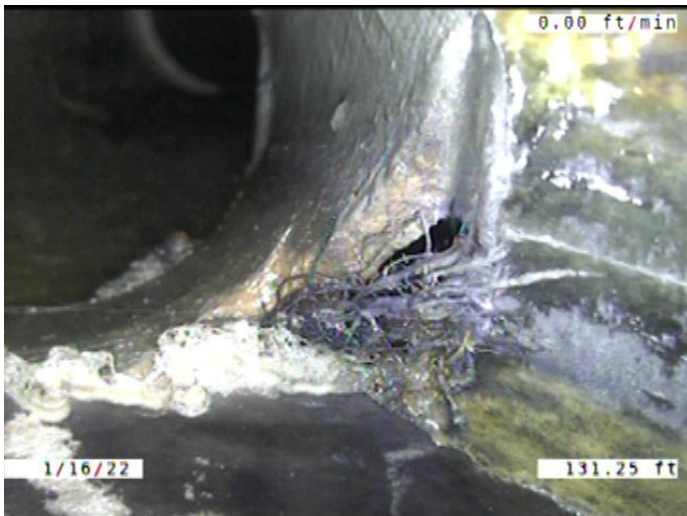
Code: **RFC**
Description: **Roots Fine Connection**

Distance (ft): **131.2**
Structural Grade: **0**
O&M Grade: **1**
Clock Start/From: **3**
Clock To:
1st Value:
2nd Value:
Value Percent:
Continuous Index:
Within 8" of Joint: **NO**
Remarks:

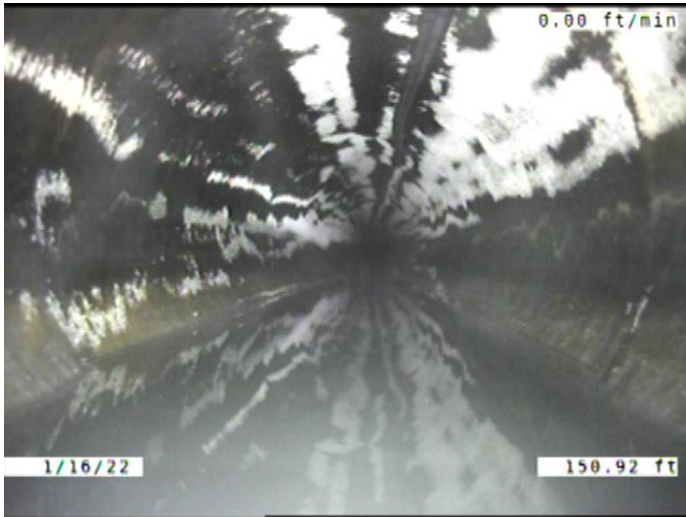
Code: **MWLS**
Description: **Miscellaneous Water Level Sag**

Distance (ft): **150.9**
Structural Grade: **2**
O&M Grade: **0**
Clock Start/From:
Clock To:
1st Value:
2nd Value:
Value Percent: **10.000**
Continuous Index: **S01**
Within 8" of Joint: **NO**
Remarks:

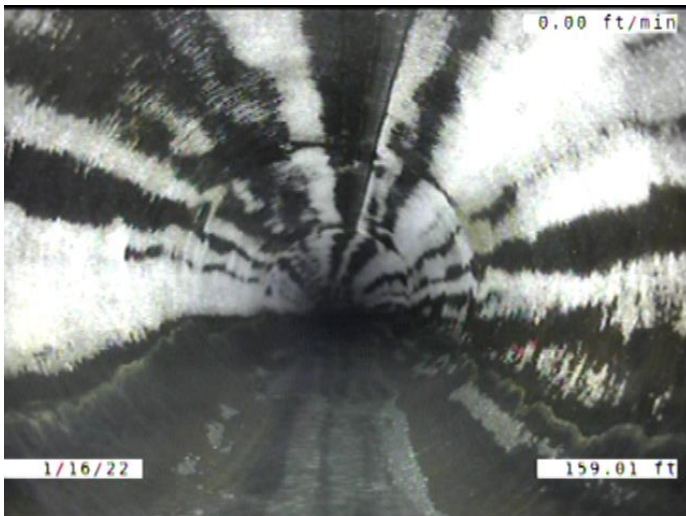
Code: **MWLS**
Description: **Miscellaneous Water Level Sag**

Distance (ft): **159.0**
Structural Grade: **2**
O&M Grade: **0**
Clock Start/From:
Clock To:
1st Value:
2nd Value:
Value Percent: **10.000**
Continuous Index: **F01**
Within 8" of Joint: **NO**
Remarks:

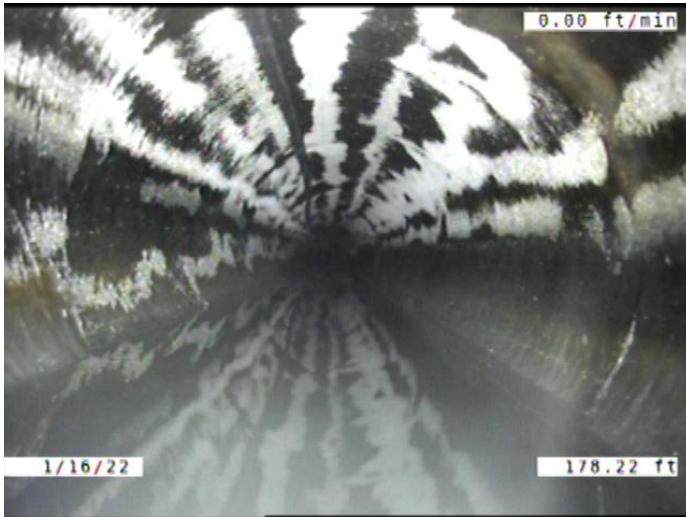
Code: **MWLS**
 Description: **Miscellaneous Water Level Sag**

Distance (ft): **178.2**
 Structural Grade: **2**
 O&M Grade: **0**
 Clock Start/From:
 Clock To:
 1st Value:
 2nd Value:
 Value Percent: **15.000**
 Continuous Index: **S02**
 Within 8" of Joint: **NO**
 Remarks:

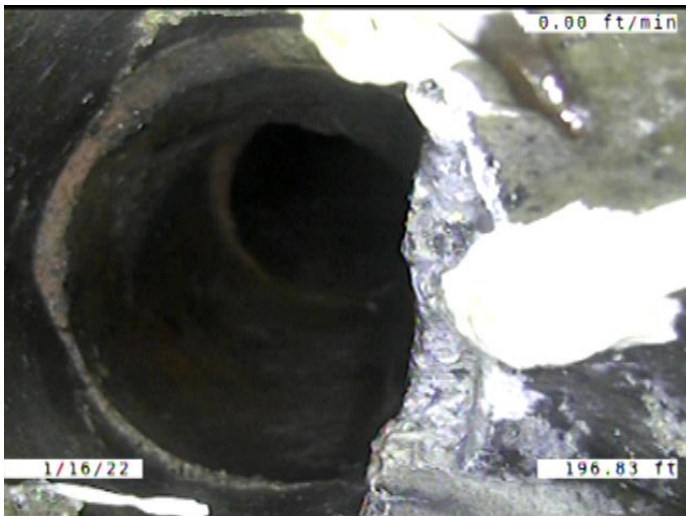
Code: **LFUC**
 Description: **Lining Feature Undercut Service**

Distance (ft): **196.8**
 Structural Grade: **3**
 O&M Grade: **0**
 Clock Start/From: **1**
 Clock To: **3**
 1st Value:
 2nd Value:
 Value Percent:
 Continuous Index:
 Within 8" of Joint: **NO**
 Remarks:

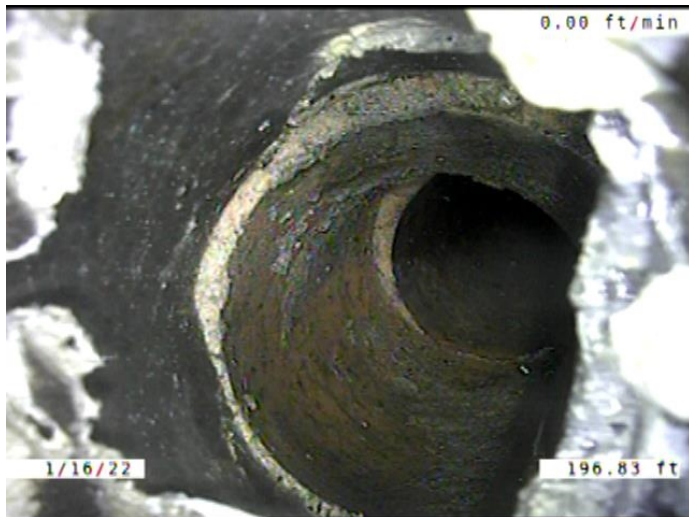
Code: **TB**
 Description: **Tap Break-in/Hammer**

Distance (ft): **196.8**
 Structural Grade: **0**
 O&M Grade: **0**
 Clock Start/From: **2**
 Clock To:
 1st Value: **4.000**
 2nd Value:
 Value Percent:
 Continuous Index:
 Within 8" of Joint: **NO**
 Remarks: **OFFSET JOINTS**

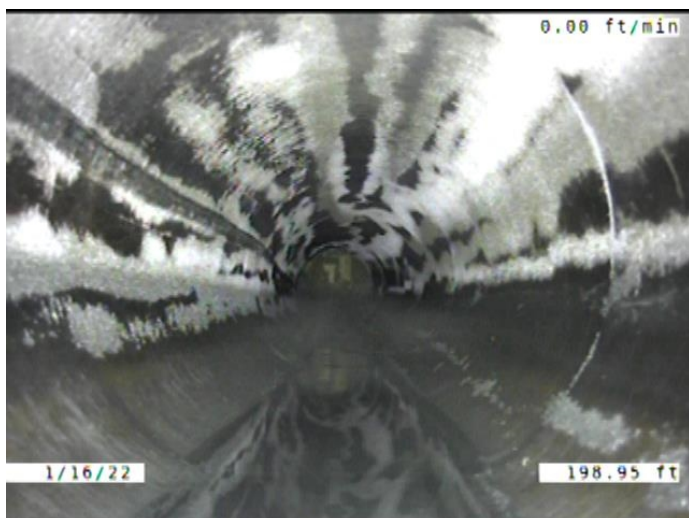
Code: **MWLS**
 Description: **Miscellaneous Water Level Sag**

Distance (ft): **198.9**
 Structural Grade: **2**
 O&M Grade: **0**
 Clock Start/From:
 Clock To:
 1st Value:
 2nd Value:
 Value Percent: **15.000**
 Continuous Index: **F02**
 Within 8" of Joint: **NO**
 Remarks:

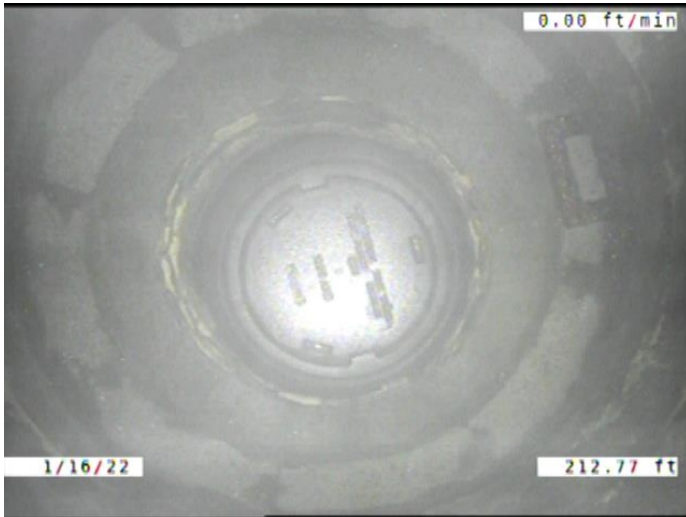
Code:	AMH
Description:	Manhole
Distance (ft):	212.8
Structural Grade:	0
O&M Grade:	0
Clock Start/From:	
Clock To:	
1st Value:	
2nd Value:	
Value Percent:	
Continuous Index:	
Within 8" of Joint:	NO
Remarks:	M-405-003
