Profile/Photo Observation Report

Street:	S WABASH ST	Flow Control:	Not Controlled
City:	Hobart, IN	Year Renewed:	
Location:	Yard	Tape/Media #:	
Purpose:	Routine Assessment	Dia/Height:	12"
Use:	Sanitary	Material:	VCP
Drain Area:	NA	Lining:	Cured in Place
Category:	NA		
Comment:

Location Details:		Direction of Survey:	Upstream
US MH:	M-405-004	DS MH:	M-405-003
		Total Length Surveyed (ft):	138.9

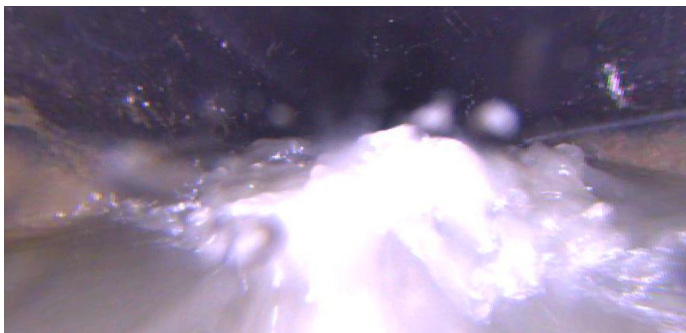
Code: **AMH**
Description: **Manhole**

Distance (ft): **.0**
Structural Grade: **0**
O&M Grade: **0**
Clock Start/From:
Clock To:
1st Value:
2nd Value:
Value Percent:
Continuous Index:
Within 8" of Joint: **NO**
Remarks: **M-405-003**

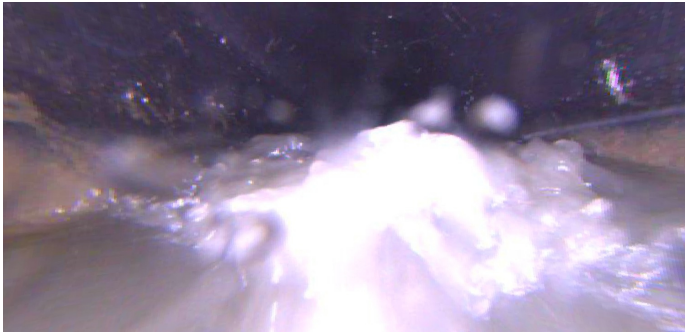
Code:	MWL
Description:	Water Level

Distance (ft):	.0
Structural Grade:	0
O&M Grade:	0
Clock Start/From:	
Clock To:	
1st Value:	
2nd Value:	
Value Percent:	5.000
Continuous Index:	
Within 8" of Joint:	NO
Remarks:

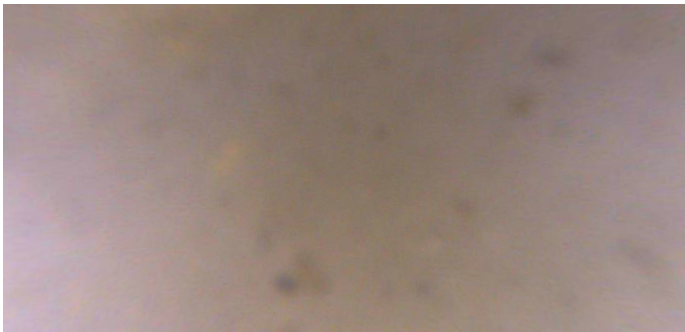
Code:	MWLS
Description:	Water Level Sag

Distance (ft):	3.7
Structural Grade:	2
O&M Grade:	3
Clock Start/From:	
Clock To:	
1st Value:	
2nd Value:	
Value Percent:	10.000
Continuous Index:	
Within 8" of Joint:	NO
Remarks:

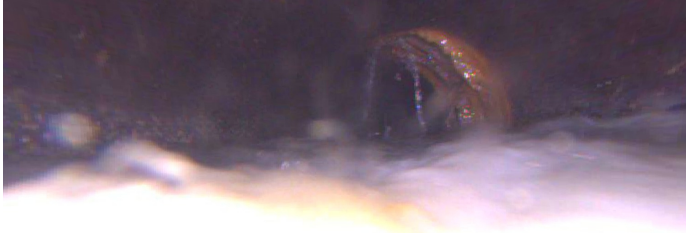
Code: **DAE**
Description: **Deposits Attached Encrustation**

Distance (ft): **39.1**
Structural Grade: **0**
O&M Grade: **2**
Clock Start/From: **12**
Clock To: **4**
1st Value:
2nd Value:
Value Percent: **10.000**
Continuous Index:
Within 8" of Joint: **NO**
Remarks:

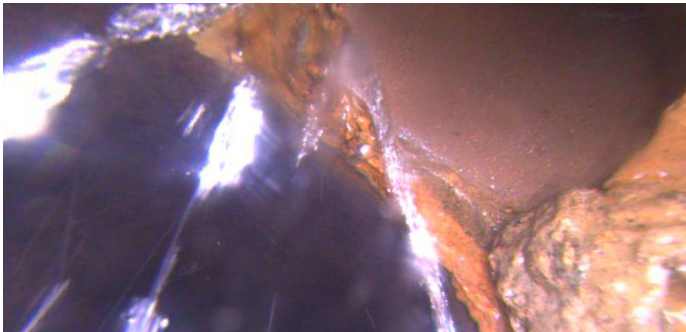
Code: **TBD**
Description: **Tap Break-in Defective**

Distance (ft): **40.3**
Structural Grade: **0**
O&M Grade: **3**
Clock Start/From: **1**
Clock To:
1st Value: **4.000**
2nd Value:
Value Percent:
Continuous Index:
Within 8" of Joint:
Remarks: **IR**

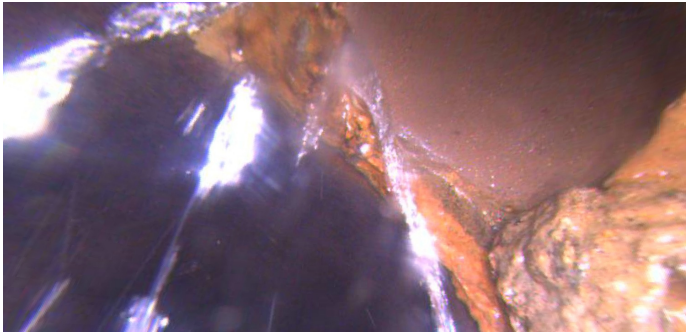
Code: **IR**
Description: **Infil Runner**

Distance (ft): **40.3**
Structural Grade: **0**
O&M Grade: **4**
Clock Start/From: **12**
Clock To:
1st Value:
2nd Value:
Value Percent:
Continuous Index:
Within 8" of Joint:
Remarks:

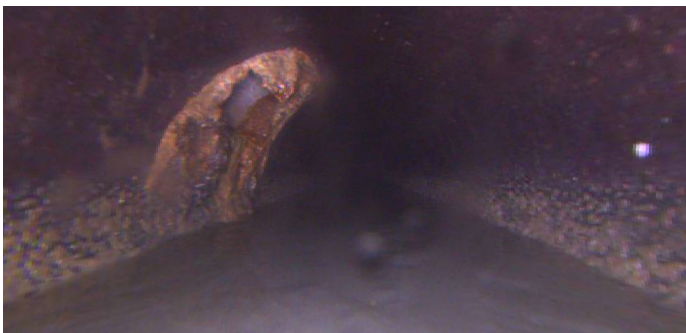
Code: **DAE**
Description: **Deposits Attached Encrustation**

Distance (ft): **72.4**
Structural Grade: **0**
O&M Grade: **2**
Clock Start/From: **7**
Clock To: **12**
1st Value:
2nd Value:
Value Percent: **10.000**
Continuous Index:
Within 8" of Joint: **NO**
Remarks:

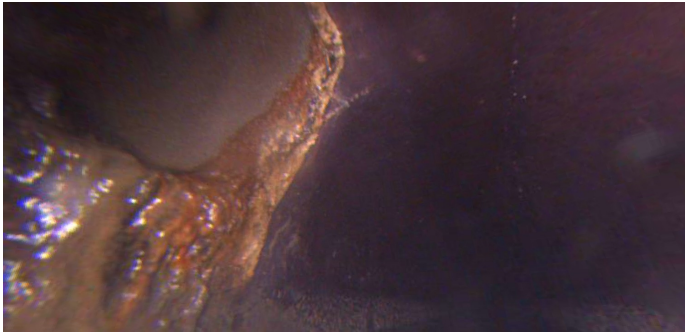
Code: **TB**
Description: **Tap Break-in**

Distance (ft): **73.3**
Structural Grade: **0**
O&M Grade: **0**
Clock Start/From: **10**
Clock To:
1st Value: **4.000**
2nd Value:
Value Percent:
Continuous Index:
Within 8" of Joint:
Remarks:

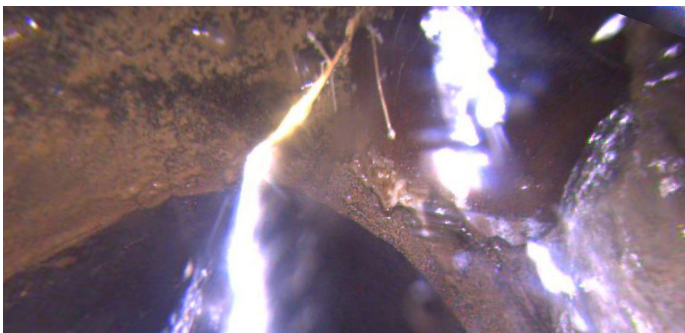
Code: **TBD**
Description: **Tap Break-in Defective**

Distance (ft): **112.0**
Structural Grade: **0**
O&M Grade: **3**
Clock Start/From: **1**
Clock To:
1st Value: **4.000**
2nd Value:
Value Percent:
Continuous Index:
Within 8" of Joint:
Remarks: **rfc**

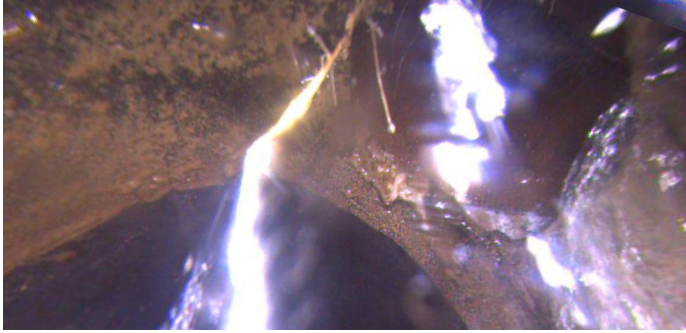
Code: **RFC**
Description: **Roots Fine Connection**

Distance (ft): **112.0**
Structural Grade: **0**
O&M Grade: **1**
Clock Start/From: **1**
Clock To: **2**
1st Value:
2nd Value:
Value Percent:
Continuous Index:
Within 8" of Joint: **NO**
Remarks:

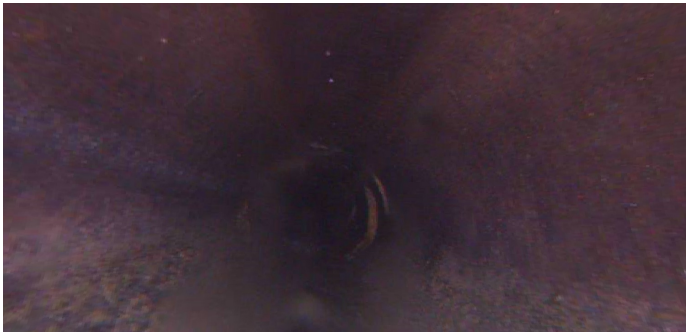
Code: **MSA**
Description: **Abandoned Survey**

Distance (ft): **138.9**
Structural Grade: **0**
O&M Grade: **0**
Clock Start/From:
Clock To:
1st Value:
2nd Value:
Value Percent:
Continuous Index:
Within 8" of Joint: **NO**
Remarks: **camera stopped**
