## Profile/Photo Observation Report

| Street: | <b>FOXCROFT STREET</b> | Flow Control: | <b>Not Controlled</b> |
| City: | <b>Hobart, IN</b> | Year Renewed: | |

| US MH: | <b>M-405-004</b> | DS MH: | <b>M-405-003</b> |

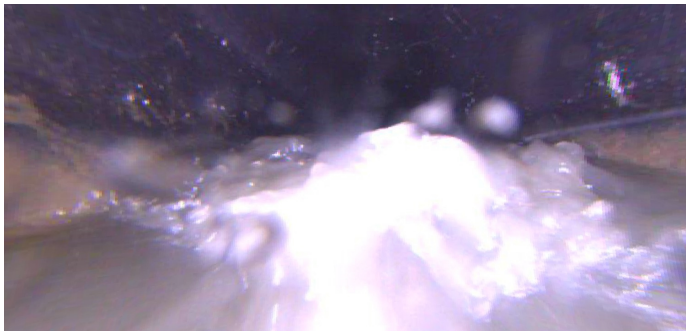
Code: **AMH**  
Description: **Manhole**

Distance (ft): **.0**  
Structural Grade: **0**  
O&M Grade: **0**  
Clock Start/From:  
Clock To:  
1st Value:  
2nd Value:  
Value Percent:  
Continuous Index:  
Within 8" of Joint: **NO**  
Remarks: **M-405-003**

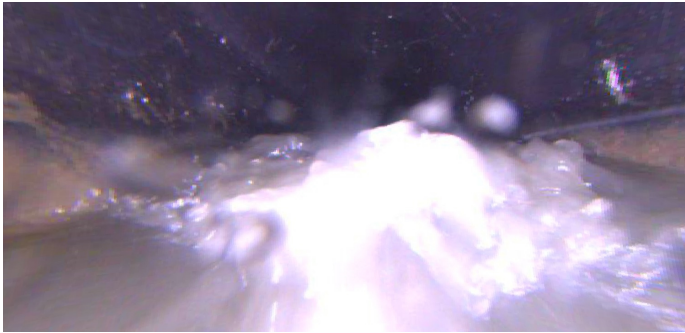
| Code: | <b>MWL</b> |
| Description: | <b>Water Level</b> |

| Value Percent: | <b>5.000</b> |

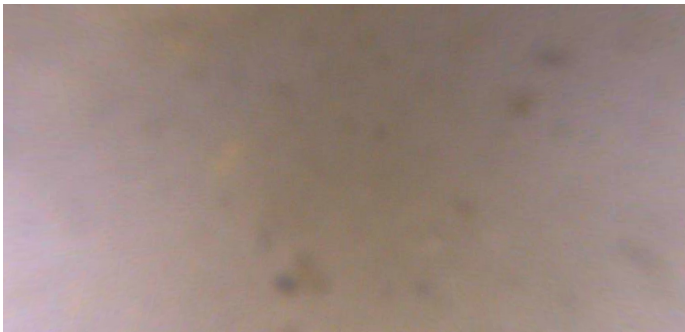
| Code: | <b>MWLS</b> |
| Description: | <b>Water Level Sag</b> |

| Distance (ft): | <b>3.7</b> |
| Structural Grade: | <b>2</b> |
| O&M Grade: | <b>3</b> |
| Value Percent: | <b>10.000</b> |

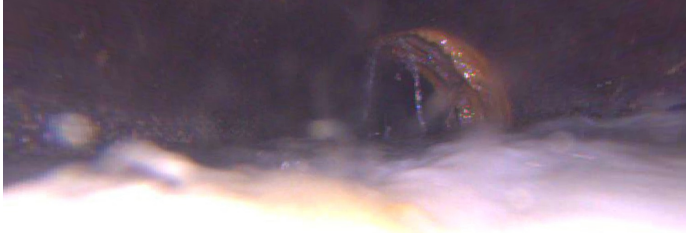
Code: **DAE**  
Description: **Deposits Attached Encrustation**

Distance (ft): **39.1**  
Structural Grade: **0**  
O&M Grade: **2**  
Clock Start/From: **12**  
Clock To: **4**  
1st Value:  
2nd Value:  
Value Percent: **10.000**  
Continuous Index:  
Within 8" of Joint: **NO**  
Remarks:

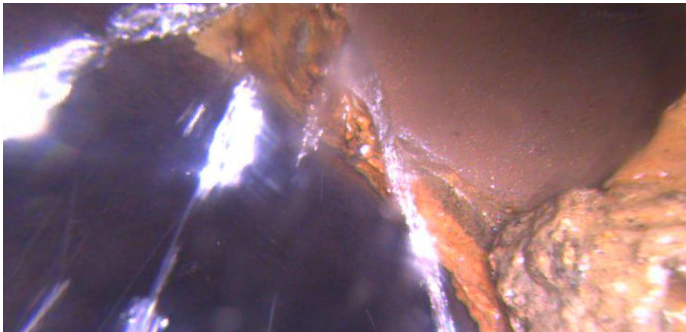
Code: **TBD**  
Description: **Tap Break-in Defective**

Distance (ft): **40.3**  
Structural Grade: **0**  
O&M Grade: **3**  
Clock Start/From: **1**  
Clock To:  
1st Value: **4.000**  
2nd Value:  
Value Percent:  
Continuous Index:  
Within 8" of Joint:  
Remarks: **IR**

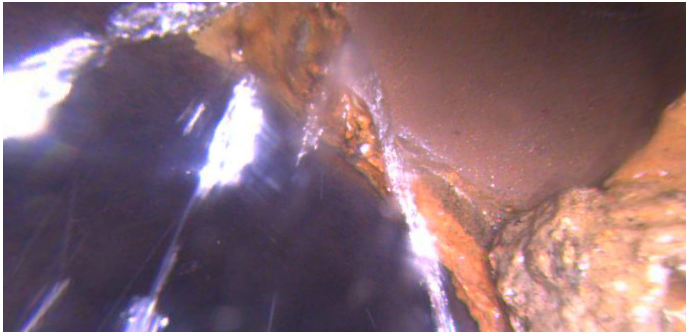
Code: **IR**  
Description: **Infil Runner**

Distance (ft): **40.3**  
Structural Grade: **0**  
O&M Grade: **4**  
Clock Start/From: **12**  
Clock To:  
1st Value:  
2nd Value:  
Value Percent:  
Continuous Index:  
Within 8" of Joint:  
Remarks:

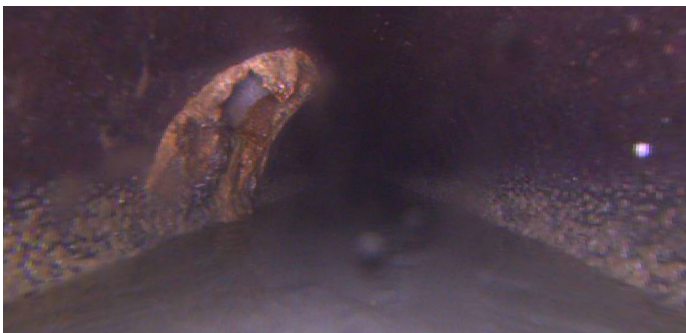
Code: **DAE**  
Description: **Deposits Attached Encrustation**

Distance (ft): **72.4**  
Structural Grade: **0**  
O&M Grade: **2**  
Clock Start/From: **7**  
Clock To: **12**  
1st Value:  
2nd Value:  
Value Percent: **10.000**  
Continuous Index:  
Within 8" of Joint: **NO**  
Remarks:

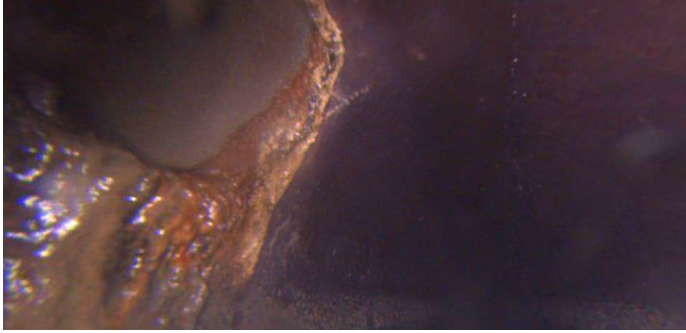
Code: **TB**  
Description: **Tap Break-in**

Distance (ft): **73.3**  
Structural Grade: **0**  
O&M Grade: **0**  
Clock Start/From: **10**  
Clock To:  
1st Value: **4.000**  
2nd Value:  
Value Percent:  
Continuous Index:  
Within 8" of Joint:  
Remarks:

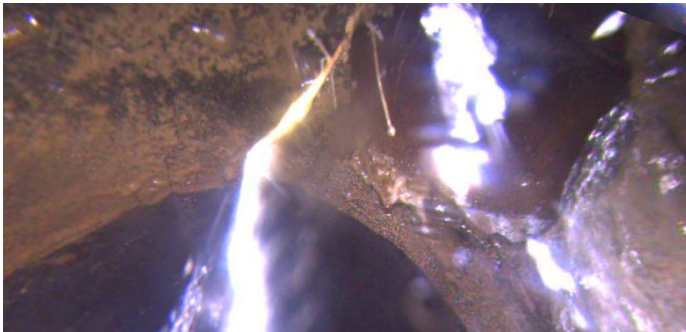
Code: **TBD**  
Description: **Tap Break-in Defective**

Distance (ft): **112.0**  
Structural Grade: **0**  
O&M Grade: **3**  
Clock Start/From: **1**  
Clock To:  
1st Value: **4.000**  
2nd Value:  
Value Percent:  
Continuous Index:  
Within 8" of Joint:  
Remarks: **rfc**

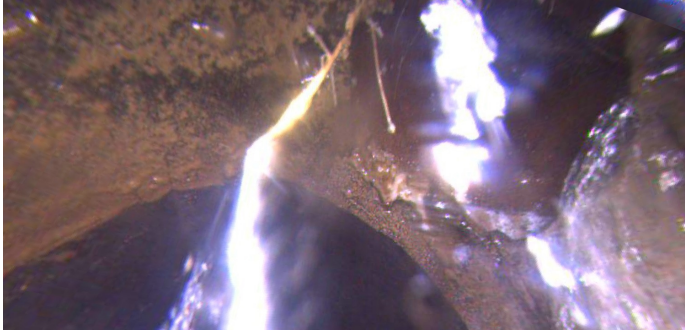
Code: **RFC**  
Description: **Roots Fine Connection**

Distance (ft): **112.0**  
Structural Grade: **0**  
O&M Grade: **1**  
Clock Start/From: **1**  
Clock To: **2**  
1st Value:  
2nd Value:  
Value Percent:  
Continuous Index:  
Within 8" of Joint: **NO**  
Remarks:

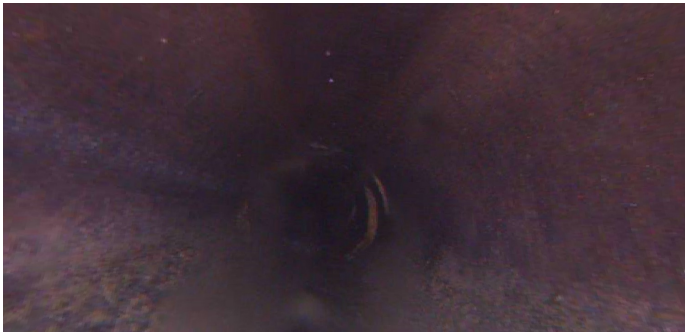
Code: **MSA**  
Description: **Abandoned Survey**

Distance (ft): **138.9**  
Structural Grade: **0**  
O&M Grade: **0**  
Clock Start/From:  
Clock To:  
1st Value:  
2nd Value:  
Value Percent:  
Continuous Index:  
Within 8" of Joint: **NO**  
Remarks: **camera stopped**
