## Profile/Photo Observation Report

Date:	<b>04/15/2018</b>	Weather:		Coding:	<b>PACP 6.0</b>
Pipe Length (ft):	<b>199.5</b>	Owner:	<b>NA</b>	Pre Clean:	<b>No Pre-Cleaning</b>
P.O.#:		Surveyor:	<b>Selasie Honu</b>	PSR:	<b>P-405-003-004</b>
Customer:		Clean Date:	<b>01/01/1900</b>	Shape:	<b>C</b>

Street:	<b>S WABASH ST</b>	Flow Control:	<b>Not Controlled</b>
City:	<b>Hobart, IN</b>	Year Renewed:	
Location:	<b>Yard</b>	Tape/Media #:	
Purpose:	<b>Routine Assessment</b>	Dia/Height:	<b>12"</b>
Use:	<b>Sanitary</b>	Material:	<b>VCP</b>
Drain Area:	<b>NA</b>	Lining:	<b>Cured in Place</b>
Category:	<b>NA</b>		
Comment:	<b>Flow direction is marked wrong.</b>		
Location Details:		Direction of Survey:	<b>Downstream</b>
US MH:	<b>M-405-004</b>	DS MH:	<b>M-405-003</b>
		Total Length Surveyed (ft):	<b>12.8</b>

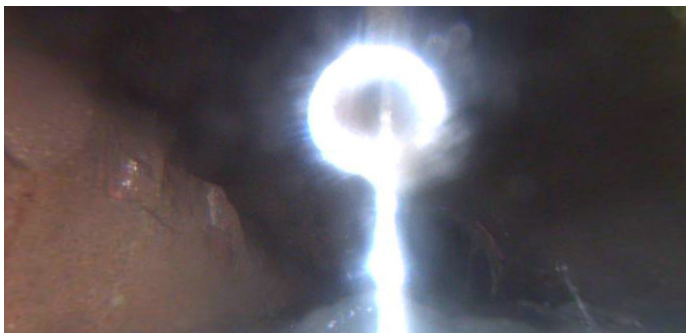
Code: **MGO**  
Description: **General Observation**

Distance (ft): **.0**  
Structural Grade: **0**  
O&M Grade: **0**  
Clock Start/From:  
Clock To:  
1st Value:  
2nd Value:  
Value Percent:  
Continuous Index:  
Within 8" of Joint: **NO**  
Remarks: **REAR CAMERA**

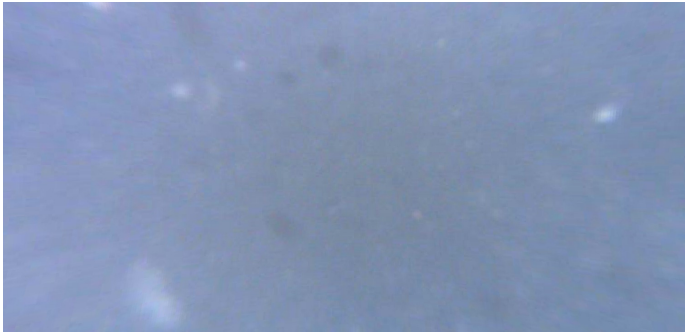
Code:	<b>AMH</b>
Description:	<b>Manhole</b>

Distance (ft):	<b>.0</b>
Structural Grade:	<b>0</b>
O&M Grade:	<b>0</b>
Clock Start/From:	
Clock To:	
1st Value:	
2nd Value:	
Value Percent:	
Continuous Index:	
Within 8" of Joint:	<b>NO</b>
Remarks:	<b>M-405-004</b>

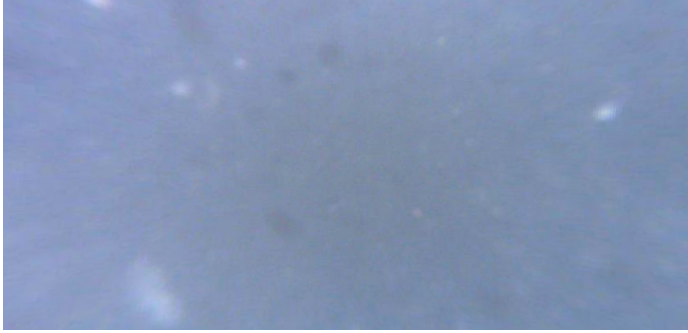
Code:	<b>MWLS</b>
Description:	<b>Water Level Sag</b>
Distance (ft):	<b>.0</b>
Structural Grade:	<b>2</b>
O&M Grade:	<b>3</b>
Clock Start/From:	
Clock To:	
1st Value:	
2nd Value:	
Value Percent:	<b>10.000</b>
Continuous Index:	<b>S01</b>
Within 8" of Joint:	<b>NO</b>
Remarks:
