## Profile/Photo Observation Report

| Street: | <b>South Wabash Street</b> | Flow Control: | <b>Not Controlled</b> |
| City: | <b>Hobart, IN</b> | Year Renewed: | |
| US MH: | <b>M-405-004</b> | DS MH: | <b>M-405-003</b> |

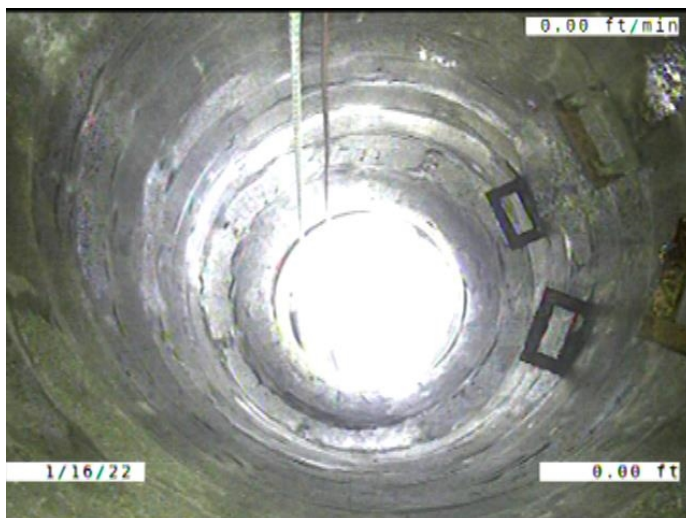
Code: **AMH**  
 Description: **Manhole**

Distance (ft): **.0**  
 Structural Grade: **0**  
 O&M Grade: **0**  
 Clock Start/From:  
 Clock To:  
 1st Value:  
 2nd Value:  
 Value Percent:  
 Continuous Index:  
 Within 8" of Joint: **NO**  
 Remarks: **M-405-003**

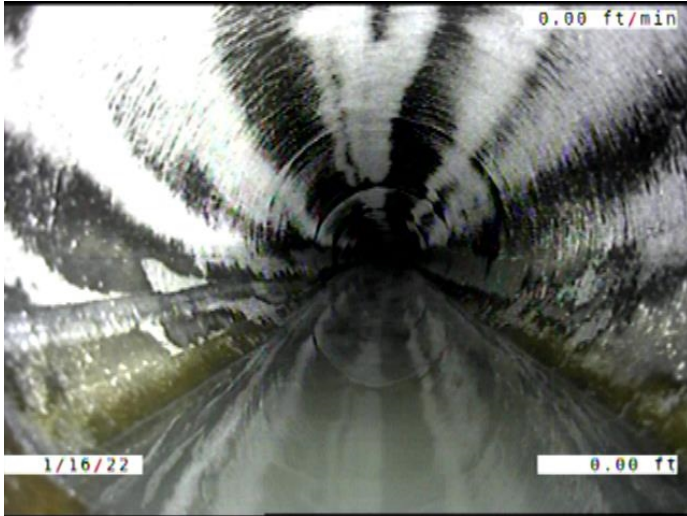
Code: **MWL**  
Description: **Miscellaneous Water Level**

Distance (ft): **.0**  
Structural Grade: **0**  
O&M Grade: **0**  
Clock Start/From:  
Clock To:  
1st Value:  
2nd Value:  
Value Percent: **10.000**  
Continuous Index:  
Within 8" of Joint: **NO**  
Remarks:

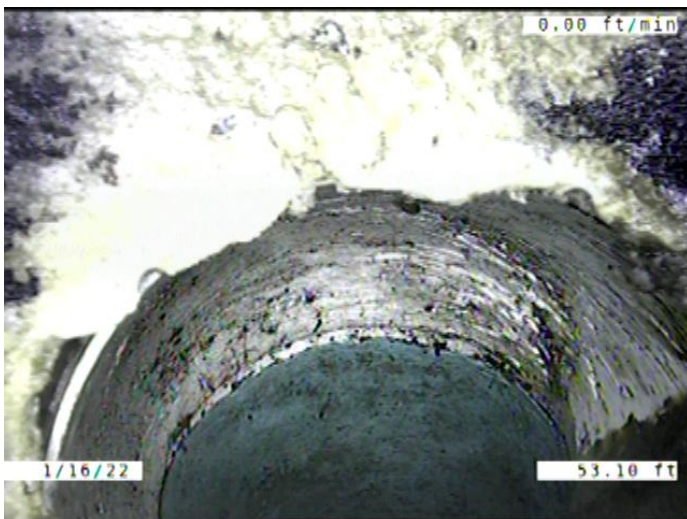
Code: **LFUC**  
Description: **Lining Feature Undercut Service**

Distance (ft): **53.1**  
Structural Grade: **3**  
O&M Grade: **0**  
Clock Start/From: **1**  
Clock To: **2**  
1st Value:  
2nd Value:  
Value Percent:  
Continuous Index:  
Within 8" of Joint: **NO**  
Remarks:

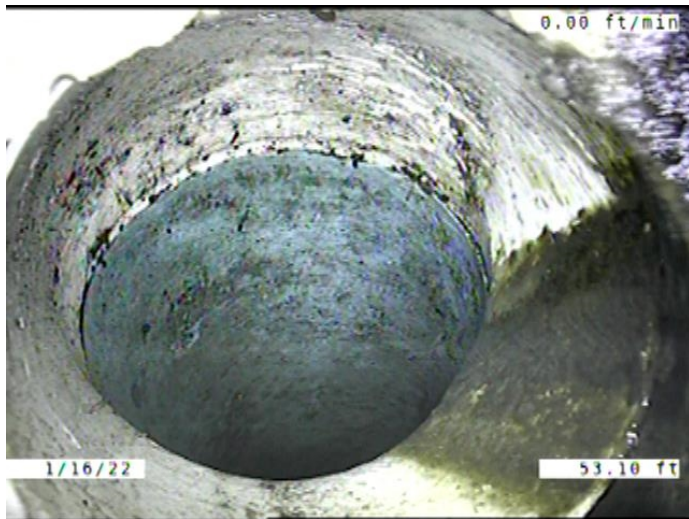
Code: **TB**  
Description: **Tap Break-in/Hammer**

Distance (ft): **53.1**  
Structural Grade: **0**  
O&M Grade: **0**  
Clock Start/From: **1**  
Clock To:  
1st Value: **4.000**  
2nd Value:  
Value Percent:  
Continuous Index:  
Within 8" of Joint: **NO**  
Remarks: **CONSTANTLY RUNNING WATER.**

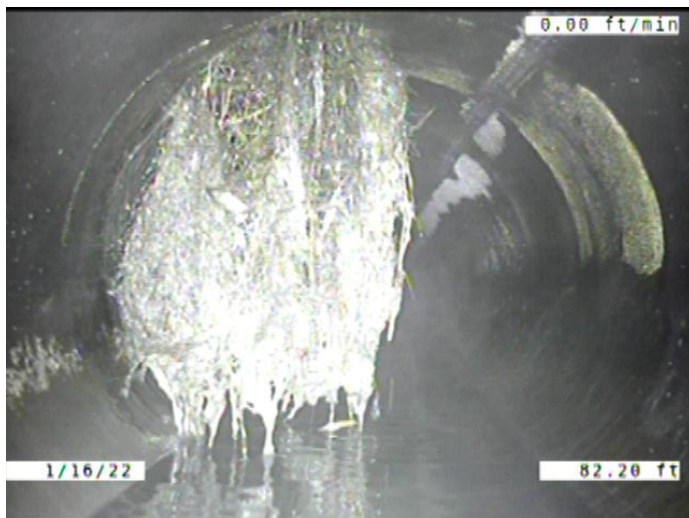
Code: **RML**  
Description: **Roots Medium Lateral**

Distance (ft): **82.2**  
Structural Grade: **0**  
O&M Grade: **3**  
Clock Start/From: **7**  
Clock To: **12**  
1st Value:  
2nd Value:  
Value Percent: **45.000**  
Continuous Index:  
Within 8" of Joint: **NO**  
Remarks:

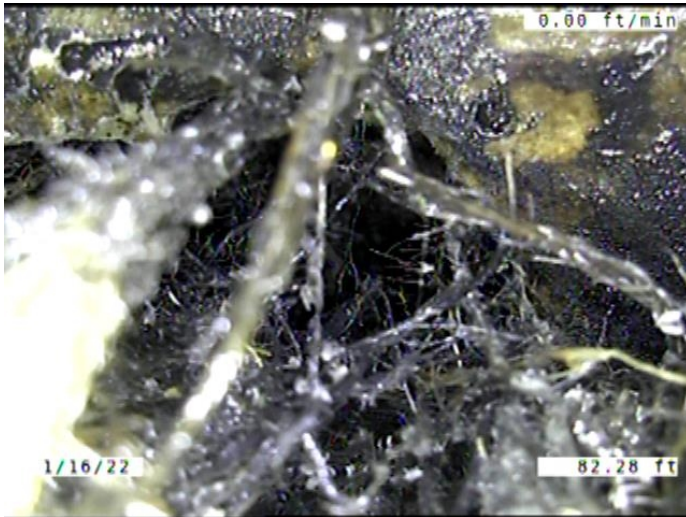
Code: **TB**  
 Description: **Tap Break-in/Hammer**

Distance (ft): **82.3**  
 Structural Grade: **0**  
 O&M Grade: **0**  
 Clock Start/From: **11**  
 Clock To:  
 1st Value: **4.000**  
 2nd Value:  
 Value Percent:  
 Continuous Index:  
 Within 8" of Joint: **YES**  
 Remarks: **ROOTS GROWING OUT OF THE SERVICE INTO THE MAIN.**

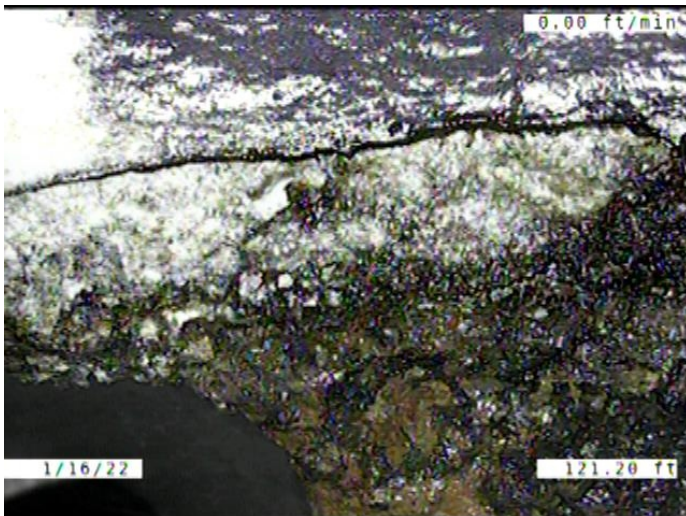
Code: **DAE**  
 Description: **Deposits Attached Encrustation**

Distance (ft): **121.2**  
 Structural Grade: **0**  
 O&M Grade: **2**  
 Clock Start/From: **12**  
 Clock To: **4**  
 1st Value:  
 2nd Value:  
 Value Percent: **5.000**  
 Continuous Index:  
 Within 8" of Joint: **YES**  
 Remarks:

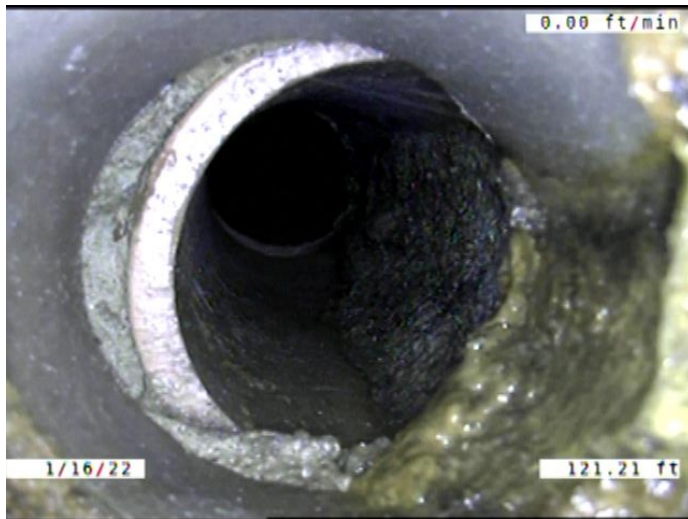
Code: **TB**  
 Description: **Tap Break-in/Hammer**

Distance (ft): **121.2**  
 Structural Grade: **0**  
 O&M Grade: **0**  
 Clock Start/From: **1**  
 Clock To:  
 1st Value: **4.000**  
 2nd Value:  
 Value Percent:  
 Continuous Index:  
 Within 8" of Joint: **NO**  
 Remarks: **LARGE OFFSET. SOIL VISIBLE. ENCRUSTATION COMING FROM THE**

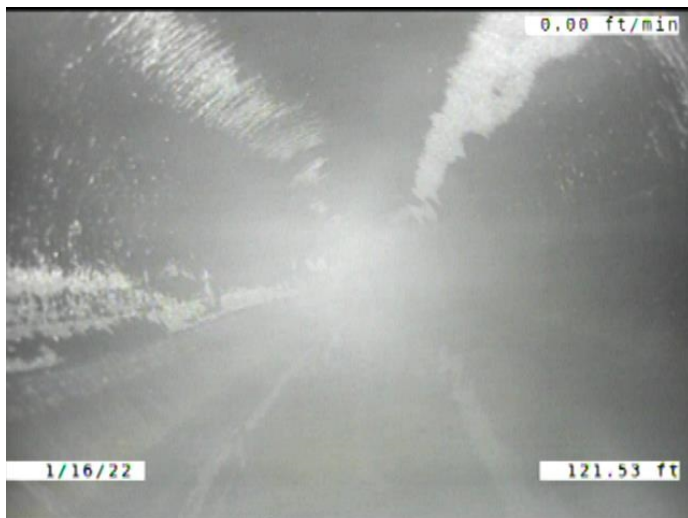
Code: **MGO**  
 Description: **Miscellaneous General Observation**

Distance (ft): **121.5**  
 Structural Grade: **0**  
 O&M Grade: **0**  
 Clock Start/From:  
 Clock To:  
 1st Value:  
 2nd Value:  
 Value Percent:  
 Continuous Index:  
 Within 8" of Joint: **NO**  
 Remarks: **LIFT STATION KICKED ON. CAMERA WENT UNDER WATER FOR A WHILE.**

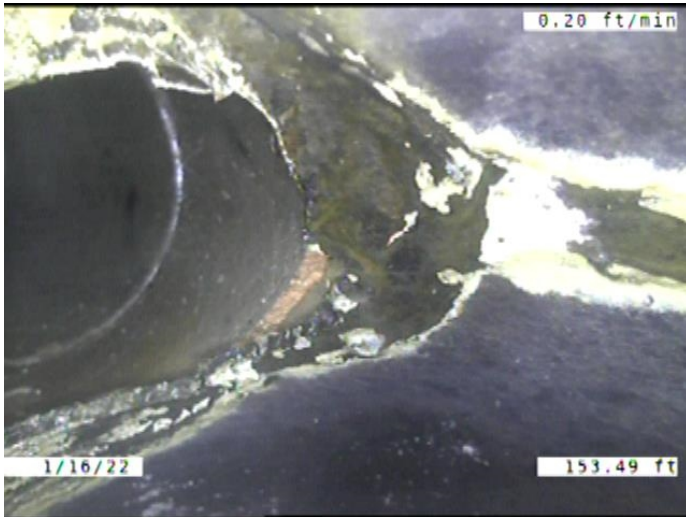
Code: **IDC**  
 Description: **Infiltration Dripper Connection**

Distance (ft): **153.5**  
 Structural Grade: **0**  
 O&M Grade: **3**  
 Clock Start/From: **11**  
 Clock To: **12**  
 1st Value:  
 2nd Value:  
 Value Percent:  
 Continuous Index:  
 Within 8" of Joint: **NO**  
 Remarks:

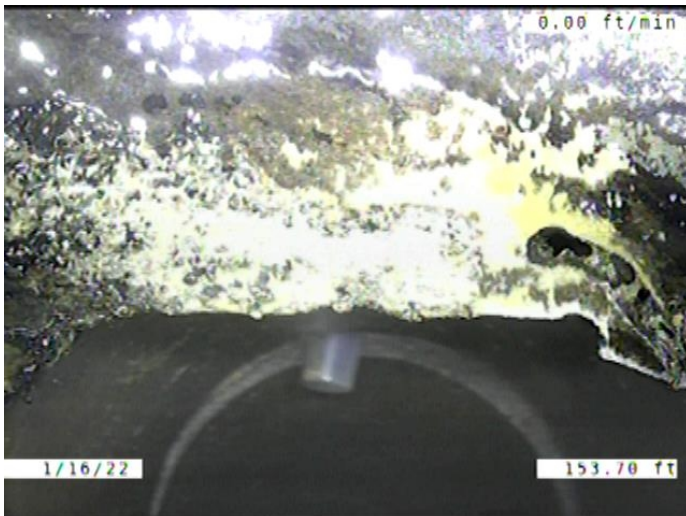
Code: **LFUC**  
 Description: **Lining Feature Undercut Service**

Distance (ft): **153.7**  
 Structural Grade: **3**  
 O&M Grade: **0**  
 Clock Start/From: **10**  
 Clock To: **11**  
 1st Value:  
 2nd Value:  
 Value Percent:  
 Continuous Index:  
 Within 8" of Joint: **NO**  
 Remarks:

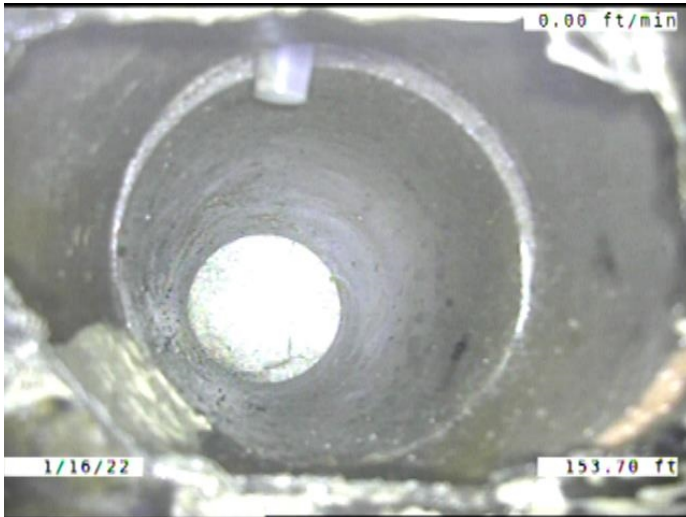
Code: **TBC**  
 Description: **Tap Break-in Capped**

Distance (ft): **153.7**  
 Structural Grade: **0**  
 O&M Grade: **0**  
 Clock Start/From: **11**  
 Clock To:  
 1st Value: **4.000**  
 2nd Value:  
 Value Percent:  
 Continuous Index:  
 Within 8" of Joint: **NO**  
 Remarks:

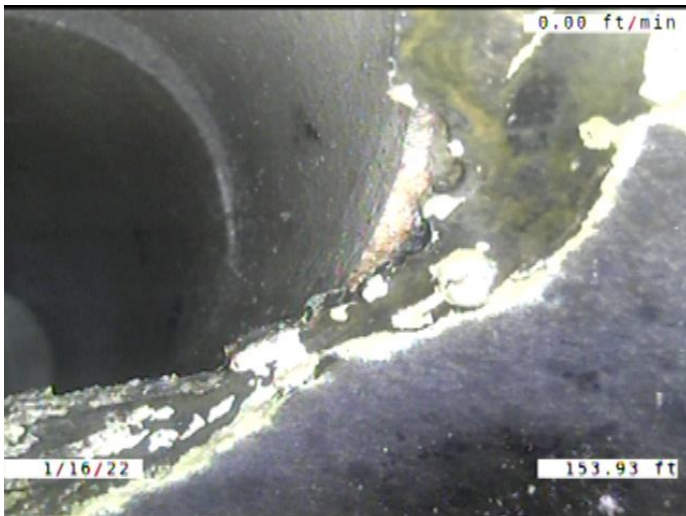
Code: **LFOC**  
 Description: **Lining Feature Overcut Service**

Distance (ft): **153.9**  
 Structural Grade: **3**  
 O&M Grade: **0**  
 Clock Start/From: **11**  
 Clock To: **12**  
 1st Value:  
 2nd Value:  
 Value Percent:  
 Continuous Index:  
 Within 8" of Joint: **NO**  
 Remarks:

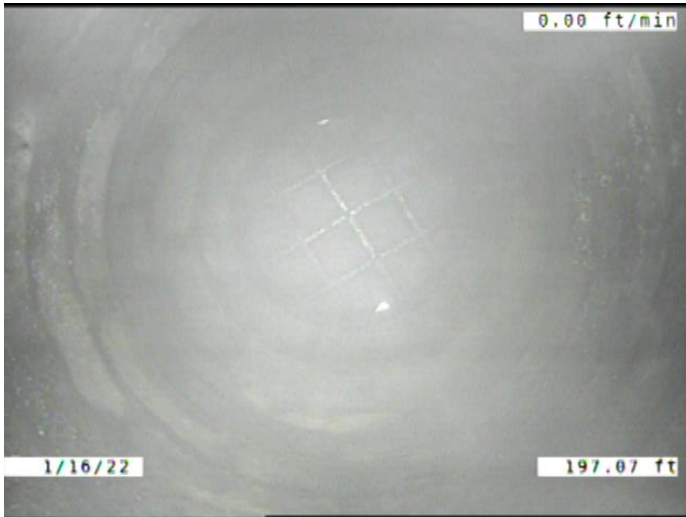
| Code: | <b>AMH</b> |
| Description: | <b>Manhole</b> |
| Distance (ft): | <b>197.1</b> |
| Remarks: | <b>M-405-004</b> |
