## Profile/Photo Observation Report

Street:	<b>W 4TH PL &amp; S WABASH ST</b>	Flow Control:	<b>Not Controlled</b>
City:	<b>Hobart, IN</b>	Year Renewed:	
Location:	<b>Yard</b>	Tape/Media #:	
Purpose:	<b>Routine Assessment</b>	Dia/Height:	<b>10"</b>
Use:	<b>Sanitary</b>	Material:	<b>VCP</b>
Drain Area:	<b>NA</b>	Lining:	<b>Cured in Place</b>
Category:	<b>NA</b>		
Comment:	<b>Flow direction is marked wrong.</b>		
Location Details:		Direction of Survey:	<b>Upstream</b>
US MH:	<b>M-405-004</b>	DS MH:	<b>M-405-005</b>
		Total Length Surveyed (ft):	<b>174.6</b>

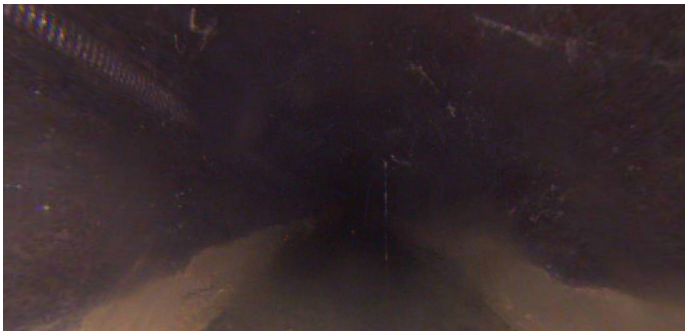
Code: **AMH**  
Description: **Manhole**

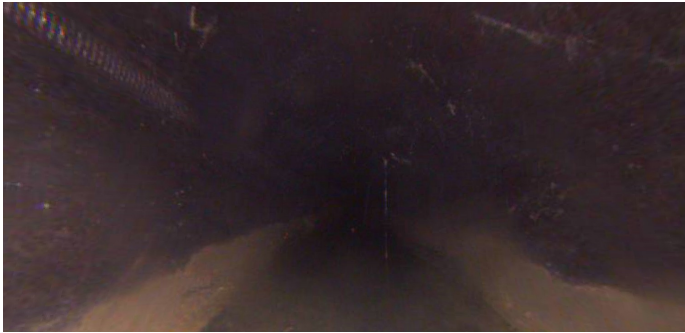
Code:	<b>MWL</b>
Description:	<b>Water Level</b>

Distance (ft):	<b>.0</b>
Structural Grade:	<b>0</b>
O&M Grade:	<b>0</b>
Clock Start/From:	
Clock To:	
1st Value:	
2nd Value:	
Value Percent:	<b>10.000</b>
Continuous Index:	
Within 8" of Joint:	<b>NO</b>
Remarks:

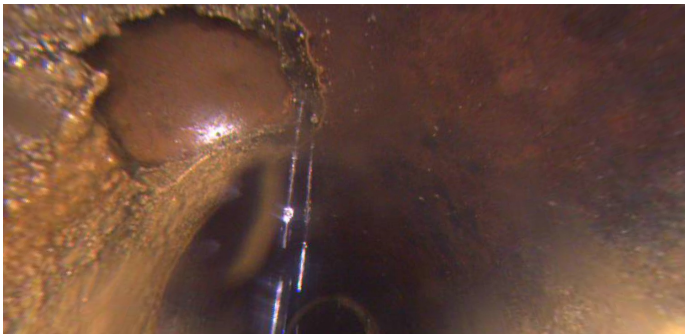
Code:	<b>TBD</b>
Description:	<b>Tap Break-in Defective</b>

Distance (ft):	<b>78.1</b>
Structural Grade:	<b>0</b>
O&M Grade:	<b>3</b>
Clock Start/From:	<b>11</b>
Clock To:	
1st Value:	<b>4.000</b>
2nd Value:	
Value Percent:	
Continuous Index:	
Within 8" of Joint:	
Remarks:	<b>id</b>

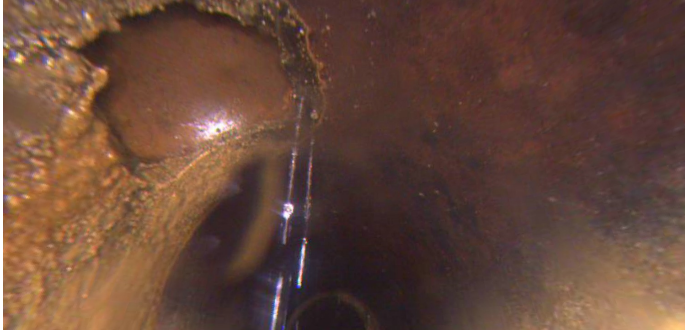
Code: ID  
Description: Infil Dripper

Distance (ft): 78.1  
Structural Grade: 0  
O&M Grade: 3  
Clock Start/From: 12  
Clock To:  
1st Value:  
2nd Value:  
Value Percent:  
Continuous Index:  
Within 8" of Joint:  
Remarks: from tap

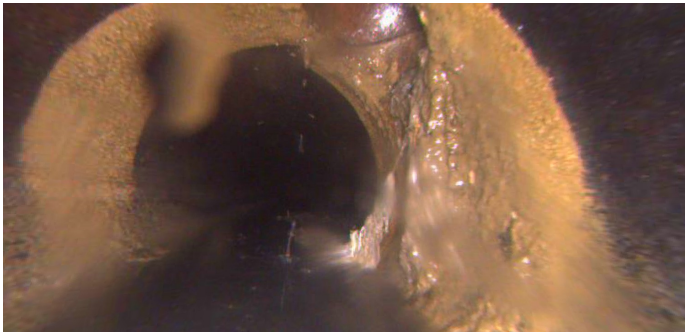
Code: DAZ  
Description: Deposits Attached Other

Distance (ft): 80.9  
Structural Grade: 0  
O&M Grade: 2  
Clock Start/From: 1  
Clock To: 4  
1st Value:  
2nd Value:  
Value Percent: 10.000  
Continuous Index:  
Within 8" of Joint: NO  
Remarks:

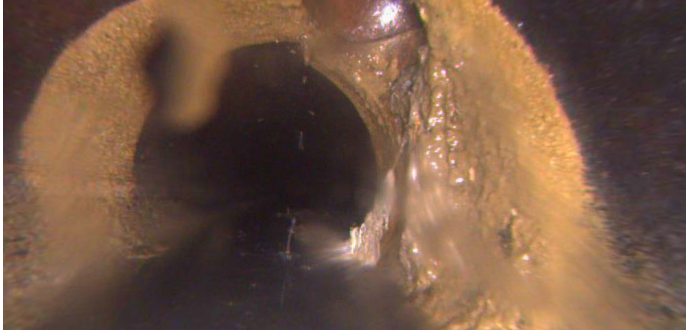
Code: ID  
Description: Infil Dripper

Distance (ft): 80.9  
Structural Grade: 0  
O&M Grade: 3  
Clock Start/From: 12  
Clock To:  
1st Value:  
2nd Value:  
Value Percent:  
Continuous Index:  
Within 8" of Joint:  
Remarks: FROM TAP

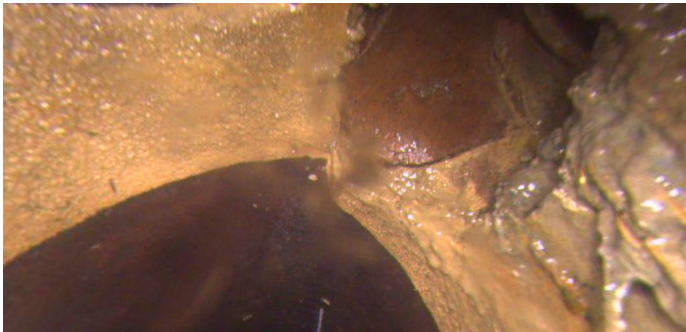
Code: TBD  
Description: Tap Break-in Defective

Distance (ft): 81.4  
Structural Grade: 0  
O&M Grade: 3  
Clock Start/From: 1  
Clock To:  
1st Value: 4.000  
2nd Value:  
Value Percent:  
Continuous Index:  
Within 8" of Joint:  
Remarks: ID, DAZ

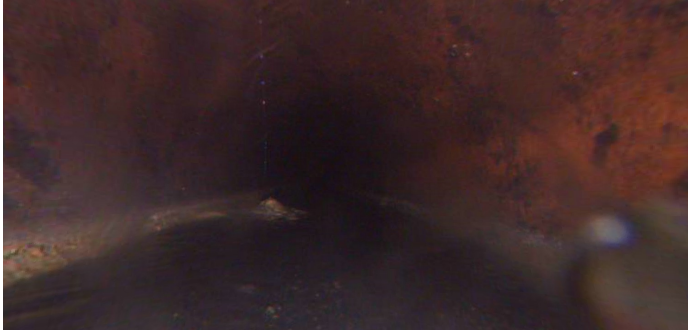
Code:	MSA
Description:	Abandoned Survey
Distance (ft):	174.6
Structural Grade:	0
O&M Grade:	0
Clock Start/From:	
Clock To:	
1st Value:	
2nd Value:	
Value Percent:	
Continuous Index:	
Within 8" of Joint:	NO
Remarks:	DEBRIS UNDER WATER
