## Profile/Photo Observation Report

Date:	<b>04/14/2018</b>	Weather:		Coding:	<b>PACP 6.0</b>
Pipe Length (ft):	<b>289.9</b>	Owner:	<b>NA</b>	Pre Clean:	<b>No Pre-Cleaning</b>
P.O.#:		Surveyor:	<b>Jen Costello</b>	PSR:	<b>P-405-005-004</b>
Customer:		Clean Date:	<b>01/01/1900</b>	Shape:	<b>C</b>

Street:	<b>FOXCROFT STREET</b>	Flow Control:	<b>Not Controlled</b>
City:	<b>Hobart, IN</b>	Year Renewed:	
Location:	<b>Yard</b>	Tape/Media #:	
Purpose:	<b>Routine Assessment</b>	Dia/Height:	<b>10"</b>
Use:	<b>Sanitary</b>	Material:	<b>VCP</b>
Drain Area:	<b>NA</b>	Lining:	<b>Cured in Place</b>
Category:	<b>NA</b>		
Comment:	<b>Flow direction is marked wrong.</b>		
Location Details:		Direction of Survey:	<b>Upstream</b>
US MH:	<b>M-405-004</b>	DS MH:	<b>M-405-005</b>
		Total Length Surveyed (ft):	<b>174.6</b>

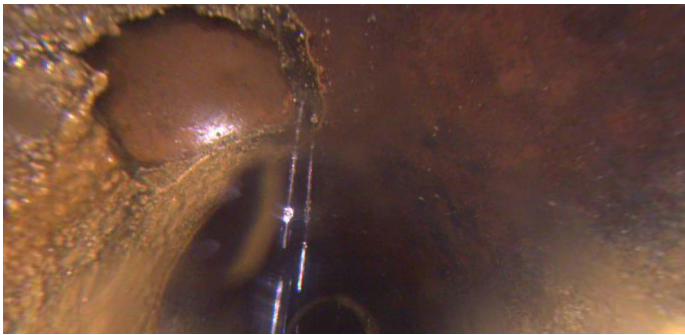
Code:	<b>TBD</b>
Description:	<b>Tap Break-in Defective</b>

Distance (ft):	<b>78.1</b>
Structural Grade:	<b>0</b>
O&M Grade:	<b>3</b>
Clock Start/From:	<b>11</b>
Clock To:	
1st Value:	<b>4.000</b>
2nd Value:	
Value Percent:	
Continuous Index:	
Within 8" of Joint:	
Remarks:	<b>id</b>

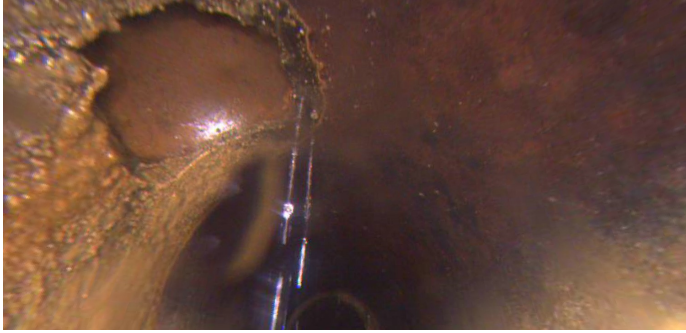
Code: ID  
Description: Infil Dripper

Distance (ft): 78.1  
Structural Grade: 0  
O&M Grade: 3  
Clock Start/From: 12  
Clock To:  
1st Value:  
2nd Value:  
Value Percent:  
Continuous Index:  
Within 8" of Joint:  
Remarks: from tap

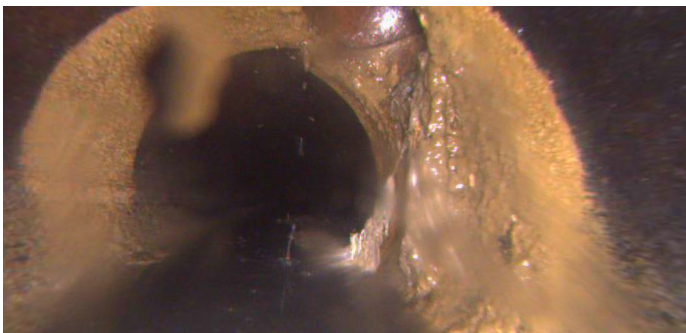
Code: DAZ  
Description: Deposits Attached Other

Distance (ft): 80.9  
Structural Grade: 0  
O&M Grade: 2  
Clock Start/From: 1  
Clock To: 4  
1st Value:  
2nd Value:  
Value Percent: 10.000  
Continuous Index:  
Within 8" of Joint: NO  
Remarks:

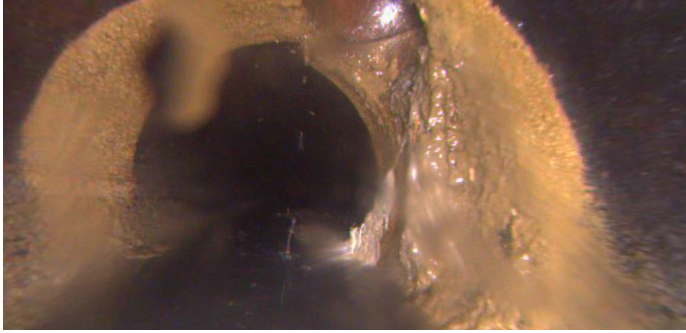
Code: ID  
Description: Infil Dripper

Distance (ft): 80.9  
Structural Grade: 0  
O&M Grade: 3  
Clock Start/From: 12  
Clock To:  
1st Value:  
2nd Value:  
Value Percent:  
Continuous Index:  
Within 8" of Joint:  
Remarks: FROM TAP

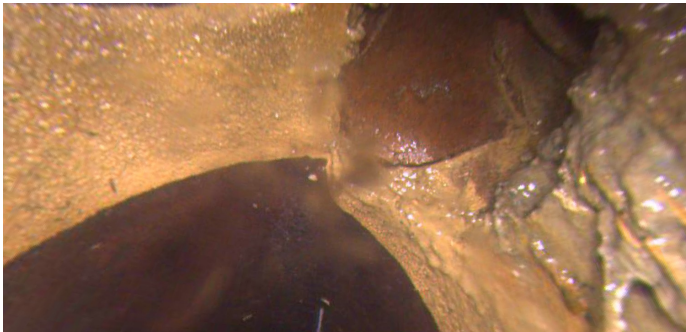
Code: TBD  
Description: Tap Break-in Defective

Distance (ft): 81.4  
Structural Grade: 0  
O&M Grade: 3  
Clock Start/From: 1  
Clock To:  
1st Value: 4.000  
2nd Value:  
Value Percent:  
Continuous Index:  
Within 8" of Joint:  
Remarks: ID, DAZ

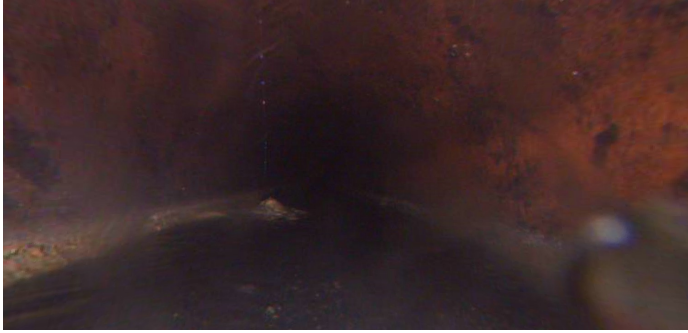
Code:	<b>MSA</b>
Description:	<b>Abandoned Survey</b>
Distance (ft):	<b>174.6</b>
Structural Grade:	<b>0</b>
O&M Grade:	<b>0</b>
Clock Start/From:	
Clock To:	
1st Value:	
2nd Value:	
Value Percent:	
Continuous Index:	
Within 8" of Joint:	<b>NO</b>
Remarks:	<b>DEBRIS UNDER WATER</b>
