Profile/Photo Observation Report

Street:	W 4TH PL & S WABASH ST	Flow Control:	Not Controlled
City:	Hobart, IN	Year Renewed:	
Location:	Yard	Tape/Media #:	
Purpose:	Routine Assessment	Dia/Height:	10"
Use:	Sanitary	Material:	VCP
Drain Area:	NA	Lining:	Cured in Place
Category:	NA		
Comment:	Flow direction is marked wrong.		
Location Details:		Direction of Survey:	Downstream
US MH:	M-405-004	DS MH:	M-405-005
		Total Length Surveyed (ft):	77.7

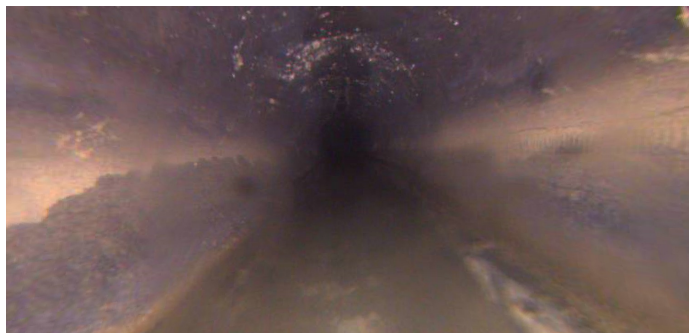
Code: **AMH**
Description: **Manhole**

Distance (ft): **.0**
Structural Grade: **0**
O&M Grade: **0**
Clock Start/From:
Clock To:
1st Value:
2nd Value:
Value Percent:
Continuous Index:
Within 8" of Joint: **NO**
Remarks: **M-405-004**

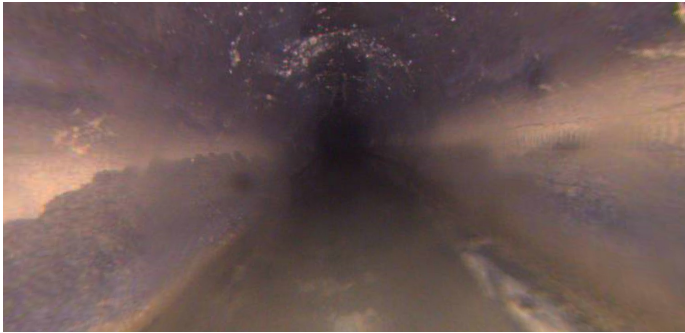
Code:	MWL
Description:	Water Level

Distance (ft):	.0
Structural Grade:	0
O&M Grade:	0
Clock Start/From:	
Clock To:	
1st Value:	
2nd Value:	
Value Percent:	10.000
Continuous Index:	
Within 8" of Joint:	NO
Remarks:

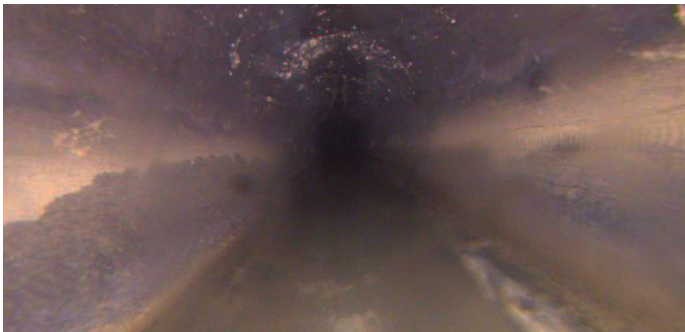
Code:	DAGS
Description:	Deposits Attached Grease

Distance (ft):	.0
Structural Grade:	0
O&M Grade:	2
Clock Start/From:	8
Clock To:	4
1st Value:	
2nd Value:	
Value Percent:	5.000
Continuous Index:	S01
Within 8" of Joint:	NO
Remarks:

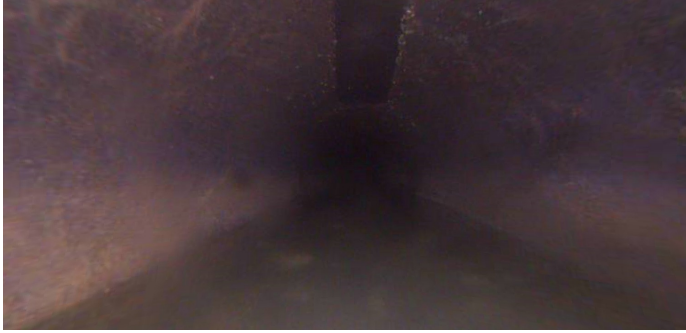
Code: **DAGS**
Description: **Deposits Attached Grease**

Distance (ft): **9.7**
Structural Grade: **0**
O&M Grade: **2**
Clock Start/From: **8**
Clock To: **4**
1st Value:
2nd Value:
Value Percent: **5.000**
Continuous Index: **F01**
Within 8" of Joint: **NO**
Remarks:

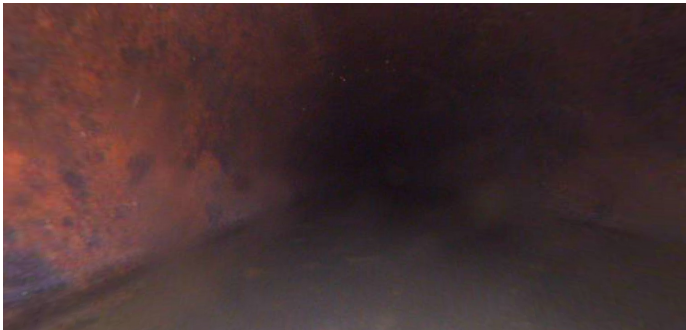
Code: **MSA**
Description: **Abandoned Survey**

Distance (ft): **77.7**
Structural Grade: **0**
O&M Grade: **0**
Clock Start/From:
Clock To:
1st Value:
2nd Value:
Value Percent:
Continuous Index:
Within 8" of Joint: **NO**
Remarks: **DEBRIS UNDER WATER**
