## Profile/Photo Observation Report

Date:	<b>04/14/2018</b>	Weather:		Coding:	<b>PACP 6.0</b>
Pipe Length (ft):	<b>289.9</b>	Owner:	<b>NA</b>	Pre Clean:	<b>No Pre-Cleaning</b>
P.O.#:		Surveyor:	<b>Jen Costello</b>	PSR:	<b>P-405-005-004</b>
Customer:		Clean Date:	<b>01/01/1900</b>	Shape:	<b>C</b>

Street:	<b>FOXCROFT STREET</b>	Flow Control:	<b>Not Controlled</b>
City:	<b>Hobart, IN</b>	Year Renewed:	
Location:	<b>Yard</b>	Tape/Media #:	
Purpose:	<b>Routine Assessment</b>	Dia/Height:	<b>10"</b>
Use:	<b>Sanitary</b>	Material:	<b>VCP</b>
Drain Area:	<b>NA</b>	Lining:	<b>Cured in Place</b>
Category:	<b>NA</b>		
Comment:	<b>Flow direction is marked wrong.</b>		
Location Details:		Direction of Survey:	<b>Downstream</b>
US MH:	<b>M-405-004</b>	DS MH:	<b>M-405-005</b>
		Total Length Surveyed (ft):	<b>77.7</b>

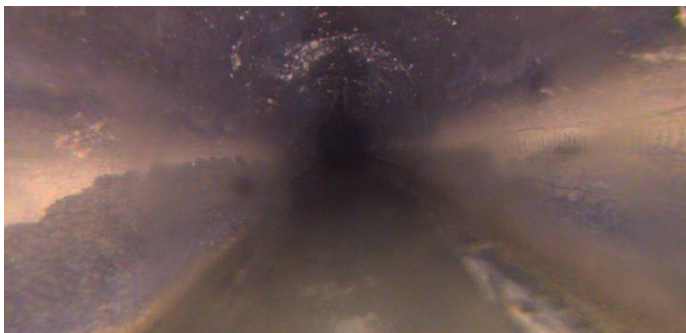
Code: **AMH**  
Description: **Manhole**

Distance (ft): **.0**  
Structural Grade: **0**  
O&M Grade: **0**  
Clock Start/From:  
Clock To:  
1st Value:  
2nd Value:  
Value Percent:  
Continuous Index:  
Within 8" of Joint: **NO**  
Remarks: **M-405-004**

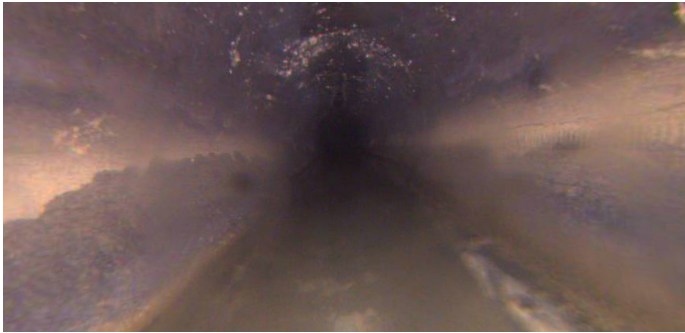
Code:	<b>MWL</b>
Description:	<b>Water Level</b>

Distance (ft):	<b>.0</b>
Structural Grade:	<b>0</b>
O&M Grade:	<b>0</b>
Clock Start/From:	
Clock To:	
1st Value:	
2nd Value:	
Value Percent:	<b>10.000</b>
Continuous Index:	
Within 8" of Joint:	<b>NO</b>
Remarks:

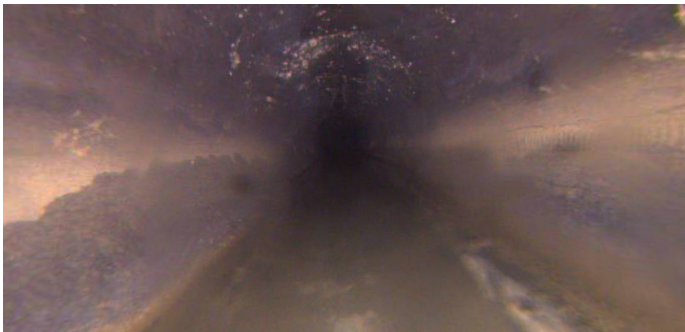
Code:	<b>DAGS</b>
Description:	<b>Deposits Attached Grease</b>

Distance (ft):	<b>.0</b>
Structural Grade:	<b>0</b>
O&M Grade:	<b>2</b>
Clock Start/From:	<b>8</b>
Clock To:	<b>4</b>
1st Value:	
2nd Value:	
Value Percent:	<b>5.000</b>
Continuous Index:	<b>S01</b>
Within 8" of Joint:	<b>NO</b>
Remarks:

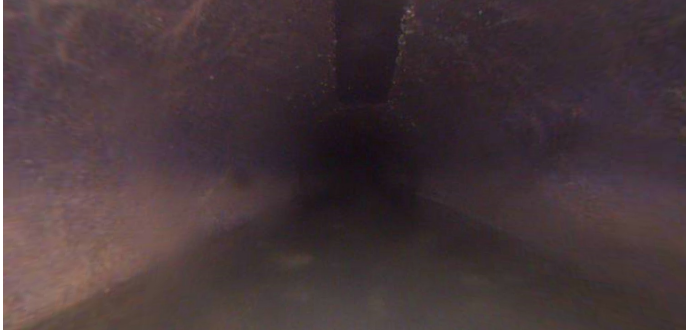
Code: **DAGS**  
Description: **Deposits Attached Grease**

Distance (ft): **9.7**  
Structural Grade: **0**  
O&M Grade: **2**  
Clock Start/From: **8**  
Clock To: **4**  
1st Value:  
2nd Value:  
Value Percent: **5.000**  
Continuous Index: **F01**  
Within 8" of Joint: **NO**  
Remarks:

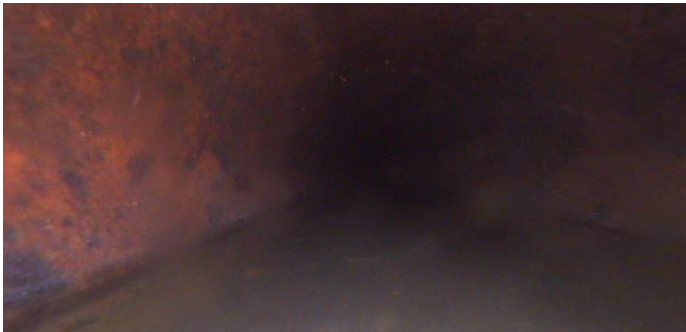
Code: **MSA**  
Description: **Abandoned Survey**

Distance (ft): **77.7**  
Structural Grade: **0**  
O&M Grade: **0**  
Clock Start/From:  
Clock To:  
1st Value:  
2nd Value:  
Value Percent:  
Continuous Index:  
Within 8" of Joint: **NO**  
Remarks: **DEBRIS UNDER WATER**
