## Profile/Photo Observation Report

Date:	<b>01/16/2022</b>	Weather:		Coding:	<b>PACP 7.0</b>
Pipe Length (ft):	<b>287.9</b>	Owner:	<b>City of Hobart</b>	Pre Clean:	<b>Heavy Cleaning</b>
P.O.#:	<b>YES502259</b>	Surveyor:	<b>S. Bucklin</b>	PSR:	<b>P-405-005-004</b>
Customer:	<b>City of Hobart</b>	Clean Date:	<b>01/13/2021</b>	Shape:	<b>C</b>

Location Details:		Direction of Survey:	<b>Upstream</b>
US MH:	<b>M-405-004</b>	DS MH:	<b>M-405-005</b>
		Total Length Surveyed (ft):	<b>287.9</b>

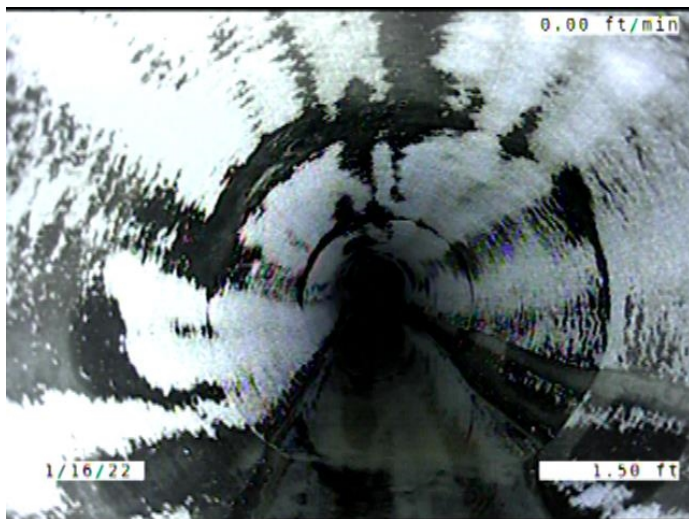
Code: **MGO**  
Description: **Miscellaneous General Observation**

Distance (ft): **1.5**  
Structural Grade: **0**  
O&M Grade: **0**  
Clock Start/From:  
Clock To:  
1st Value:  
2nd Value:  
Value Percent:  
Continuous Index:  
Within 8" of Joint: **NO**  
Remarks: **DROP INTO THE MANHOLE. HAD TO START IN THE PIPE.**

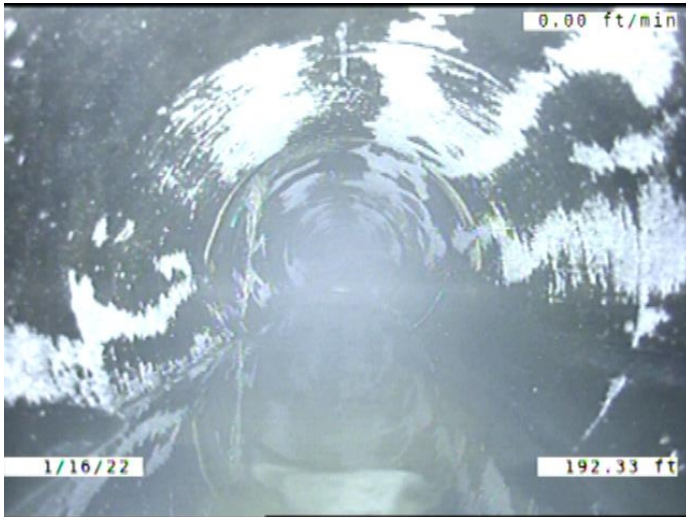
Code: **MWLS**  
 Description: **Miscellaneous Water Level Sag**

Distance (ft): **192.3**  
 Structural Grade: **2**  
 O&M Grade: **0**  
 Clock Start/From:  
 Clock To:  
 1st Value:  
 2nd Value:  
 Value Percent: **10.000**  
 Continuous Index: **S01**  
 Within 8" of Joint: **NO**  
 Remarks:

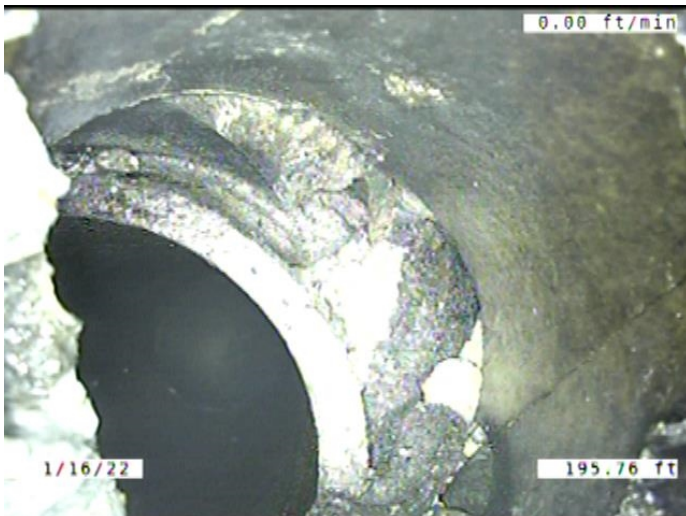
Code: **TBD**  
 Description: **Tap Break-in/Hammer Defective**

Distance (ft): **195.8**  
 Structural Grade: **0**  
 O&M Grade: **3**  
 Clock Start/From: **11**  
 Clock To:  
 1st Value: **4.000**  
 2nd Value:  
 Value Percent:  
 Continuous Index:  
 Within 8" of Joint: **NO**  
 Remarks: **CONSTANTLY RUNNING WATER. BROKEN LARGE OFFSET.**

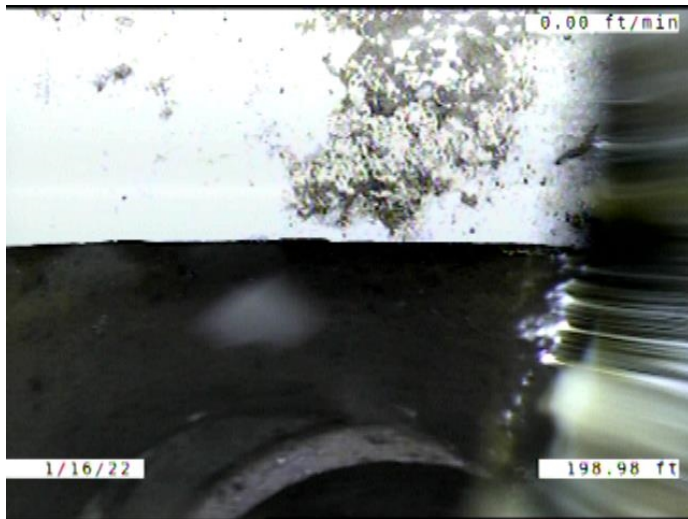
Code: **LFUC**  
 Description: **Lining Feature Undercut Service**

Distance (ft): **199.0**  
 Structural Grade: **3**  
 O&M Grade: **0**  
 Clock Start/From: **12**  
 Clock To: **3**  
 1st Value:  
 2nd Value:  
 Value Percent:  
 Continuous Index:  
 Within 8" of Joint: **NO**  
 Remarks:

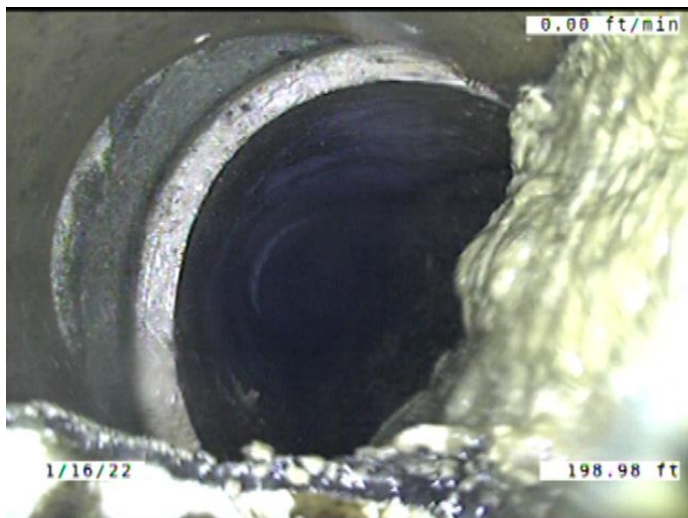
Code: **TBD**  
 Description: **Tap Break-in/Hammer Defective**

Distance (ft): **199.0**  
 Structural Grade: **0**  
 O&M Grade: **3**  
 Clock Start/From: **1**  
 Clock To:  
 1st Value: **4.000**  
 2nd Value:  
 Value Percent:  
 Continuous Index:  
 Within 8" of Joint: **NO**  
 Remarks: **LARGE OFFSET. ENCUSTATION  
 COMING FROM THE FROM THE SERV**

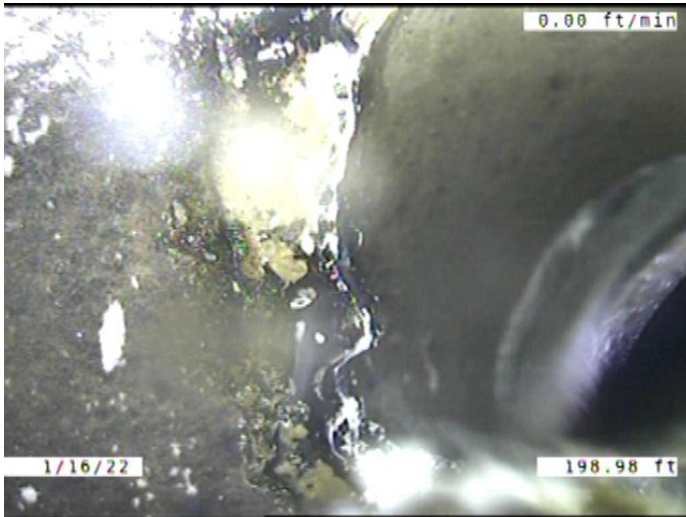
Code: **IDC**  
 Description: **Infiltration Dripper Connection**

Distance (ft): **199.0**  
 Structural Grade: **0**  
 O&M Grade: **3**  
 Clock Start/From: **12**  
 Clock To:  
 1st Value:  
 2nd Value:  
 Value Percent:  
 Continuous Index:  
 Within 8" of Joint: **NO**  
 Remarks:

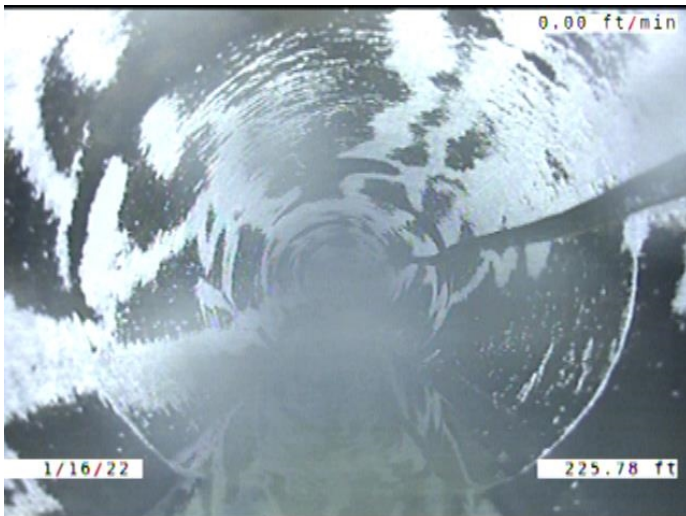
Code: **MWLS**  
 Description: **Miscellaneous Water Level Sag**

Distance (ft): **225.8**  
 Structural Grade: **2**  
 O&M Grade: **0**  
 Clock Start/From:  
 Clock To:  
 1st Value:  
 2nd Value:  
 Value Percent: **10.000**  
 Continuous Index: **F01**  
 Within 8" of Joint: **NO**  
 Remarks:

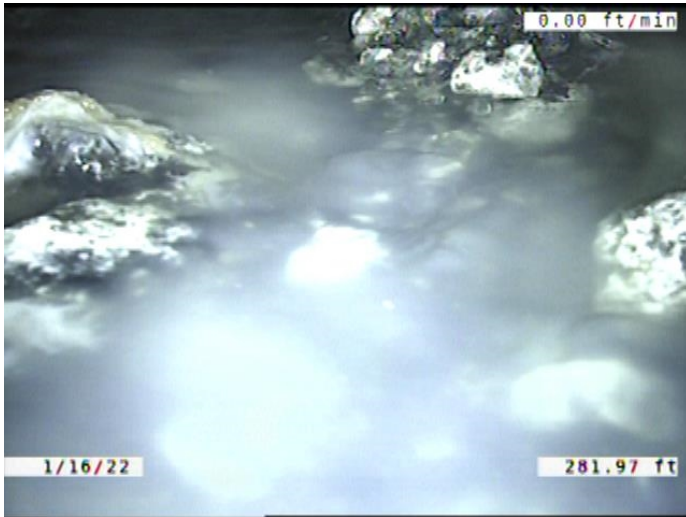
Code: **OBR**  
 Description: **Obstruction Rocks**

Distance (ft): **282.0**  
 Structural Grade: **0**  
 O&M Grade: **2**  
 Clock Start/From: **5**  
 Clock To: **7**  
 1st Value:  
 2nd Value:  
 Value Percent: **5.000**  
 Continuous Index:  
 Within 8" of Joint: **NO**  
 Remarks:

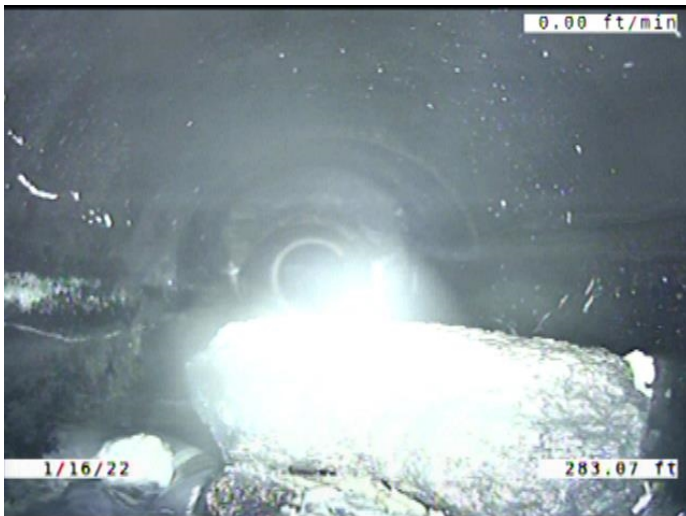
Code: **OBN**  
 Description: **Obstruction Construction Debris**

Distance (ft): **283.1**  
 Structural Grade: **0**  
 O&M Grade: **5**  
 Clock Start/From: **4**  
 Clock To: **8**  
 1st Value:  
 2nd Value:  
 Value Percent: **40.000**  
 Continuous Index:  
 Within 8" of Joint: **NO**  
 Remarks:
