## Profile/Photo Observation Report

Street:	<b>W 4TH PL</b>	Flow Control:	<b>Not Controlled</b>
City:	<b>Hobart, IN</b>	Year Renewed:	
Location:	<b>Yard</b>	Tape/Media #:	
Purpose:	<b>Routine Assessment</b>	Dia/Height:	<b>10"</b>
Use:	<b>Sanitary</b>	Material:	<b>VCP</b>
Drain Area:	<b>NA</b>	Lining:	
Category:	<b>NA</b>		
Comment:	<b>Flow direction is marked wrong.</b>		
Location Details:		Direction of Survey:	<b>Downstream</b>
US MH:	<b>M-405-005</b>	DS MH:	<b>M-505-082</b>
		Total Length Surveyed (ft):	<b>16.3</b>

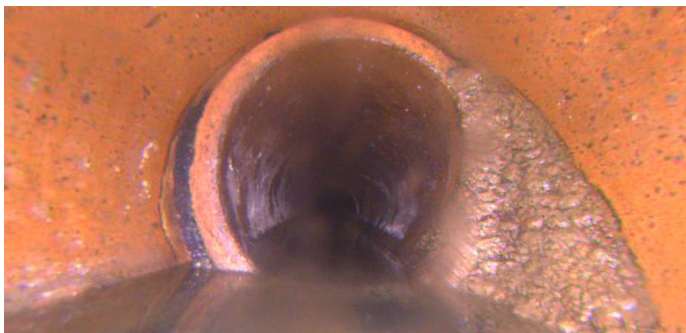
Code: **AMH**  
Description: **Manhole**

Distance (ft): **.0**  
Structural Grade: **0**  
O&M Grade: **0**  
Clock Start/From:  
Clock To:  
1st Value:  
2nd Value:  
Value Percent:  
Continuous Index:  
Within 8" of Joint: **NO**  
Remarks: **M-405-005**

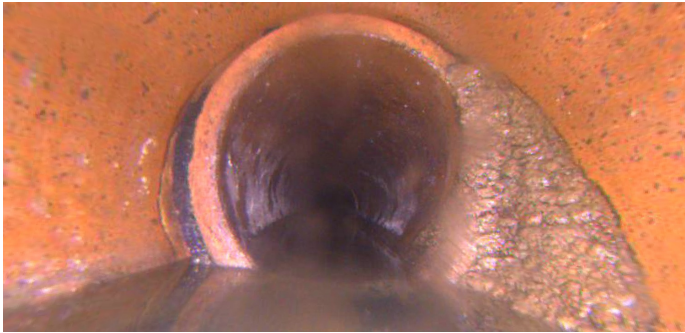
Code:	<b>MWL</b>
Description:	<b>Water Level</b>

Distance (ft):	<b>.0</b>
Structural Grade:	<b>0</b>
O&M Grade:	<b>0</b>
Clock Start/From:	
Clock To:	
1st Value:	
2nd Value:	
Value Percent:	<b>20.000</b>
Continuous Index:	
Within 8" of Joint:	<b>NO</b>
Remarks:

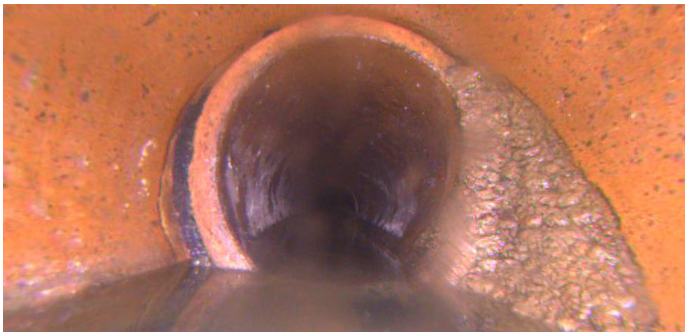
Code:	<b>DAE</b>
Description:	<b>Deposits Attached Encrustation</b>

Distance (ft):	<b>.0</b>
Structural Grade:	<b>0</b>
O&M Grade:	<b>2</b>
Clock Start/From:	<b>1</b>
Clock To:	<b>4</b>
1st Value:	
2nd Value:	
Value Percent:	<b>10.000</b>
Continuous Index:	
Within 8" of Joint:	<b>YES</b>
Remarks:

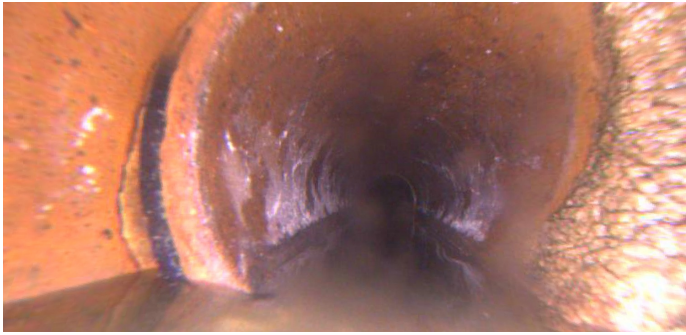
Code: **FC**  
Description: **Fracture Circumferential**

Distance (ft): **.7**  
Structural Grade: **2**  
O&M Grade: **0**  
Clock Start/From: **8**  
Clock To: **10**  
1st Value:  
2nd Value:  
Value Percent:  
Continuous Index:  
Within 8" of Joint: **YES**  
Remarks:

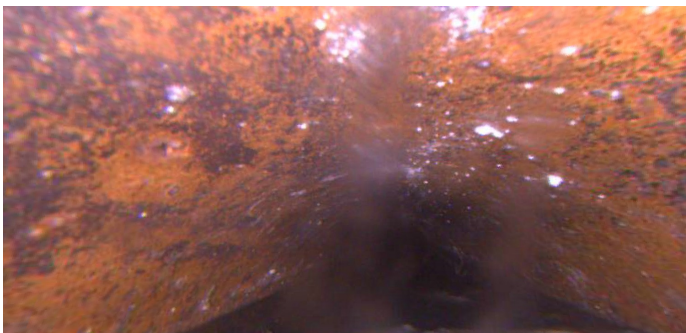
Code: **MSA**  
Description: **Abandoned Survey**

Distance (ft): **16.3**  
Structural Grade: **0**  
O&M Grade: **0**  
Clock Start/From:  
Clock To:  
1st Value:  
2nd Value:  
Value Percent:  
Continuous Index:  
Within 8" of Joint: **NO**  
Remarks: **DEBRIS UNDER WATER**
