Profile/Photo Observation Report

Street:	FOXCROFT STREET	Flow Control:	Not Controlled
City:	Hobart, IN	Year Renewed:	
Location:	Yard	Tape/Media #:	
Purpose:	Routine Assessment	Dia/Height:	10"
Use:	Sanitary	Material:	VCP
Drain Area:	NA	Lining:	
Category:	NA		
Comment:	Flow direction is marked wrong.

Location Details:		Direction of Survey:	Downstream
US MH:	M-405-005	DS MH:	M-505-082
		Total Length Surveyed (ft):	16.3

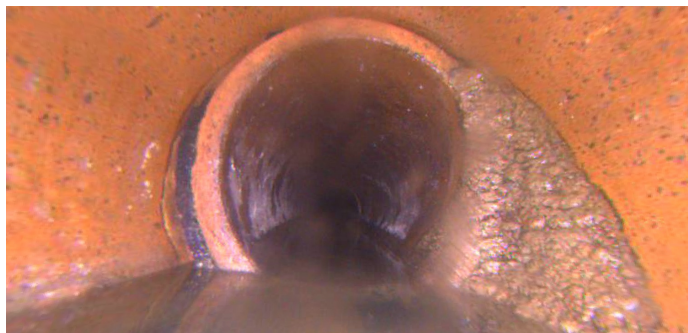
Code: **AMH**
Description: **Manhole**

Distance (ft): **.0**
Structural Grade: **0**
O&M Grade: **0**
Clock Start/From:
Clock To:
1st Value:
2nd Value:
Value Percent:
Continuous Index:
Within 8" of Joint: **NO**
Remarks: **M-405-005**

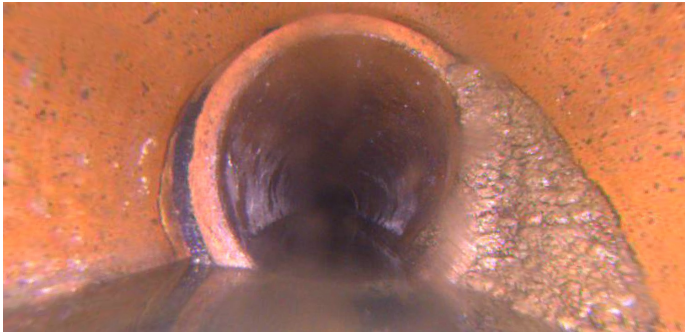
Code:	MWL
Description:	Water Level

Distance (ft):	.0
Structural Grade:	0
O&M Grade:	0
Clock Start/From:	
Clock To:	
1st Value:	
2nd Value:	
Value Percent:	20.000
Continuous Index:	
Within 8" of Joint:	NO
Remarks:

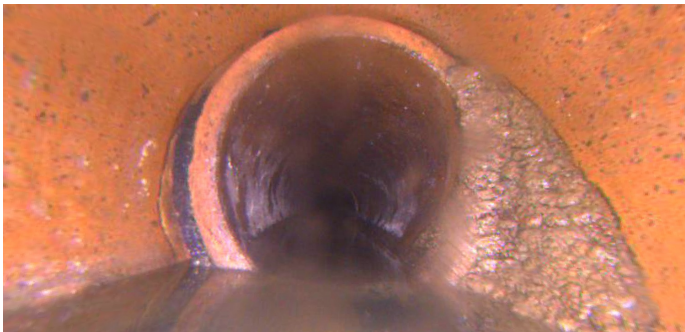
Code:	DAE
Description:	Deposits Attached Encrustation

Distance (ft):	.0
Structural Grade:	0
O&M Grade:	2
Clock Start/From:	1
Clock To:	4
1st Value:	
2nd Value:	
Value Percent:	10.000
Continuous Index:	
Within 8" of Joint:	YES
Remarks:

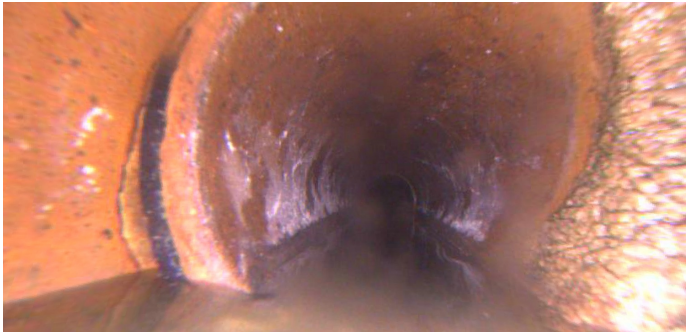
Code: **FC**
Description: **Fracture Circumferential**

Distance (ft): **.7**
Structural Grade: **2**
O&M Grade: **0**
Clock Start/From: **8**
Clock To: **10**
1st Value:
2nd Value:
Value Percent:
Continuous Index:
Within 8" of Joint: **YES**
Remarks:

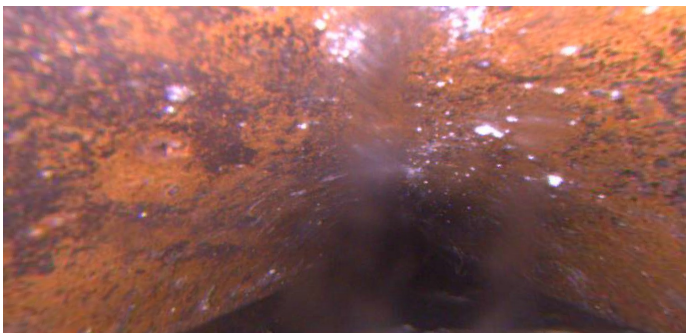
Code: **MSA**
Description: **Abandoned Survey**

Distance (ft): **16.3**
Structural Grade: **0**
O&M Grade: **0**
Clock Start/From:
Clock To:
1st Value:
2nd Value:
Value Percent:
Continuous Index:
Within 8" of Joint: **NO**
Remarks: **DEBRIS UNDER WATER**
