## Profile/Photo Observation Report

Date:	<b>04/14/2018</b>	Weather:		Coding:	<b>PACP 6.0</b>
Pipe Length (ft):	<b>252.9</b>	Owner:	<b>NA</b>	Pre Clean:	<b>No Pre-Cleaning</b>
P.O.#:		Surveyor:	<b>Jen Costello</b>	PSR:	<b>P-505-082-005</b>
Customer:		Clean Date:	<b>01/01/1900</b>	Shape:	<b>C</b>

Street:	<b>W 4TH PL</b>	Flow Control:	<b>Not Controlled</b>
City:	<b>Hobart, IN</b>	Year Renewed:	
Location:	<b>Yard</b>	Tape/Media #:	
Purpose:	<b>Routine Assessment</b>	Dia/Height:	<b>10"</b>
Use:	<b>Sanitary</b>	Material:	<b>VCP</b>
Drain Area:	<b>NA</b>	Lining:	
Category:	<b>NA</b>		
Comment:	<b>Flow direction is marked wrong.</b>		
Location Details:		Direction of Survey:	<b>Upstream</b>
US MH:	<b>M-405-005</b>	DS MH:	<b>M-505-082</b>
		Total Length Surveyed (ft):	<b>70.1</b>

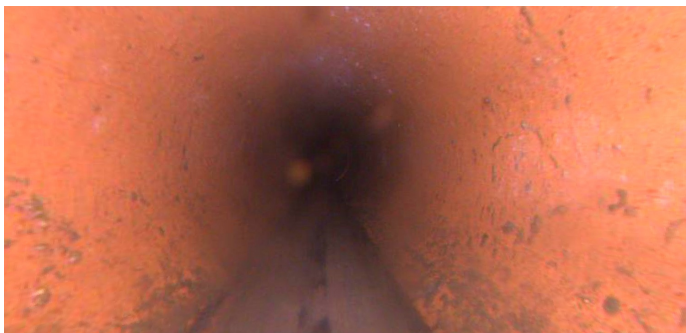
Code: **AMH**  
Description: **Manhole**

Distance (ft): **.0**  
Structural Grade: **0**  
O&M Grade: **0**  
Clock Start/From:  
Clock To:  
1st Value:  
2nd Value:  
Value Percent:  
Continuous Index:  
Within 8" of Joint: **NO**  
Remarks: **M-505-082**

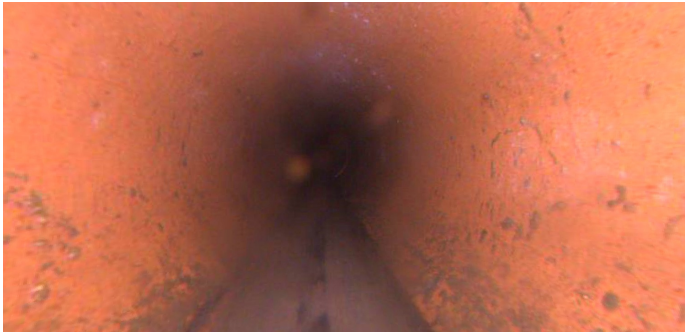
Code:	<b>MWL</b>
Description:	<b>Water Level</b>

Distance (ft):	<b>.0</b>
Structural Grade:	<b>0</b>
O&M Grade:	<b>0</b>
Clock Start/From:	
Clock To:	
1st Value:	
2nd Value:	
Value Percent:	<b>5.000</b>
Continuous Index:	
Within 8" of Joint:	<b>NO</b>
Remarks:

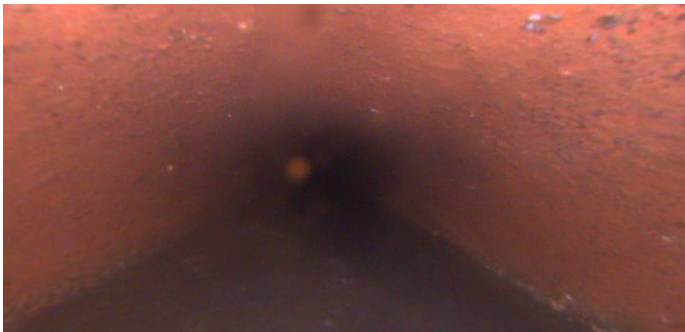
Code:	<b>MWL</b>
Description:	<b>Water Level</b>

Distance (ft):	<b>22.0</b>
Structural Grade:	<b>0</b>
O&M Grade:	<b>0</b>
Clock Start/From:	
Clock To:	
1st Value:	
2nd Value:	
Value Percent:	<b>30.000</b>
Continuous Index:	
Within 8" of Joint:	<b>NO</b>
Remarks:

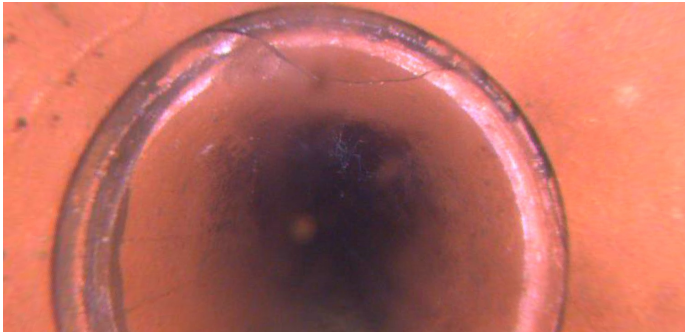
Code: **FS**  
Description: **Fracture Spiral**

Distance (ft): **39.6**  
Structural Grade: **3**  
O&M Grade: **0**  
Clock Start/From: **11**  
Clock To: **1**  
1st Value:  
2nd Value:  
Value Percent:  
Continuous Index:  
Within 8" of Joint: **YES**  
Remarks:

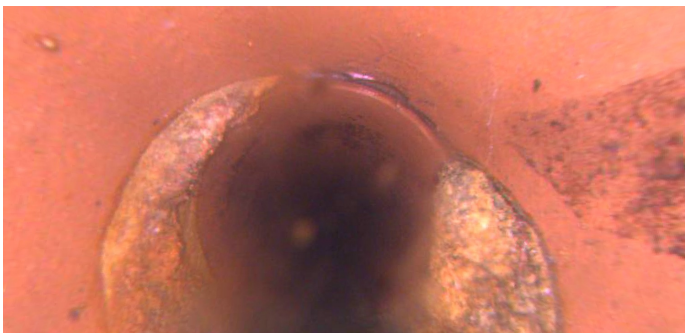
Code: **DAE**  
Description: **Deposits Attached Encrustation**

Distance (ft): **49.3**  
Structural Grade: **0**  
O&M Grade: **3**  
Clock Start/From: **8**  
Clock To: **4**  
1st Value:  
2nd Value:  
Value Percent: **20.000**  
Continuous Index:  
Within 8" of Joint: **YES**  
Remarks:

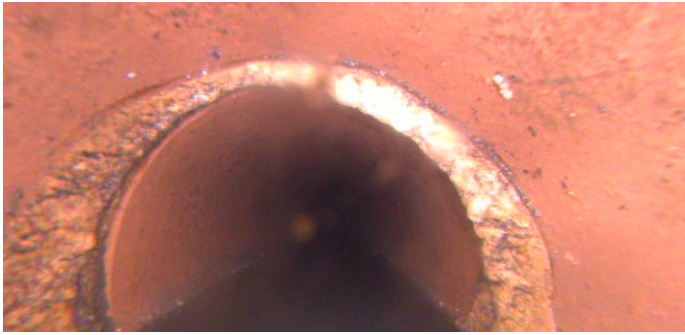
Code: **DAE**  
Description: **Deposits Attached Encrustation**

Distance (ft): **59.5**  
Structural Grade: **0**  
O&M Grade: **2**  
Clock Start/From: **8**  
Clock To: **4**  
1st Value:  
2nd Value:  
Value Percent: **10.000**  
Continuous Index:  
Within 8" of Joint: **YES**  
Remarks:

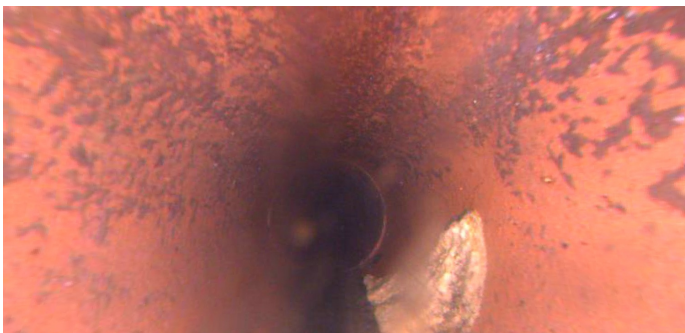
Code: **DAE**  
Description: **Deposits Attached Encrustation**

Distance (ft): **68.4**  
Structural Grade: **0**  
O&M Grade: **2**  
Clock Start/From: **3**  
Clock To: **5**  
1st Value:  
2nd Value:  
Value Percent: **5.000**  
Continuous Index:  
Within 8" of Joint: **YES**  
Remarks:

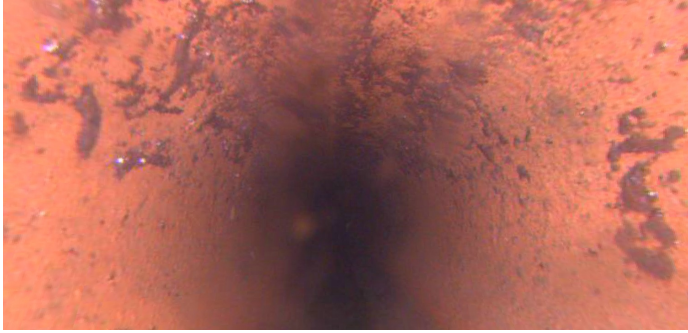
Code:	<b>MSA</b>
Description:	<b>Abandoned Survey</b>
Distance (ft):	<b>70.1</b>
Structural Grade:	<b>0</b>
O&M Grade:	<b>0</b>
Clock Start/From:	
Clock To:	
1st Value:	
2nd Value:	
Value Percent:	
Continuous Index:	
Within 8" of Joint:	<b>NO</b>
Remarks:	<b>DAE</b>
