Profile/Photo Observation Report

Street:	FOXCROFT STREET	Flow Control:	Not Controlled
City:	Hobart, IN	Year Renewed:	
Location:	Yard	Tape/Media #:	
Purpose:	Routine Assessment	Dia/Height:	10"
Use:	Sanitary	Material:	VCP
Drain Area:	NA	Lining:	
Category:	NA		
Comment:	Flow direction is marked wrong.		
Location Details:		Direction of Survey:	Upstream
US MH:	M-405-005	DS MH:	M-505-082
		Total Length Surveyed (ft):	70.1

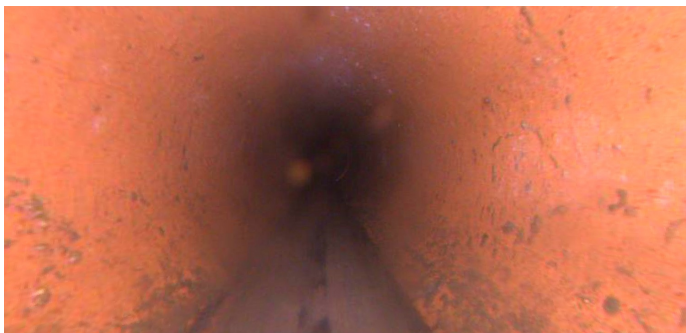
Code: **AMH**
Description: **Manhole**

Distance (ft): **.0**
Structural Grade: **0**
O&M Grade: **0**
Clock Start/From:
Clock To:
1st Value:
2nd Value:
Value Percent:
Continuous Index:
Within 8" of Joint: **NO**
Remarks: **M-505-082**

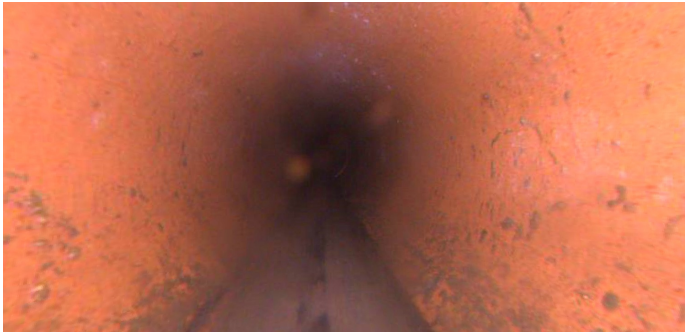
Code:	MWL
Description:	Water Level

Distance (ft):	.0
Structural Grade:	0
O&M Grade:	0
Clock Start/From:	
Clock To:	
1st Value:	
2nd Value:	
Value Percent:	5.000
Continuous Index:	
Within 8" of Joint:	NO
Remarks:

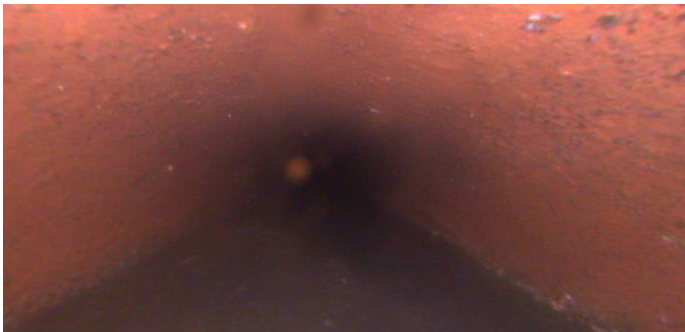
Code:	MWL
Description:	Water Level

Distance (ft):	22.0
Structural Grade:	0
O&M Grade:	0
Clock Start/From:	
Clock To:	
1st Value:	
2nd Value:	
Value Percent:	30.000
Continuous Index:	
Within 8" of Joint:	NO
Remarks:

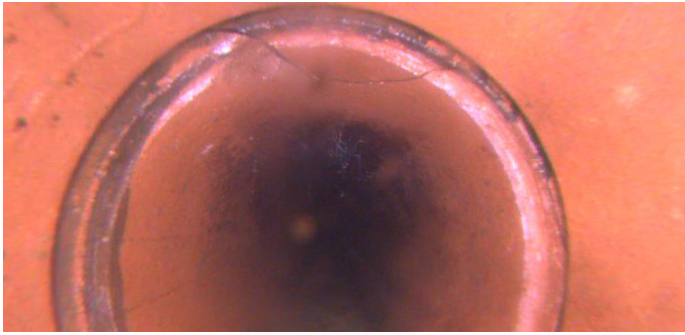
Code: **FS**
Description: **Fracture Spiral**

Distance (ft): **39.6**
Structural Grade: **3**
O&M Grade: **0**
Clock Start/From: **11**
Clock To: **1**
1st Value:
2nd Value:
Value Percent:
Continuous Index:
Within 8" of Joint: **YES**
Remarks:

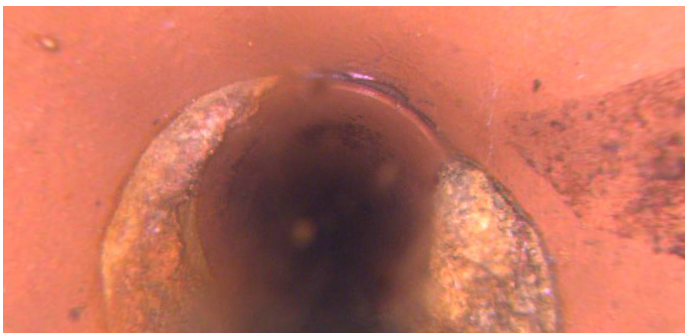
Code: **DAE**
Description: **Deposits Attached Encrustation**

Distance (ft): **49.3**
Structural Grade: **0**
O&M Grade: **3**
Clock Start/From: **8**
Clock To: **4**
1st Value:
2nd Value:
Value Percent: **20.000**
Continuous Index:
Within 8" of Joint: **YES**
Remarks:

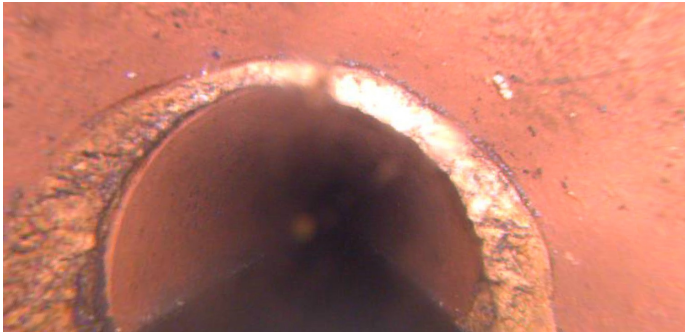
Code: **DAE**
Description: **Deposits Attached Encrustation**

Distance (ft): **59.5**
Structural Grade: **0**
O&M Grade: **2**
Clock Start/From: **8**
Clock To: **4**
1st Value:
2nd Value:
Value Percent: **10.000**
Continuous Index:
Within 8" of Joint: **YES**
Remarks:

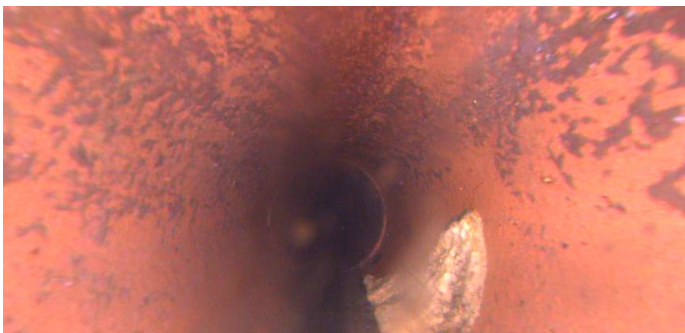
Code: **DAE**
Description: **Deposits Attached Encrustation**

Distance (ft): **68.4**
Structural Grade: **0**
O&M Grade: **2**
Clock Start/From: **3**
Clock To: **5**
1st Value:
2nd Value:
Value Percent: **5.000**
Continuous Index:
Within 8" of Joint: **YES**
Remarks:

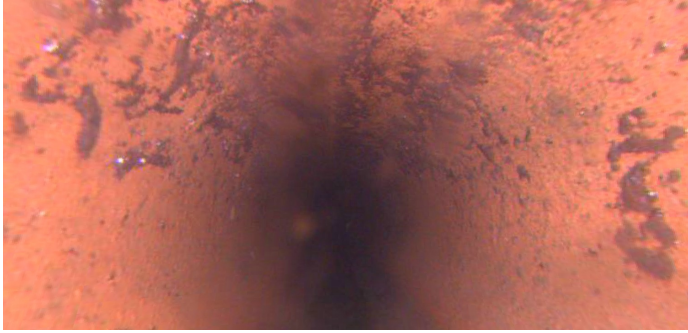
Code:	MSA
Description:	Abandoned Survey
Distance (ft):	70.1
Structural Grade:	0
O&M Grade:	0
Clock Start/From:	
Clock To:	
1st Value:	
2nd Value:	
Value Percent:	
Continuous Index:	
Within 8" of Joint:	NO
Remarks:	DAE
