Profile/Photo Observation Report

Date:	04/15/2018	Weather:		Coding:	PACP 6.0
Pipe Length (ft):	218.3	Owner:	NA	Pre Clean:	No Pre-Cleaning
P.O.#:		Surveyor:	Selasie Honu	PSR:	P-405-004-006
Customer:		Clean Date:	01/01/1900	Shape:	C

Street:	S WABASH ST	Flow Control:	Not Controlled
City:	Hobart, IN	Year Renewed:	
Location:	Yard	Tape/Media #:	
Purpose:	Routine Assessment	Dia/Height:	12"
Use:	Sanitary	Material:	VCP
Drain Area:	NA	Lining:	Cured in Place
Category:	NA		
Comment:	Flow direction is marked wrong.		
Location Details:		Direction of Survey:	Upstream
US MH:	M-405-006	DS MH:	M-405-004
		Total Length Surveyed (ft):	76.2

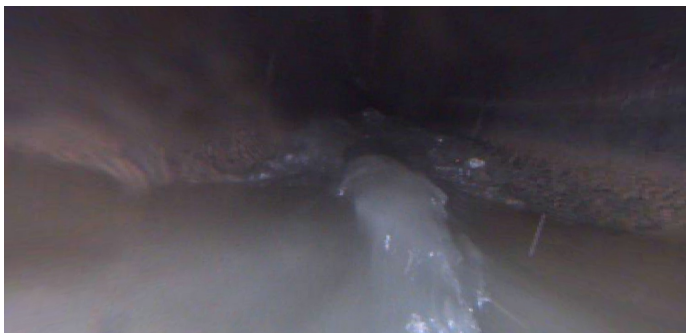
Code: **AMH**
Description: **Manhole**

Distance (ft): **.0**
Structural Grade: **0**
O&M Grade: **0**
Clock Start/From:
Clock To:
1st Value:
2nd Value:
Value Percent:
Continuous Index:
Within 8" of Joint: **NO**
Remarks: **M-405-004**

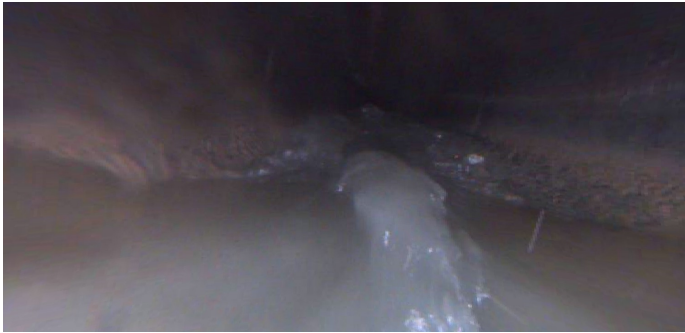
Code:	MWL
Description:	Water Level

Distance (ft):	.0
Structural Grade:	0
O&M Grade:	0
Clock Start/From:	
Clock To:	
1st Value:	
2nd Value:	
Value Percent:	5.000
Continuous Index:	
Within 8" of Joint:	NO
Remarks:

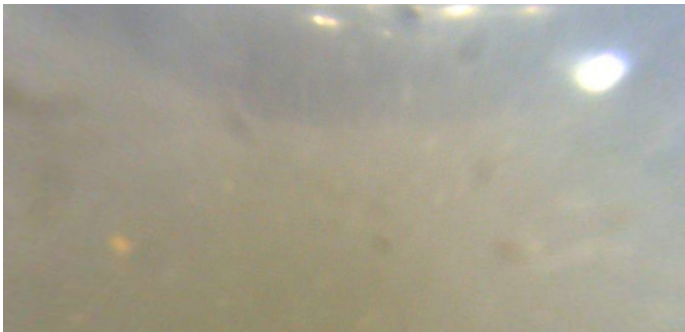
Code:	MCU
Description:	Camera Underwater

Distance (ft):	3.7
Structural Grade:	0
O&M Grade:	4
Clock Start/From:	
Clock To:	
1st Value:	
2nd Value:	
Value Percent:	
Continuous Index:	S01
Within 8" of Joint:	NO
Remarks:

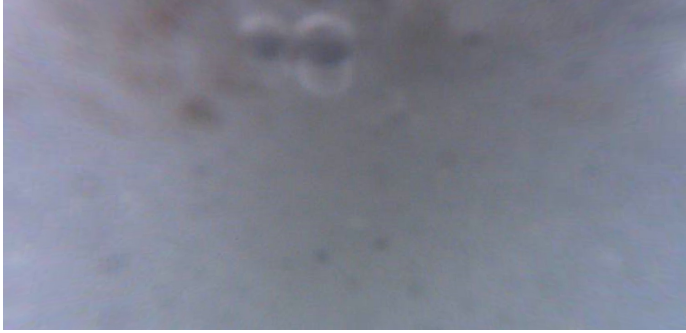
Code: **MCU**
Description: **Camera Underwater**

Distance (ft): **76.2**
Structural Grade: **0**
O&M Grade: **4**
Clock Start/From:
Clock To:
1st Value:
2nd Value:
Value Percent:
Continuous Index: **F01**
Within 8" of Joint: **NO**
Remarks:

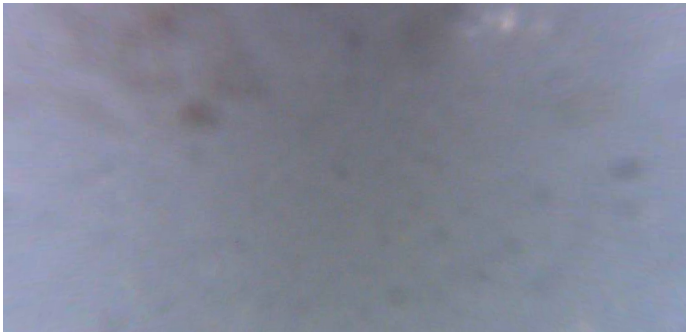
Code: **MSA**
Description: **Abandoned Survey**

Distance (ft): **76.2**
Structural Grade: **0**
O&M Grade: **0**
Clock Start/From:
Clock To:
1st Value:
2nd Value:
Value Percent:
Continuous Index:
Within 8" of Joint: **NO**
Remarks: **mcu**
