## Profile/Photo Observation Report

Date:	<b>04/15/2018</b>	Weather:		Coding:	<b>PACP 6.0</b>
Pipe Length (ft):	<b>218.3</b>	Owner:	<b>NA</b>	Pre Clean:	<b>No Pre-Cleaning</b>
P.O.#:		Surveyor:	<b>Selasie Honu</b>	PSR:	<b>P-405-004-006</b>
Customer:		Clean Date:	<b>01/01/1900</b>	Shape:	<b>C</b>

Street:	<b>FOXCROFT STREET</b>	Flow Control:	<b>Not Controlled</b>
City:	<b>Hobart, IN</b>	Year Renewed:	
Location:	<b>Yard</b>	Tape/Media #:	
Purpose:	<b>Routine Assessment</b>	Dia/Height:	<b>12"</b>
Use:	<b>Sanitary</b>	Material:	<b>VCP</b>
Drain Area:	<b>NA</b>	Lining:	<b>Cured in Place</b>
Category:	<b>NA</b>		
Comment:	<b>Flow direction is marked wrong.</b>		
Location Details:		Direction of Survey:	<b>Upstream</b>
US MH:	<b>M-405-006</b>	DS MH:	<b>M-405-004</b>
		Total Length Surveyed (ft):	<b>76.2</b>

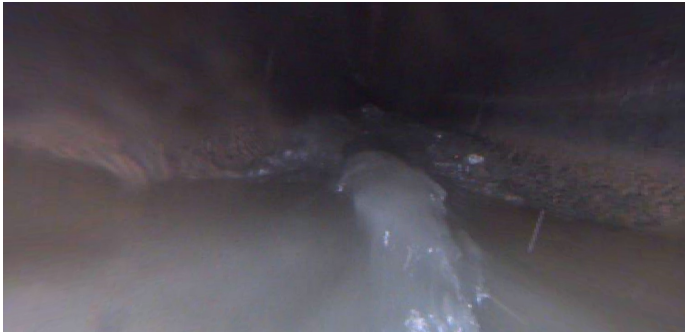
Code:	<b>MWL</b>
Description:	<b>Water Level</b>

Distance (ft):	<b>.0</b>
Structural Grade:	<b>0</b>
O&M Grade:	<b>0</b>
Clock Start/From:	
Clock To:	
1st Value:	
2nd Value:	
Value Percent:	<b>5.000</b>
Continuous Index:	
Within 8" of Joint:	<b>NO</b>
Remarks:

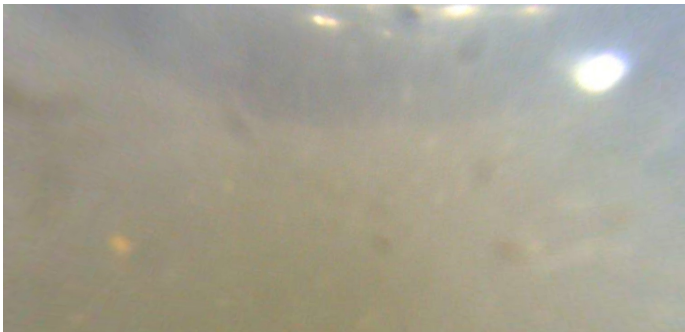
Code:	<b>MCU</b>
Description:	<b>Camera Underwater</b>

Distance (ft):	<b>3.7</b>
Structural Grade:	<b>0</b>
O&M Grade:	<b>4</b>
Clock Start/From:	
Clock To:	
1st Value:	
2nd Value:	
Value Percent:	
Continuous Index:	<b>S01</b>
Within 8" of Joint:	<b>NO</b>
Remarks:
