Profile/Photo Observation Report

Street:	S WABASH ST	Flow Control:	Not Controlled
City:	Hobart, IN	Year Renewed:	
Location:	Yard	Tape/Media #:	
Purpose:	Routine Assessment	Dia/Height:	12"
Use:	Sanitary	Material:	VCP
Drain Area:	NA	Lining:	Cured in Place
Category:	NA		
Comment:	Flow direction is marked wrong.		
Location Details:		Direction of Survey:	Downstream
US MH:	M-405-006	DS MH:	M-405-004
		Total Length Surveyed (ft):	30.5

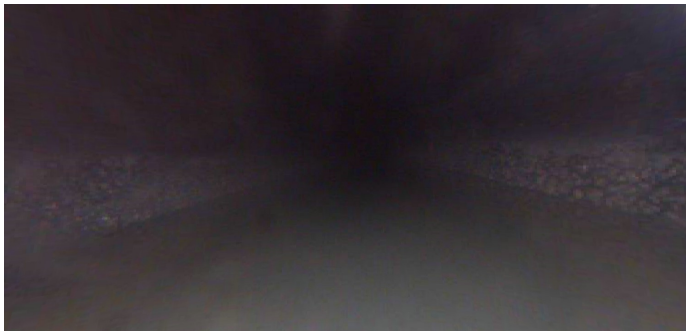
Code: **AMH**
Description: **Manhole**

Distance (ft): **.0**
Structural Grade: **0**
O&M Grade: **0**
Clock Start/From:
Clock To:
1st Value:
2nd Value:
Value Percent:
Continuous Index:
Within 8" of Joint: **NO**
Remarks: **M-405-006**

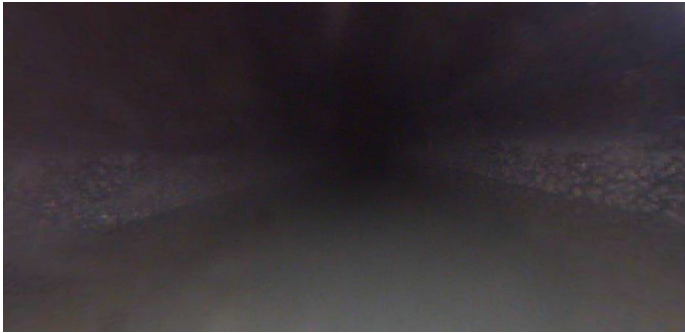
Code:	MWL
Description:	Water Level

Distance (ft):	.0
Structural Grade:	0
O&M Grade:	0
Clock Start/From:	
Clock To:	
1st Value:	
2nd Value:	
Value Percent:	5.000
Continuous Index:	
Within 8" of Joint:	NO
Remarks:

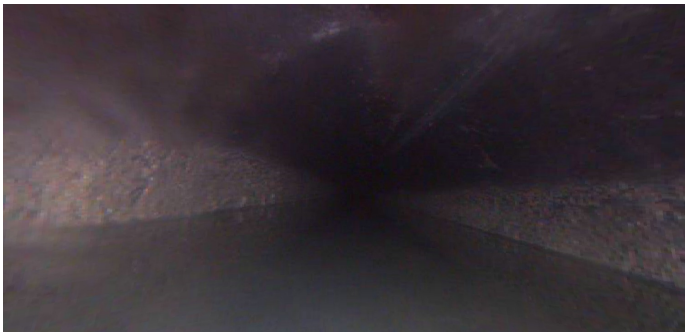
Code:	MSA
Description:	Abandoned Survey

Distance (ft):	30.5
Structural Grade:	0
O&M Grade:	0
Clock Start/From:	
Clock To:	
1st Value:	
2nd Value:	
Value Percent:	
Continuous Index:	
Within 8" of Joint:	NO
Remarks:	camera stopped
