## Profile/Photo Observation Report

| Street: | <b>FOXCROFT STREET</b> | Flow Control: | <b>Not Controlled</b> |
| City: | <b>Hobart, IN</b> | Year Renewed: | |
| US MH: | <b>M-405-006</b> | DS MH: | <b>M-405-004</b> |

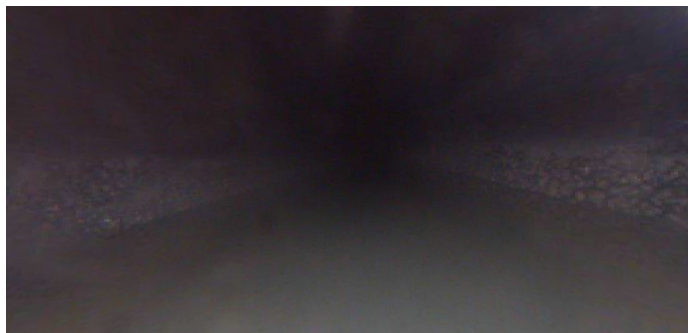
Code: **AMH**  
Description: **Manhole**

Distance (ft): **.0**  
Structural Grade: **0**  
O&M Grade: **0**  
Clock Start/From:  
Clock To:  
1st Value:  
2nd Value:  
Value Percent:  
Continuous Index:  
Within 8" of Joint: **NO**  
Remarks: **M-405-006**

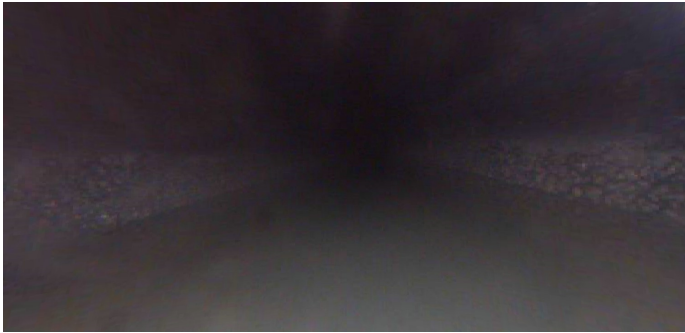
| Code: | <b>MWL</b> |
| Description: | <b>Water Level</b> |

| Value Percent: | <b>5.000</b> |

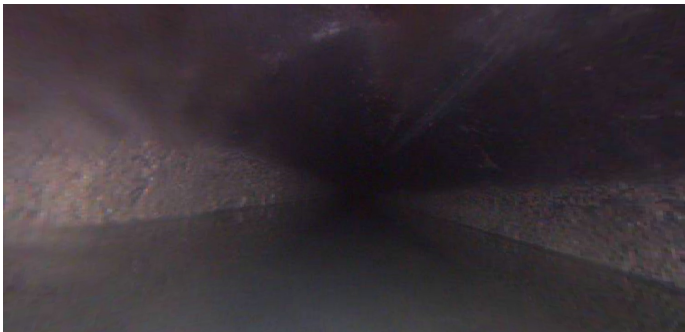
| Code: | <b>MSA</b> |
| Description: | <b>Abandoned Survey</b> |

| Distance (ft): | <b>30.5</b> |
| Remarks: | <b>camera stopped</b> |
