Profile/Photo Observation Report

Date:	01/16/2022	Weather:		Coding:	PACP 7.0
Pipe Length (ft):	217.2	Owner:	City of Hobart	Pre Clean:	Heavy Cleaning
P.O.#:	YES502259	Surveyor:	S. Bucklin	PSR:	P-405-004-006
Customer:	City of Hobart	Clean Date:	01/15/2021	Shape:	C

US MH: **M-405-006**

DS MH: **M-405-004**

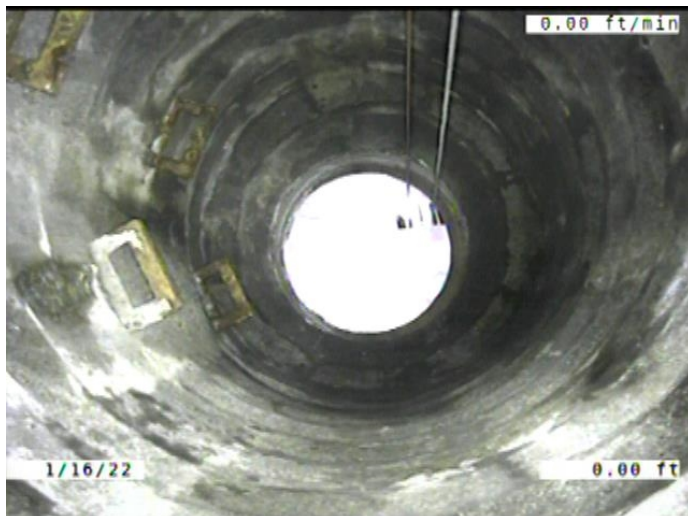
Code: **AMH**
Description: **Manhole**

Distance (ft): **.0**
Structural Grade: **0**
O&M Grade: **0**
Clock Start/From:
Clock To:
1st Value:
2nd Value:
Value Percent:
Continuous Index:
Within 8" of Joint: **NO**
Remarks: **M-405-006**

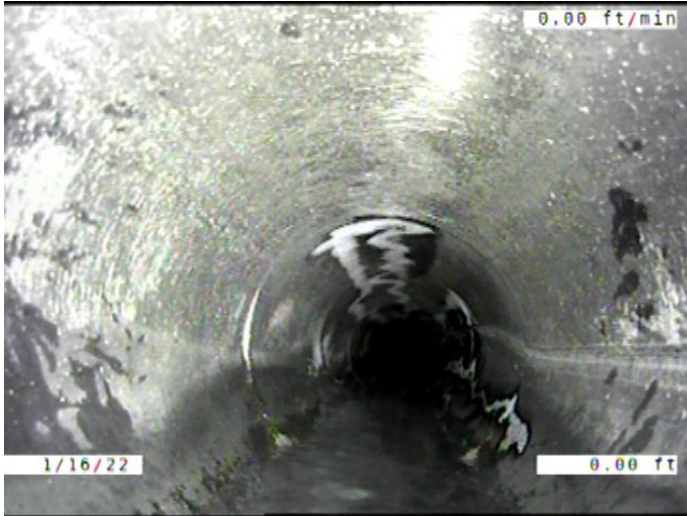
Code:	MWL
Description:	Miscellaneous Water Level
Distance (ft):	.0
Structural Grade:	0
O&M Grade:	0
Clock Start/From:	
Clock To:	
1st Value:	
2nd Value:	
Value Percent:	5.000
Continuous Index:	
Within 8" of Joint:	NO
Remarks:

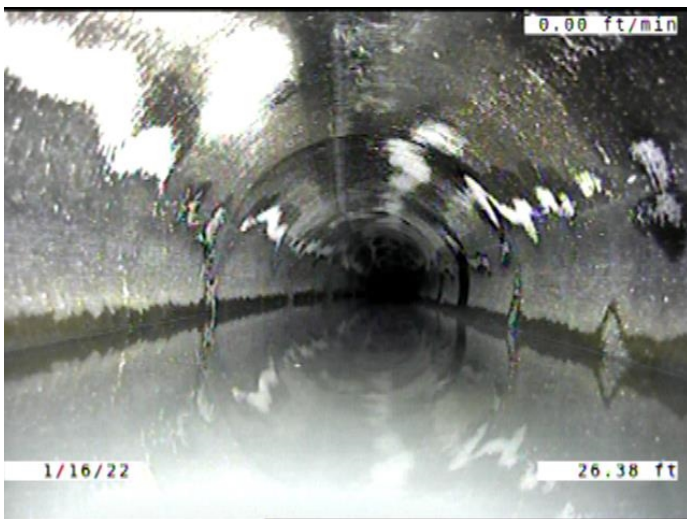
Code:	MWL
Description:	Miscellaneous Water Level
Distance (ft):	26.4
Structural Grade:	0
O&M Grade:	0
Clock Start/From:	
Clock To:	
1st Value:	
2nd Value:	
Value Percent:	15.000
Continuous Index:	
Within 8" of Joint:	NO
Remarks:

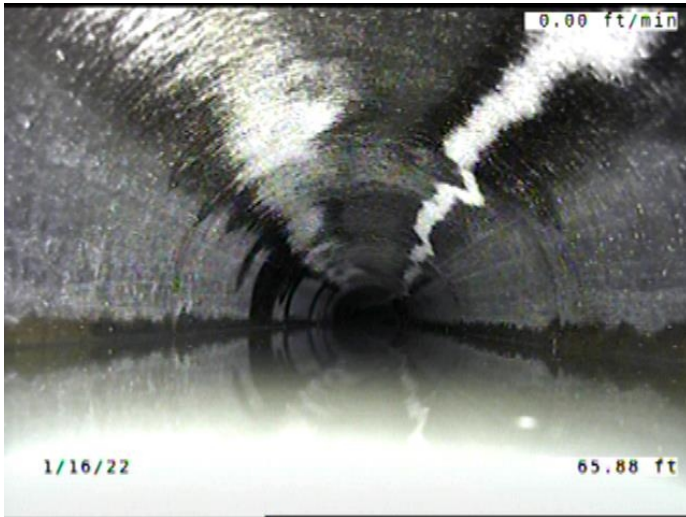
Code: **MWL**
Description: **Miscellaneous Water Level**

Distance (ft): **65.9**
Structural Grade: **0**
O&M Grade: **0**
Clock Start/From:
Clock To:
1st Value:
2nd Value:
Value Percent: **25.000**
Continuous Index:
Within 8" of Joint: **NO**
Remarks:

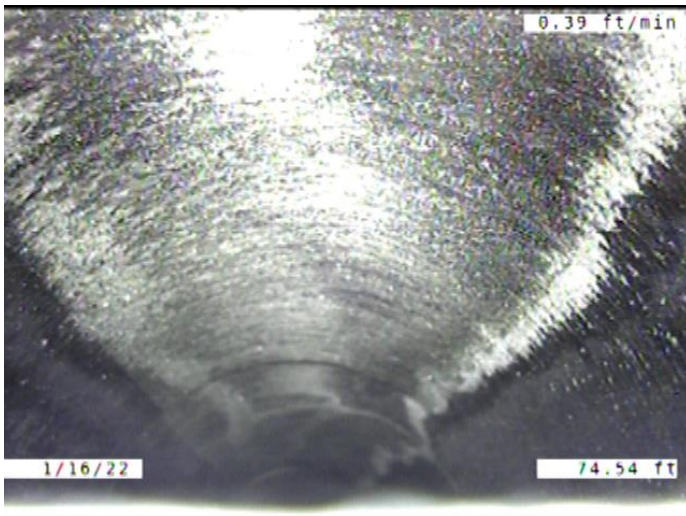
Code: **MWL**
Description: **Miscellaneous Water Level**

Distance (ft): **74.5**
Structural Grade: **0**
O&M Grade: **0**
Clock Start/From:
Clock To:
1st Value:
2nd Value:
Value Percent: **35.000**
Continuous Index:
Within 8" of Joint: **NO**
Remarks:

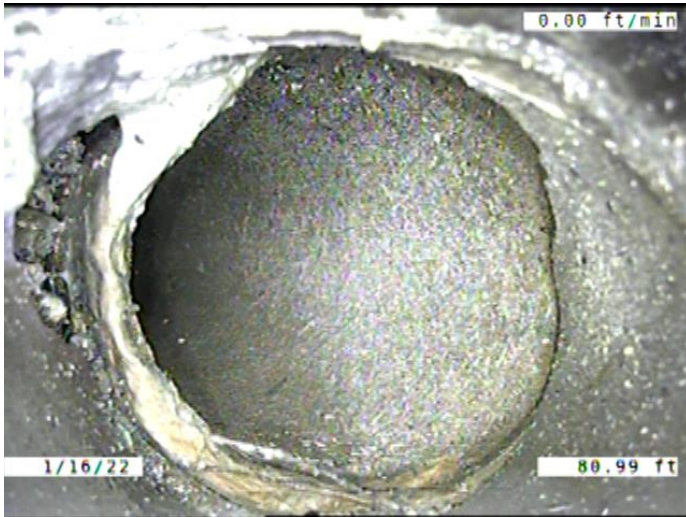
Code: **TBD**
Description: **Tap Break-in/Hammer Defective**

Distance (ft): **81.0**
Structural Grade: **0**
O&M Grade: **3**
Clock Start/From: **11**
Clock To:
1st Value: **4.000**
2nd Value:
Value Percent:
Continuous Index:
Within 8" of Joint: **NO**
Remarks: **CONSTANTLY RUNNING WATER.
BROKEN SOIL VISIBLE. OFFSET. ANGL**

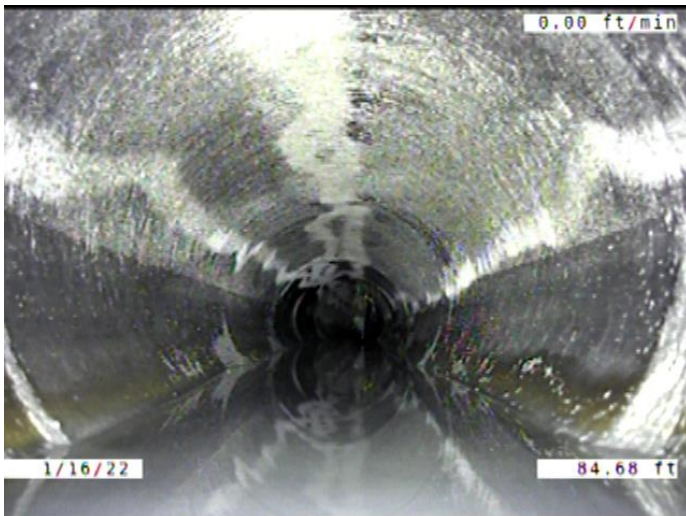
Code: **MWL**
Description: **Miscellaneous Water Level**

Distance (ft): **84.7**
Structural Grade: **0**
O&M Grade: **0**
Clock Start/From:
Clock To:
1st Value:
2nd Value:
Value Percent: **10.000**
Continuous Index:
Within 8" of Joint: **NO**
Remarks:

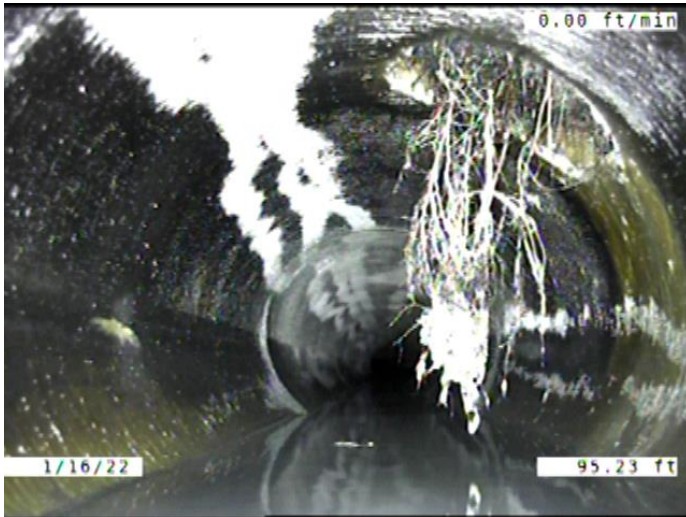
Code: **RML**
 Description: **Roots Medium Lateral**

Distance (ft): **95.2**
 Structural Grade: **0**
 O&M Grade: **3**
 Clock Start/From: **12**
 Clock To: **2**
 1st Value:
 2nd Value:
 Value Percent: **10.000**
 Continuous Index:
 Within 8" of Joint: **NO**
 Remarks:

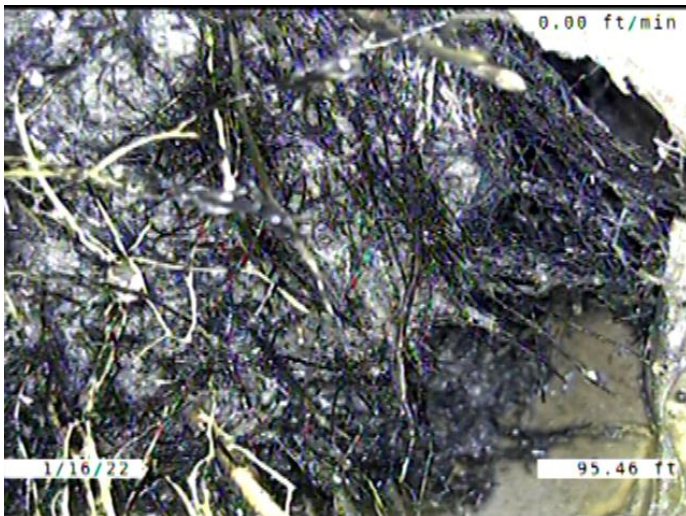
Code: **TBD**
 Description: **Tap Break-in/Hammer Defective**

Distance (ft): **95.5**
 Structural Grade: **0**
 O&M Grade: **3**
 Clock Start/From: **1**
 Clock To:
 1st Value: **4.000**
 2nd Value:
 Value Percent:
 Continuous Index:
 Within 8" of Joint: **NO**
 Remarks: **95% PLUGGED WITH ROOTS**

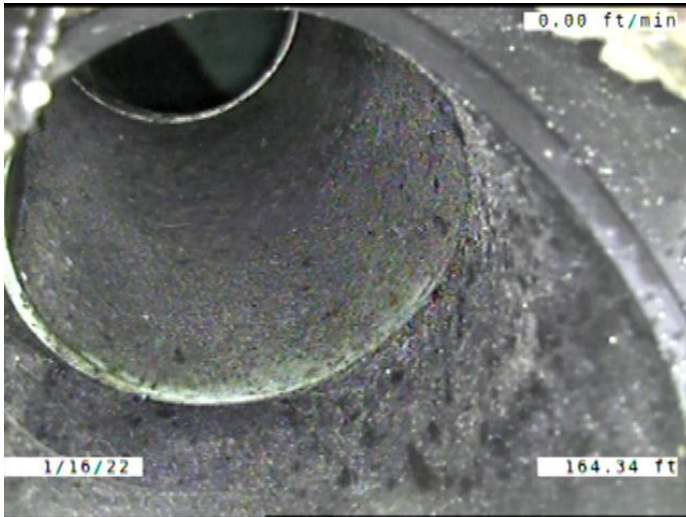
Code: **TBA**
 Description: **Tap Break-in Activity**

Distance (ft): **164.3**
 Structural Grade: **0**
 O&M Grade: **0**
 Clock Start/From: **11**
 Clock To:
 1st Value: **4.000**
 2nd Value:
 Value Percent:
 Continuous Index:
 Within 8" of Joint: **NO**
 Remarks:

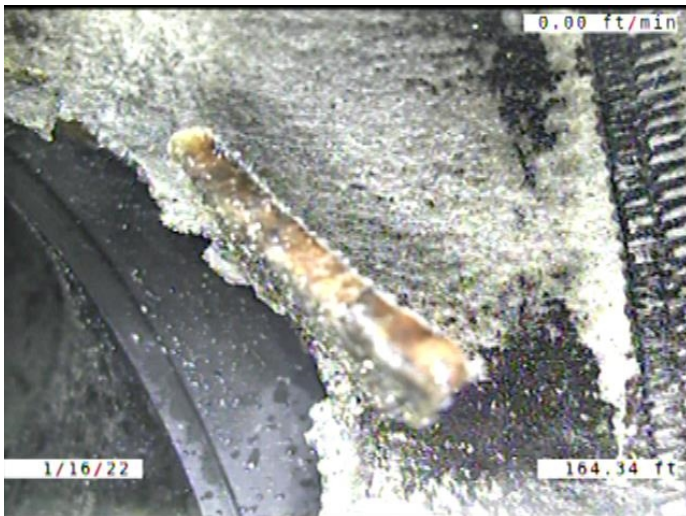
Code: **MLC**
 Description: **Miscellaneous Lining Change**

Distance (ft): **164.3**
 Structural Grade: **0**
 O&M Grade: **0**
 Clock Start/From:
 Clock To:
 1st Value:
 2nd Value:
 Value Percent:
 Continuous Index:
 Within 8" of Joint: **NO**
 Remarks: **PART OF THE LINER IS HANGING FROM WHEN THE SERVICE WAS CUT**

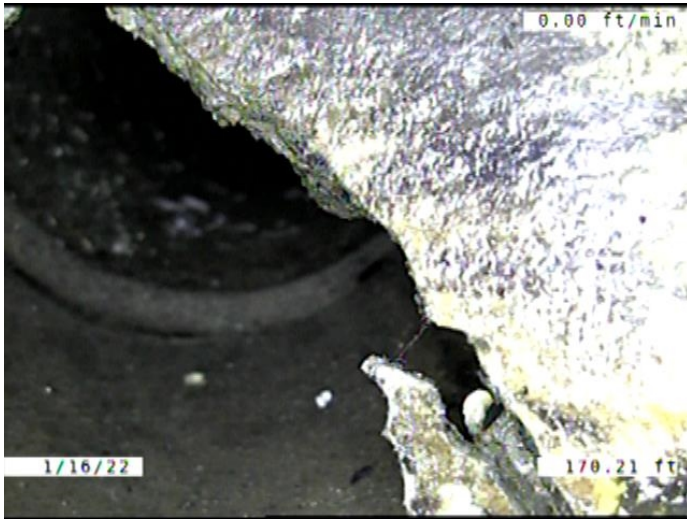
Code: **LFUC**
 Description: **Lining Feature Undercut Service**

Distance (ft): **170.2**
 Structural Grade: **3**
 O&M Grade: **0**
 Clock Start/From: **12**
 Clock To: **2**
 1st Value:
 2nd Value:
 Value Percent:
 Continuous Index:
 Within 8" of Joint: **NO**
 Remarks:

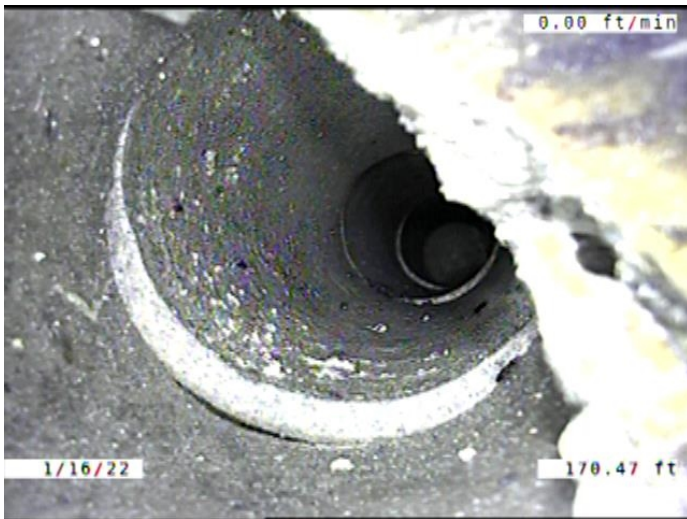
Code: **TB**
 Description: **Tap Break-in/Hammer**

Distance (ft): **170.5**
 Structural Grade: **0**
 O&M Grade: **0**
 Clock Start/From: **1**
 Clock To:
 1st Value: **4.000**
 2nd Value:
 Value Percent:
 Continuous Index:
 Within 8" of Joint: **NO**
 Remarks:

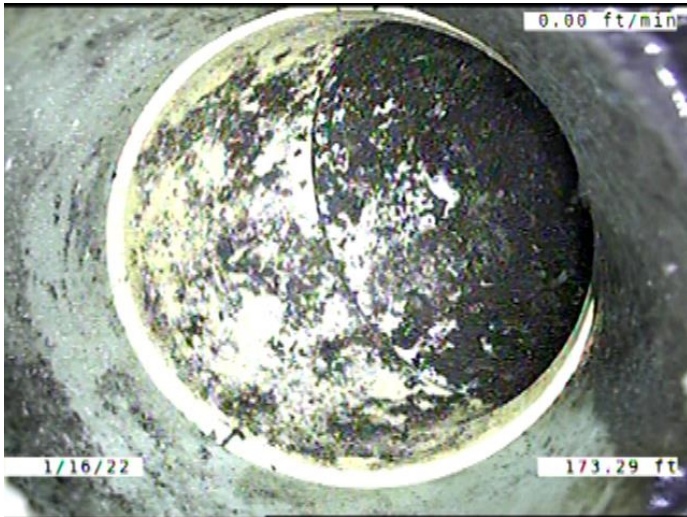
Code: **TBA**
 Description: **Tap Break-in Activity**

Distance (ft): **173.3**
 Structural Grade: **0**
 O&M Grade: **0**
 Clock Start/From: **12**
 Clock To:
 1st Value: **4.000**
 2nd Value:
 Value Percent:
 Continuous Index:
 Within 8" of Joint: **NO**
 Remarks:

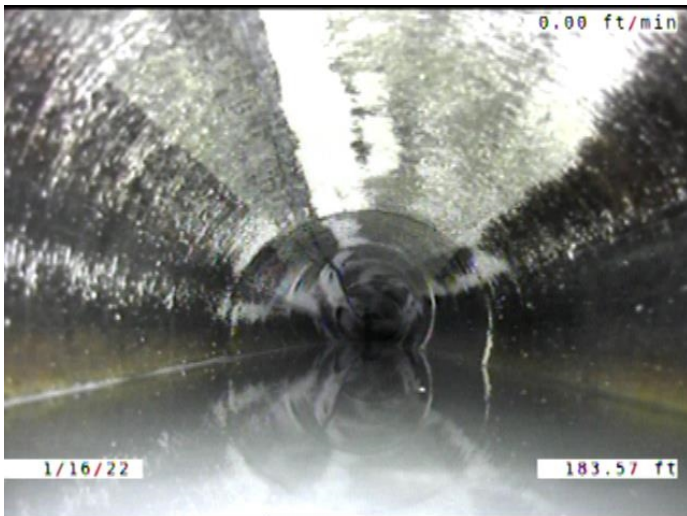
Code: **MWLS**
 Description: **Miscellaneous Water Level Sag**

Distance (ft): **183.6**
 Structural Grade: **2**
 O&M Grade: **0**
 Clock Start/From:
 Clock To:
 1st Value:
 2nd Value:
 Value Percent: **15.000**
 Continuous Index: **S01**
 Within 8" of Joint: **NO**
 Remarks:

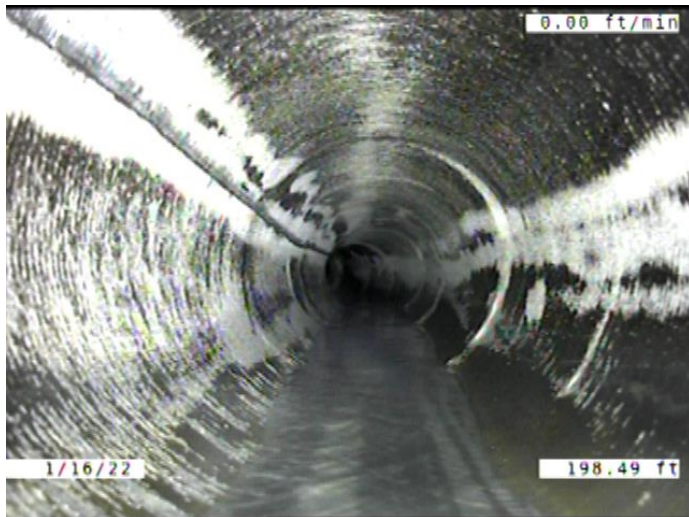
Code: **MWLS**
 Description: **Miscellaneous Water Level Sag**

Distance (ft): **198.5**
 Structural Grade: **2**
 O&M Grade: **0**
 Clock Start/From:
 Clock To:
 1st Value:
 2nd Value:
 Value Percent: **15.000**
 Continuous Index: **F01**
 Within 8" of Joint: **NO**
 Remarks:

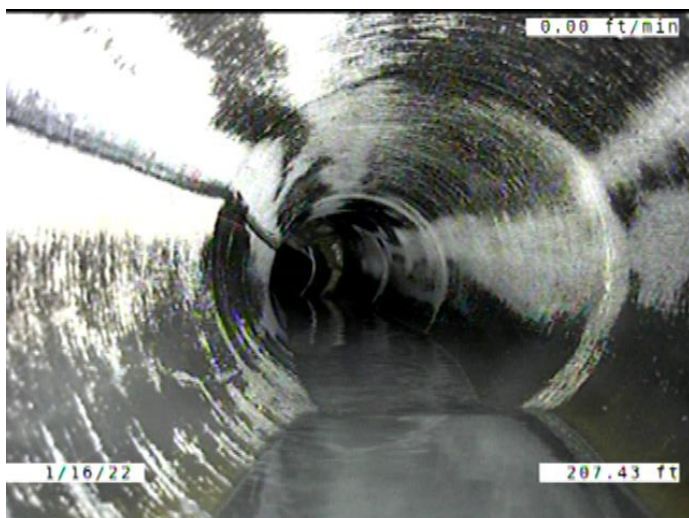
Code: **LL**
 Description: **Line Left**

Distance (ft): **207.4**
 Structural Grade: **0**
 O&M Grade: **1**
 Clock Start/From:
 Clock To:
 1st Value:
 2nd Value:
 Value Percent: **10.000**
 Continuous Index: **S02**
 Within 8" of Joint: **NO**
 Remarks:

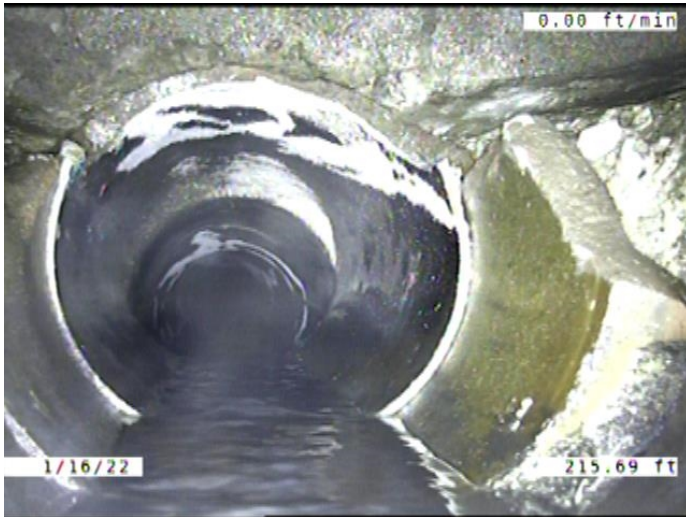
Code: **LL**
 Description: **Line Left**

Distance (ft): **215.7**
 Structural Grade: **0**
 O&M Grade: **1**
 Clock Start/From:
 Clock To:
 1st Value:
 2nd Value:
 Value Percent: **10.000**
 Continuous Index: **F02**
 Within 8" of Joint: **NO**
 Remarks:

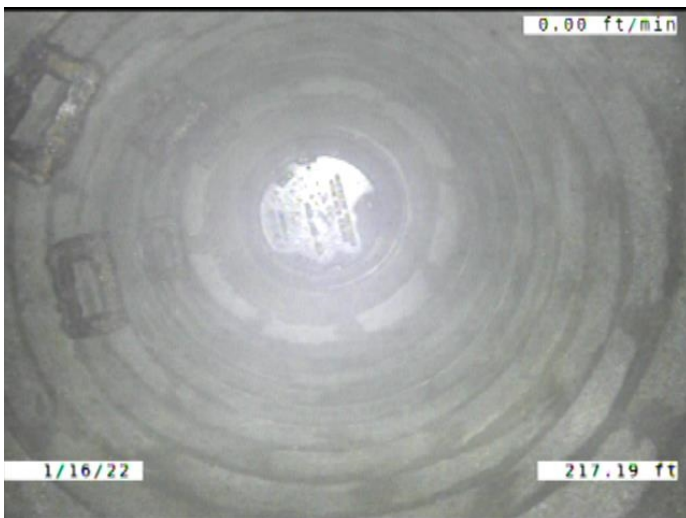
Code: **AMH**
 Description: **Manhole**

Distance (ft): **217.2**
 Structural Grade: **0**
 O&M Grade: **0**
 Clock Start/From:
 Clock To:
 1st Value:
 2nd Value:
 Value Percent:
 Continuous Index:
 Within 8" of Joint: **NO**
 Remarks: **M-405-004**
