Profile/Photo Observation Report

| Street: | FOXCROFT STREET | Flow Control: | Not Controlled |
| City: | Hobart, IN | Year Renewed: | |
| US MH: | M-405-007 | DS MH: | M-405-006 |

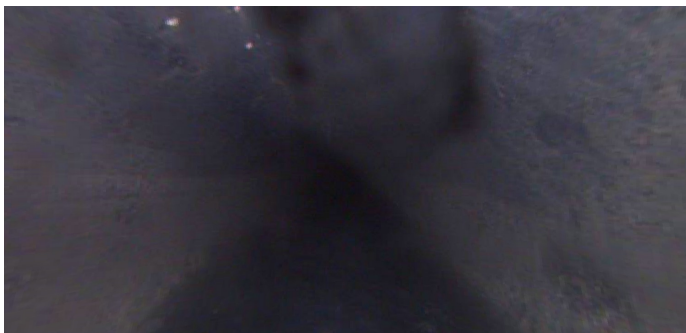
Code: **AMH**
Description: **Manhole**

Distance (ft): **.0**
Structural Grade: **0**
O&M Grade: **0**
Clock Start/From:
Clock To:
1st Value:
2nd Value:
Value Percent:
Continuous Index:
Within 8" of Joint: **NO**
Remarks: **M-405-006**

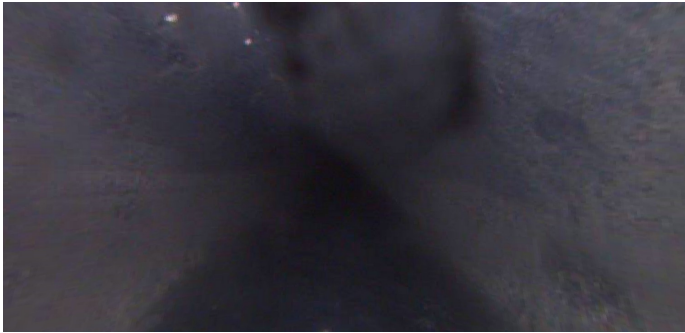
| Code: | MWL |

| Description: | Water Level |

| Value Percent: | 5.000 |

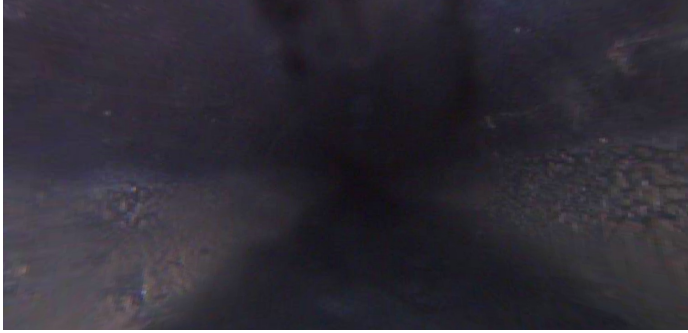
| Code: | MSA |

| Description: | Abandoned Survey |
| Distance (ft): | 14.1 |
| Remarks: | camera stopped |
