Profile/Photo Observation Report

Date:	01/16/2022	Weather:		Coding:	PACP 7.0
Pipe Length (ft):	310.1	Owner:	City of Hobart	Pre Clean:	Heavy Cleaning
P.O.#:	YES502259	Surveyor:	S. Bucklin	PSR:	P-405-006-007
Customer:	City of Hobart	Clean Date:	01/15/2021	Shape:	C

Street:	South Wabash Street	Flow Control:	Not Controlled
City:	Hobart, IN	Year Renewed:	
Location:	Easement/Right of Way	Tape/Media #:	
Purpose:	Routine Assessment	Dia/Height:	12"
Use:	Sanitary Sewage Pipe	Material:	VCP
Drain Area:		Lining:	Not Known

US MH: **M-405-007** DS MH: **M-405-006** Total Length Surveyed (ft): **310.1**

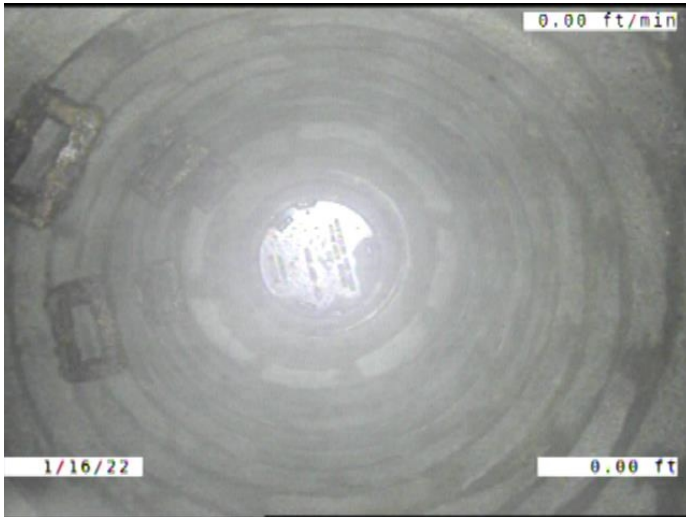
Code: **AMH**
Description: **Manhole**

Distance (ft): **.0**
Structural Grade: **0**
O&M Grade: **0**
Clock Start/From:
Clock To:
1st Value:
2nd Value:
Value Percent:
Continuous Index:
Within 8" of Joint: **NO**
Remarks: **M-405-007**

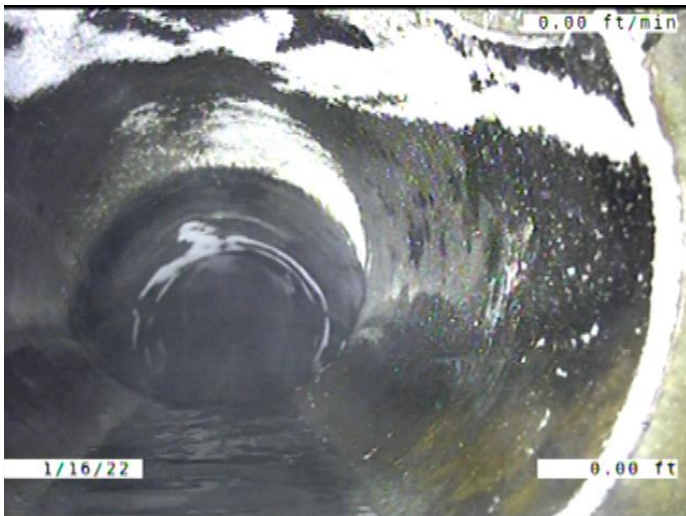
Code: **MWL**
Description: **Miscellaneous Water Level**

Distance (ft): **.0**
Structural Grade: **0**
O&M Grade: **0**
Clock Start/From:
Clock To:
1st Value:
2nd Value:
Value Percent: **5.000**
Continuous Index:
Within 8" of Joint: **NO**
Remarks:

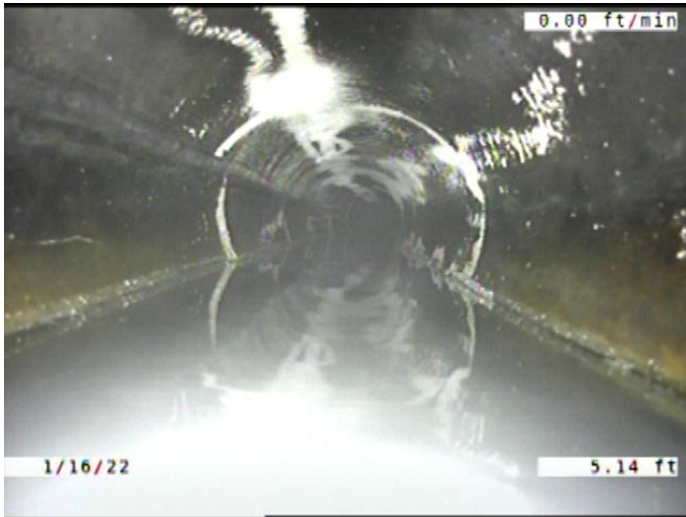
Code: **MWL**
 Description: **Miscellaneous Water Level**

Distance (ft): **5.1**
 Structural Grade: **0**
 O&M Grade: **0**
 Clock Start/From:
 Clock To:
 1st Value:
 2nd Value:
 Value Percent: **15.000**
 Continuous Index:
 Within 8" of Joint: **NO**
 Remarks:

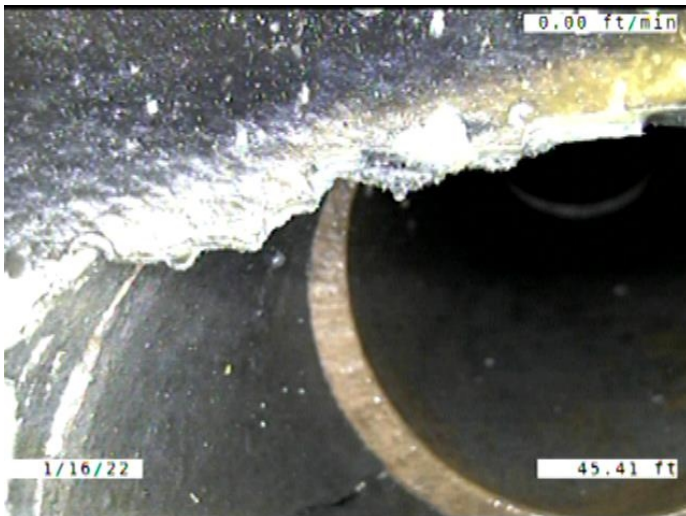
Code: **LFUC**
 Description: **Lining Feature Undercut Service**

Distance (ft): **45.4**
 Structural Grade: **3**
 O&M Grade: **0**
 Clock Start/From: **12**
 Clock To: **1**
 1st Value:
 2nd Value:
 Value Percent:
 Continuous Index:
 Within 8" of Joint: **NO**
 Remarks:

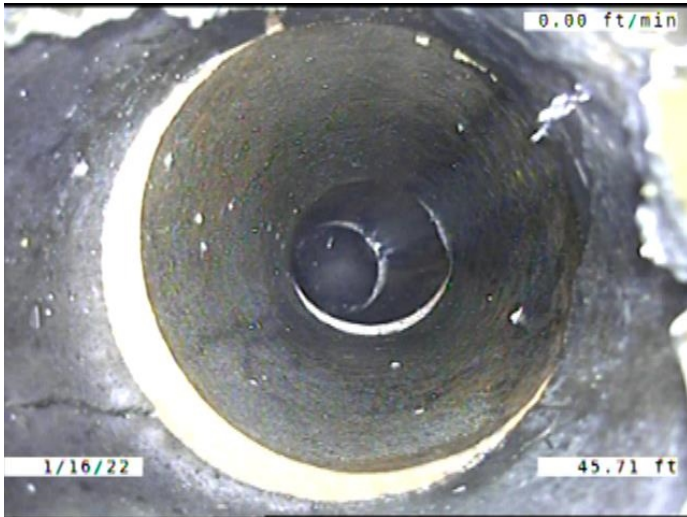
Code: **TBD**
 Description: **Tap Break-in/Hammer Defective**

Distance (ft): **45.7**
 Structural Grade: **0**
 O&M Grade: **3**
 Clock Start/From: **1**
 Clock To:
 1st Value: **4.000**
 2nd Value:
 Value Percent:
 Continuous Index:
 Within 8" of Joint: **NO**
 Remarks: **CONSTANTLY RUNNING WATER. BROKEN**

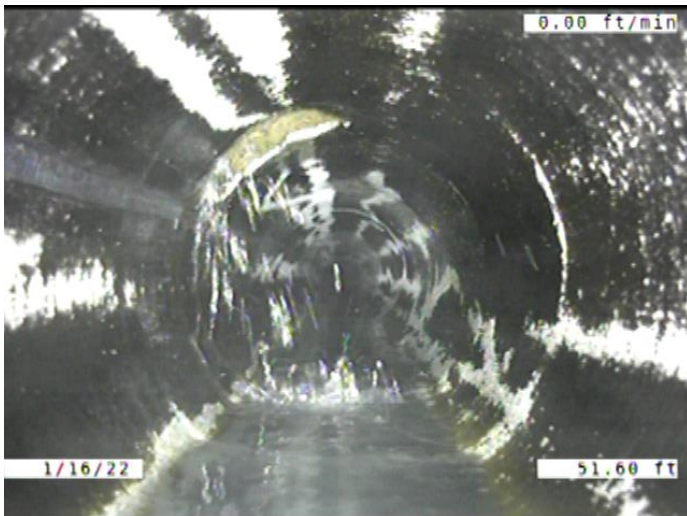
Code: **MWL**
 Description: **Miscellaneous Water Level**

Distance (ft): **51.6**
 Structural Grade: **0**
 O&M Grade: **0**
 Clock Start/From:
 Clock To:
 1st Value:
 2nd Value:
 Value Percent: **5.000**
 Continuous Index:
 Within 8" of Joint: **NO**
 Remarks:

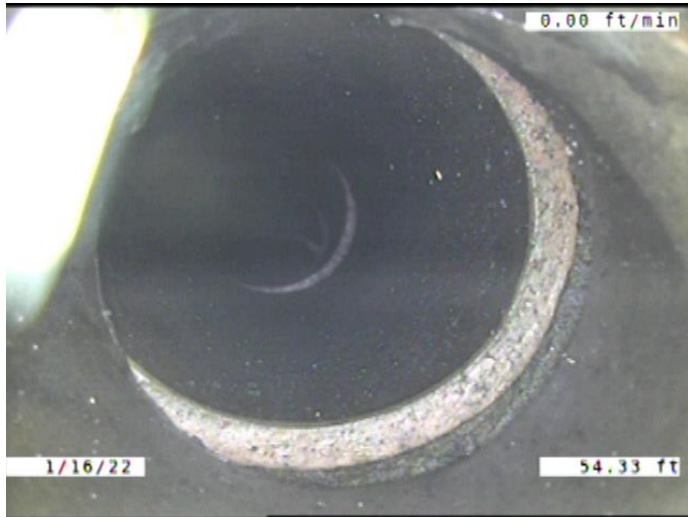
Code: **TBA**
 Description: **Tap Break-in Activity**

Distance (ft): **54.3**
 Structural Grade: **0**
 O&M Grade: **0**
 Clock Start/From: **11**
 Clock To:
 1st Value: **4.000**
 2nd Value:
 Value Percent:
 Continuous Index:
 Within 8" of Joint: **NO**
 Remarks: **LARGE OFFSET JOINT**

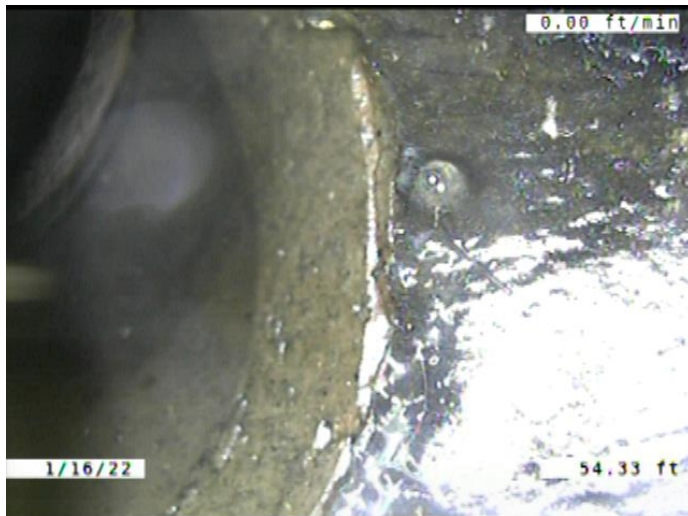
Code: **IDC**
 Description: **Infiltration Dripper Connection**

Distance (ft): **54.3**
 Structural Grade: **0**
 O&M Grade: **3**
 Clock Start/From: **12**
 Clock To:
 1st Value:
 2nd Value:
 Value Percent:
 Continuous Index:
 Within 8" of Joint: **NO**
 Remarks:

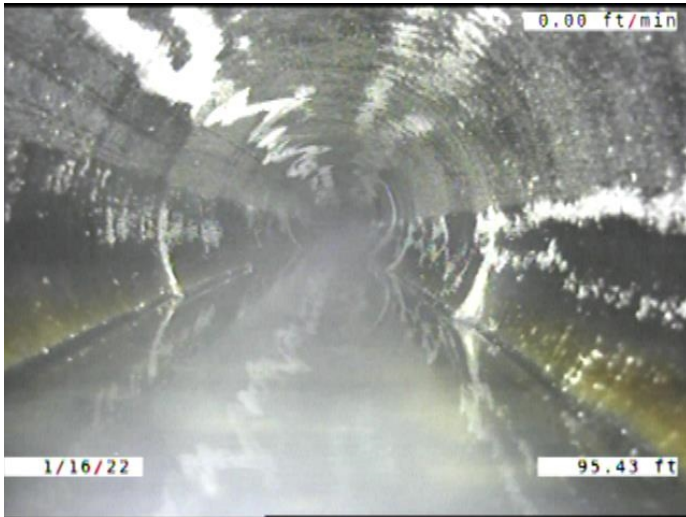
Code: **MWLS**
 Description: **Miscellaneous Water Level Sag**

Distance (ft): **95.4**
 Structural Grade: **2**
 O&M Grade: **0**
 Clock Start/From:
 Clock To:
 1st Value:
 2nd Value:
 Value Percent: **10.000**
 Continuous Index: **S01**
 Within 8" of Joint: **NO**
 Remarks:

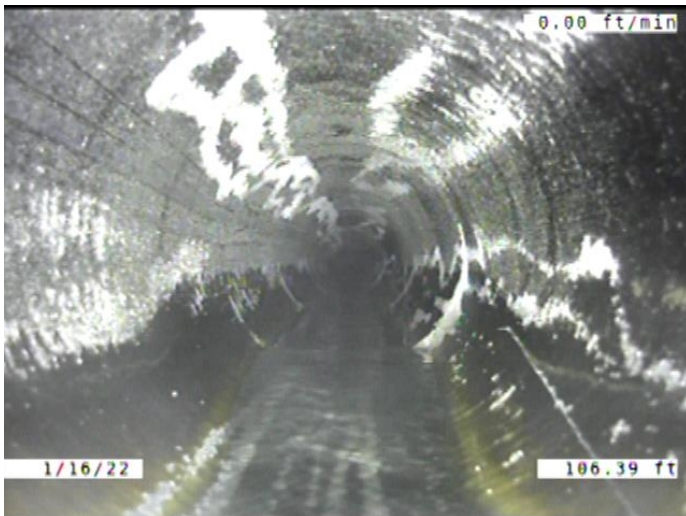
Code: **MWLS**
 Description: **Miscellaneous Water Level Sag**

Distance (ft): **106.4**
 Structural Grade: **2**
 O&M Grade: **0**
 Clock Start/From:
 Clock To:
 1st Value:
 2nd Value:
 Value Percent: **10.000**
 Continuous Index: **F01**
 Within 8" of Joint: **NO**
 Remarks:

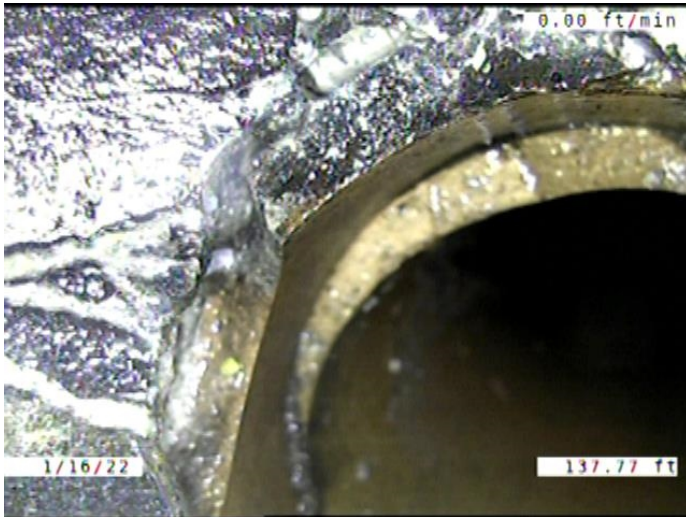
Code: **LFOC**
 Description: **Lining Feature Overcut Service**

Distance (ft): **137.8**
 Structural Grade: **3**
 O&M Grade: **0**
 Clock Start/From: **12**
 Clock To: **1**
 1st Value:
 2nd Value:
 Value Percent:
 Continuous Index:
 Within 8" of Joint: **NO**
 Remarks:

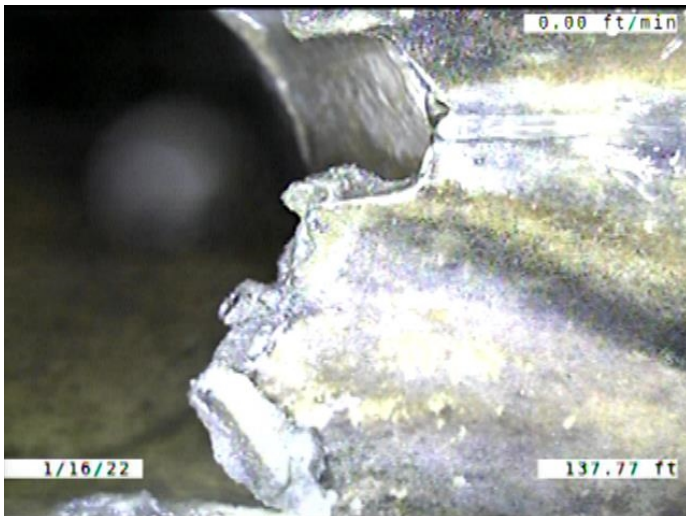
Code: **LFUC**
 Description: **Lining Feature Undercut Service**

Distance (ft): **137.8**
 Structural Grade: **3**
 O&M Grade: **0**
 Clock Start/From: **1**
 Clock To: **2**
 1st Value:
 2nd Value:
 Value Percent:
 Continuous Index:
 Within 8" of Joint: **NO**
 Remarks:

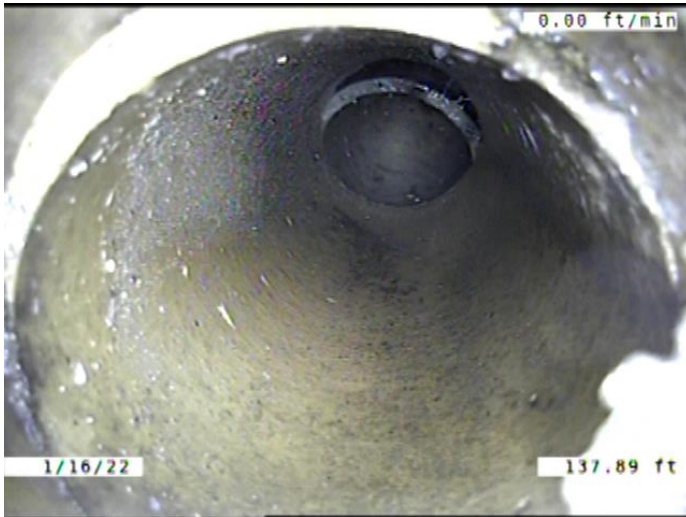
Code: **TBD**
 Description: **Tap Break-in/Hammer Defective**

Distance (ft): **137.9**
 Structural Grade: **0**
 O&M Grade: **3**
 Clock Start/From: **1**
 Clock To:
 1st Value: **4.000**
 2nd Value:
 Value Percent:
 Continuous Index:
 Within 8" of Joint: **NO**
 Remarks: **CONSTANTLY RUNNING WATER. LARGE OFFSET JOINT**

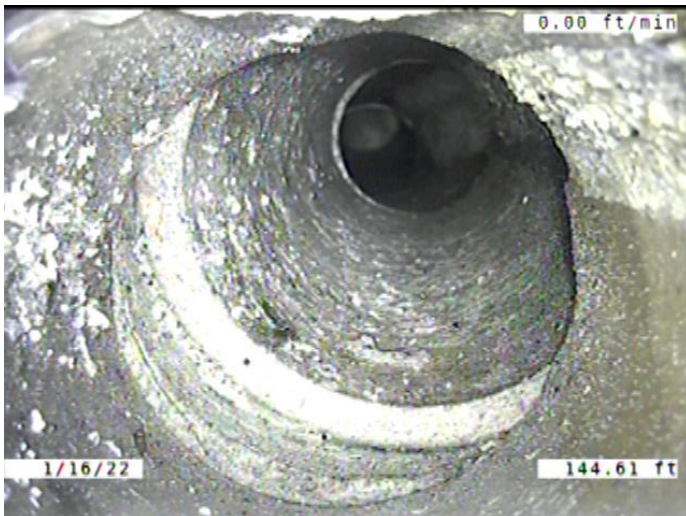
Code: **TBD**
 Description: **Tap Break-in/Hammer Defective**

Distance (ft): **144.6**
 Structural Grade: **0**
 O&M Grade: **3**
 Clock Start/From: **1**
 Clock To:
 1st Value: **4.000**
 2nd Value:
 Value Percent:
 Continuous Index:
 Within 8" of Joint: **NO**
 Remarks: **BROKEN. LARGE OFFSET**

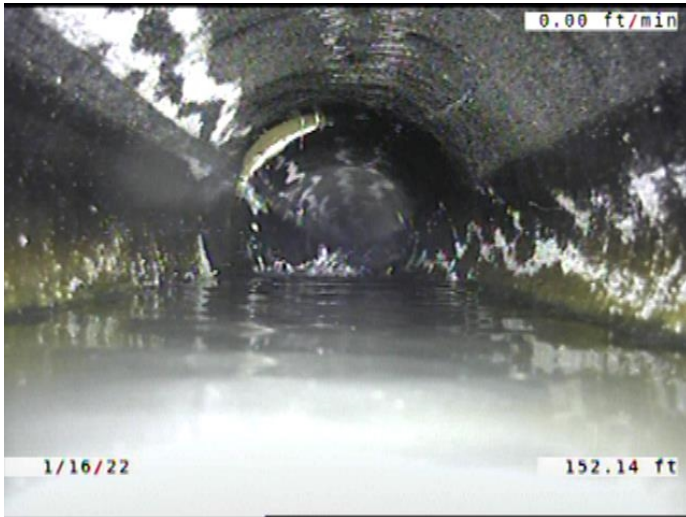
Code: **MWLS**
 Description: **Miscellaneous Water Level Sag**

Distance (ft): **152.1**
 Structural Grade: **2**
 O&M Grade: **0**
 Clock Start/From:
 Clock To:
 1st Value:
 2nd Value:
 Value Percent: **15.000**
 Continuous Index: **S02**
 Within 8" of Joint: **NO**
 Remarks:

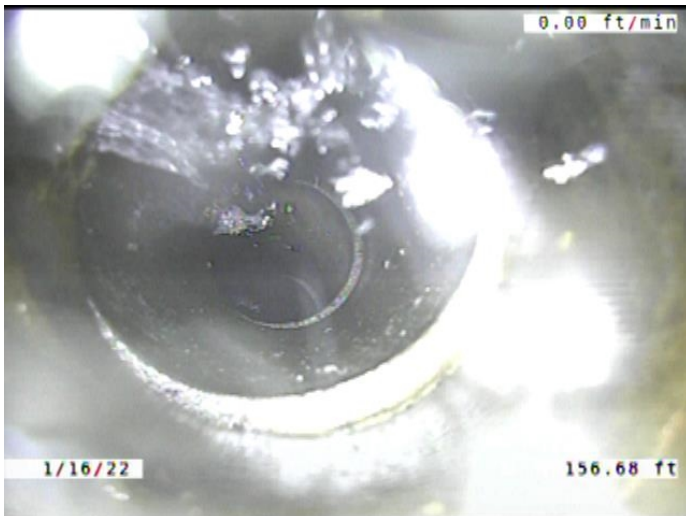
Code: **TBA**
 Description: **Tap Break-in Activity**

Distance (ft): **156.7**
 Structural Grade: **0**
 O&M Grade: **0**
 Clock Start/From: **11**
 Clock To:
 1st Value: **4.000**
 2nd Value:
 Value Percent:
 Continuous Index:
 Within 8" of Joint: **NO**
 Remarks:

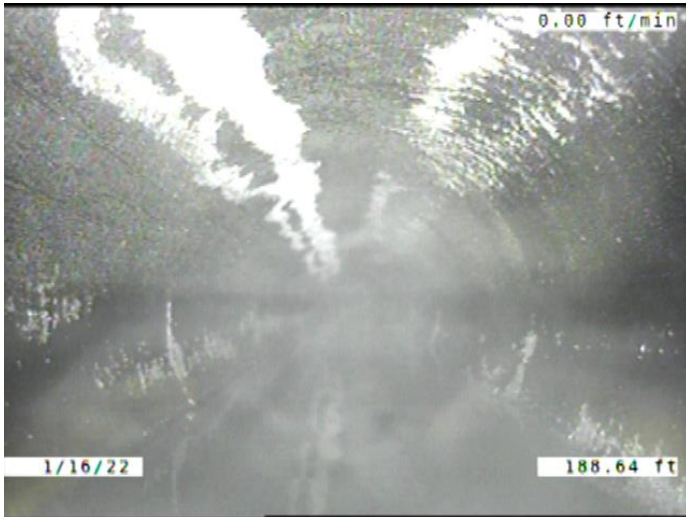
Code: **MWLS**
Description: **Miscellaneous Water Level Sag**

Distance (ft): **188.6**
Structural Grade: **2**
O&M Grade: **0**
Clock Start/From:
Clock To:
1st Value:
2nd Value:
Value Percent: **15.000**
Continuous Index: **F02**
Within 8" of Joint: **NO**
Remarks:

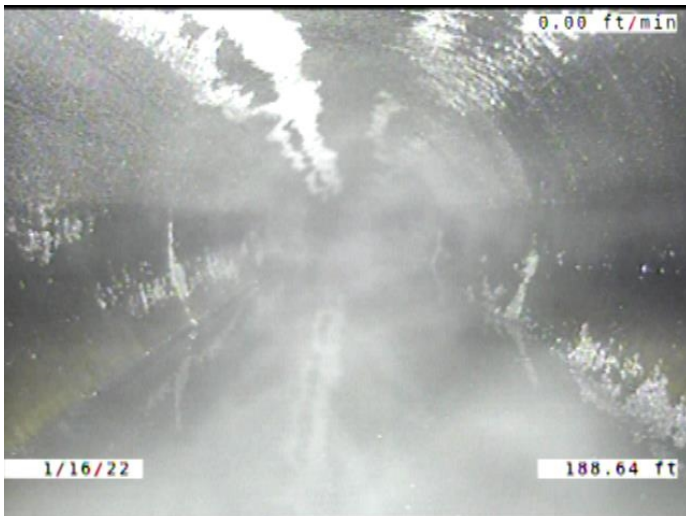
Code: **MWL**
Description: **Miscellaneous Water Level**

Distance (ft): **188.6**
Structural Grade: **0**
O&M Grade: **0**
Clock Start/From:
Clock To:
1st Value:
2nd Value:
Value Percent: **10.000**
Continuous Index:
Within 8" of Joint: **NO**
Remarks:

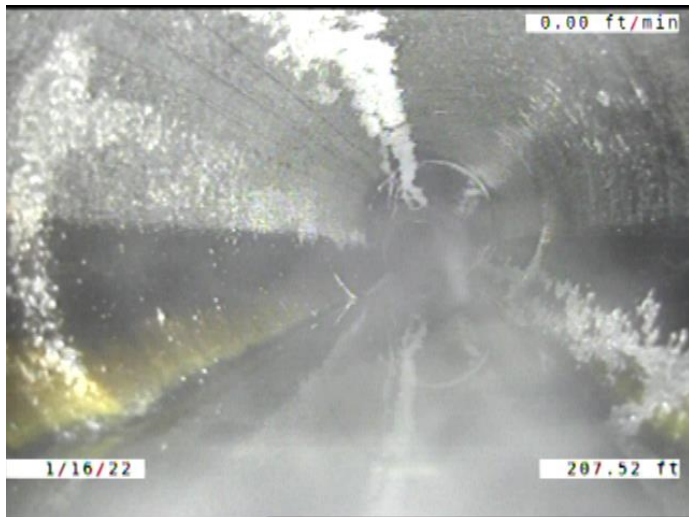
Code: **LR**
 Description: **Line Right**

Distance (ft): **207.5**
 Structural Grade: **0**
 O&M Grade: **1**
 Clock Start/From:
 Clock To:
 1st Value:
 2nd Value:
 Value Percent: **5.000**
 Continuous Index:
 Within 8" of Joint: **NO**
 Remarks:

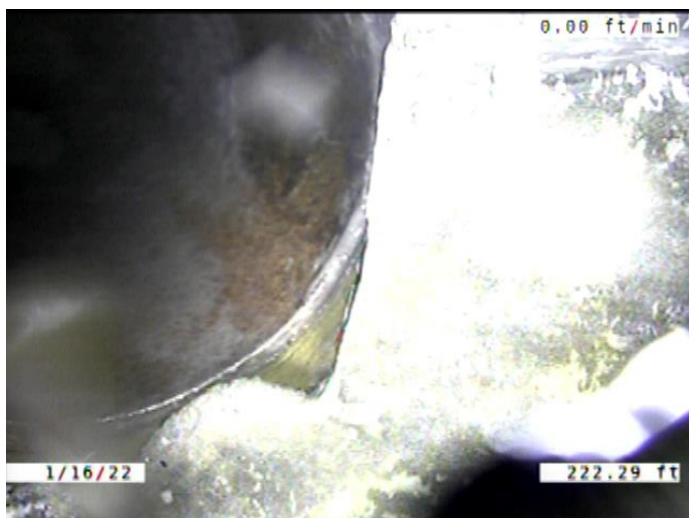
Code: **LFUC**
 Description: **Lining Feature Undercut Service**

Distance (ft): **222.3**
 Structural Grade: **3**
 O&M Grade: **0**
 Clock Start/From: **12**
 Clock To: **1**
 1st Value:
 2nd Value:
 Value Percent:
 Continuous Index:
 Within 8" of Joint: **NO**
 Remarks:

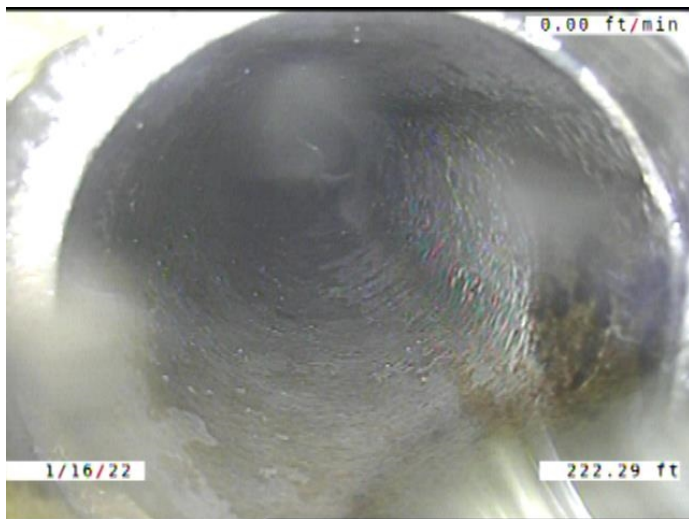
Code: **TBA**
 Description: **Tap Break-in Activity**

Distance (ft): **222.3**
 Structural Grade: **0**
 O&M Grade: **0**
 Clock Start/From: **12**
 Clock To:
 1st Value: **4.000**
 2nd Value:
 Value Percent:
 Continuous Index:
 Within 8" of Joint: **NO**
 Remarks:

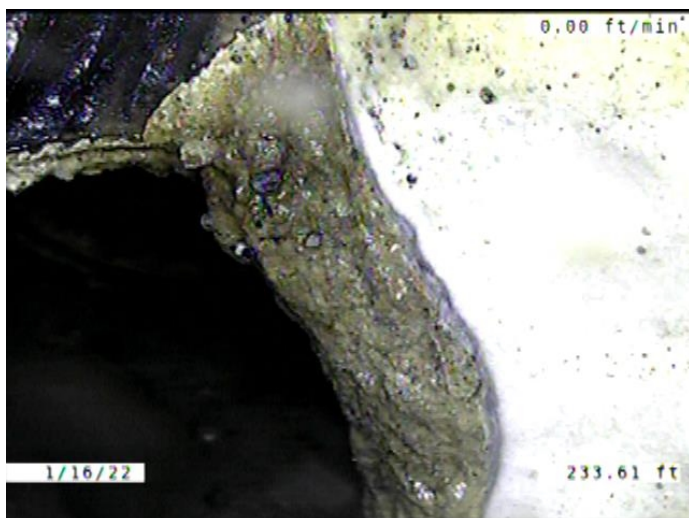
Code: **DAE**
 Description: **Deposits Attached Encrustation**

Distance (ft): **233.6**
 Structural Grade: **0**
 O&M Grade: **2**
 Clock Start/From: **1**
 Clock To: **5**
 1st Value:
 2nd Value:
 Value Percent: **5.000**
 Continuous Index:
 Within 8" of Joint: **NO**
 Remarks:

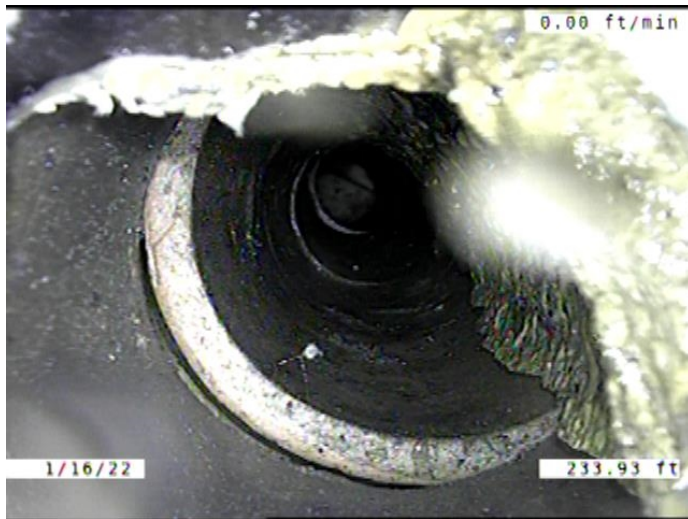
Code:	TBD
Description:	Tap Break-in/Hammer Defective
Distance (ft):	233.9
Structural Grade:	0
O&M Grade:	3
Clock Start/From:	1
Clock To:	
1st Value:	4.000
2nd Value:	
Value Percent:	
Continuous Index:	
Within 8" of Joint:	NO
Remarks:	OFFSET JOINT. ENCUSTATION COMING DOWN THE SERVICE INTO T

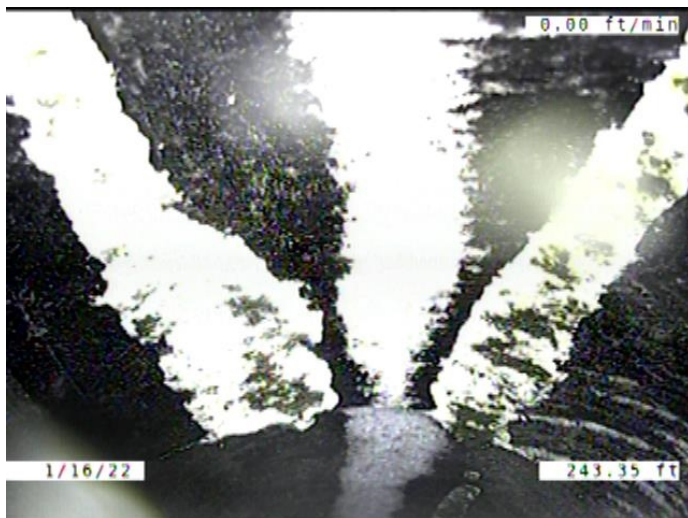
Code:	DAGS
Description:	Deposits Attached Grease
Distance (ft):	243.3
Structural Grade:	0
O&M Grade:	2
Clock Start/From:	11
Clock To:	1
1st Value:	
2nd Value:	
Value Percent:	5.000
Continuous Index:	S03
Within 8" of Joint:	YES
Remarks:

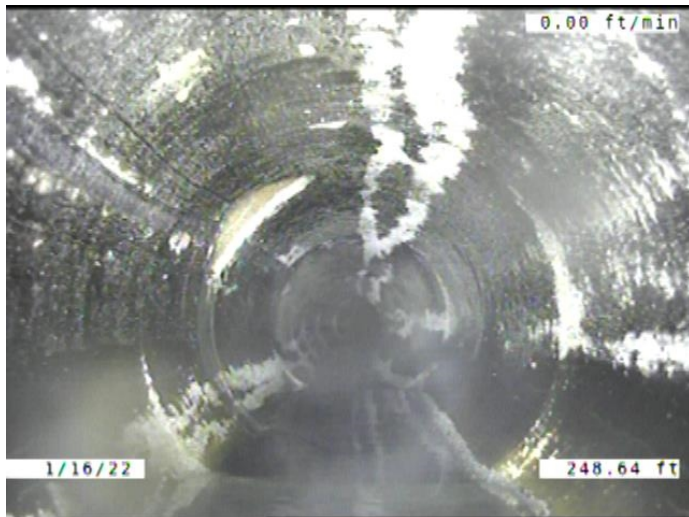
Code: **DAGS**
 Description: **Deposits Attached Grease**

Distance (ft): **248.6**
 Structural Grade: **0**
 O&M Grade: **2**
 Clock Start/From: **11**
 Clock To: **1**
 1st Value:
 2nd Value:
 Value Percent: **5.000**
 Continuous Index: **F03**
 Within 8" of Joint: **YES**
 Remarks:

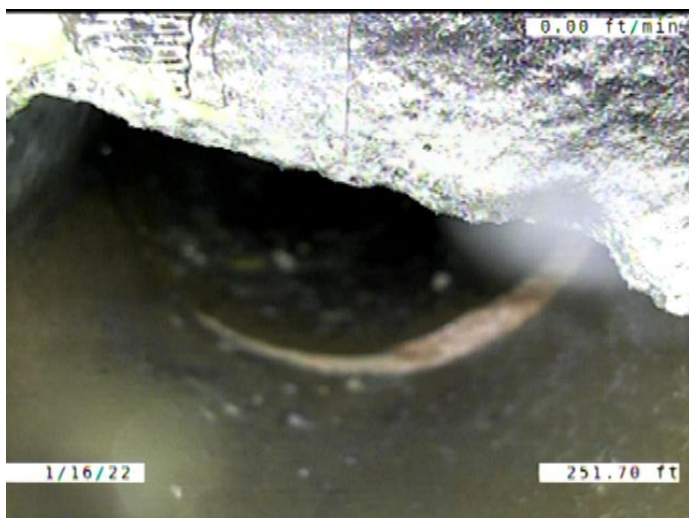
Code: **LFUC**
 Description: **Lining Feature Undercut Service**

Distance (ft): **251.7**
 Structural Grade: **3**
 O&M Grade: **0**
 Clock Start/From: **10**
 Clock To: **12**
 1st Value:
 2nd Value:
 Value Percent:
 Continuous Index:
 Within 8" of Joint: **NO**
 Remarks:

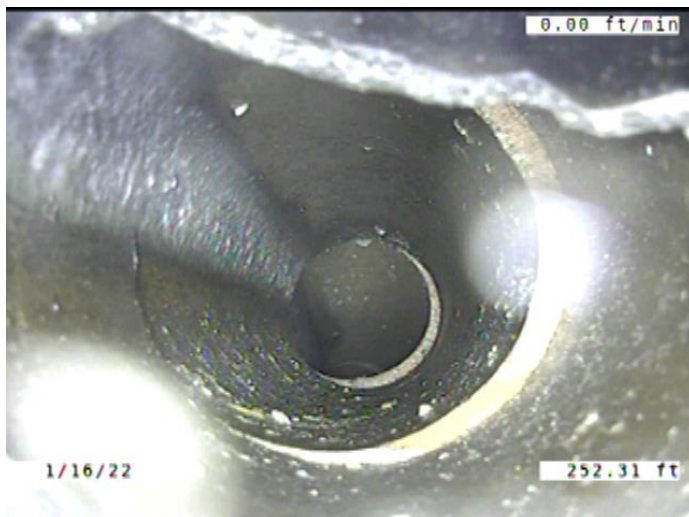
Code: **TB**
 Description: **Tap Break-in/Hammer**

Distance (ft): **252.3**
 Structural Grade: **0**
 O&M Grade: **0**
 Clock Start/From: **11**
 Clock To:
 1st Value: **4.000**
 2nd Value:
 Value Percent:
 Continuous Index:
 Within 8" of Joint: **NO**
 Remarks: **CONSTANTLY RUNNING WATER.**

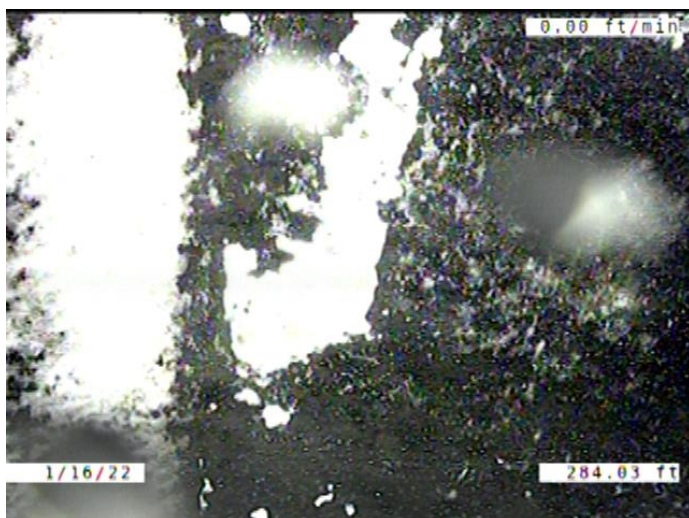
Code: **DAGS**
 Description: **Deposits Attached Grease**

Distance (ft): **284.0**
 Structural Grade: **0**
 O&M Grade: **2**
 Clock Start/From: **11**
 Clock To: **1**
 1st Value:
 2nd Value:
 Value Percent: **5.000**
 Continuous Index: **S04**
 Within 8" of Joint: **NO**
 Remarks:

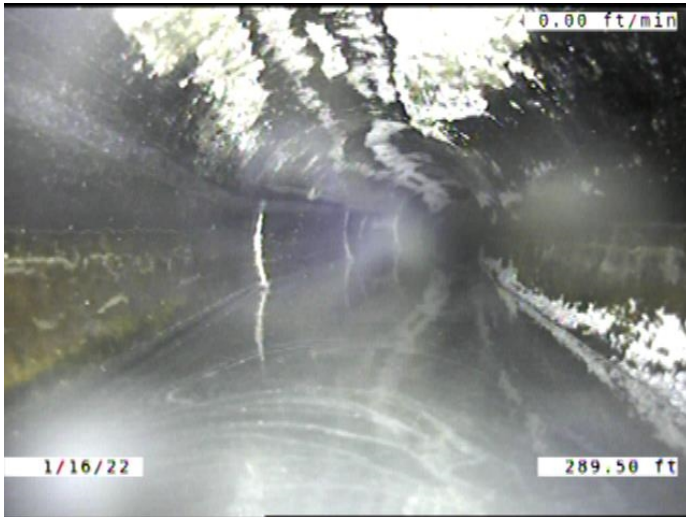
Code: **MWL**
 Description: **Miscellaneous Water Level**

Distance (ft): **289.5**
 Structural Grade: **0**
 O&M Grade: **0**
 Clock Start/From:
 Clock To:
 1st Value:
 2nd Value:
 Value Percent: **20.000**
 Continuous Index:
 Within 8" of Joint: **NO**
 Remarks:

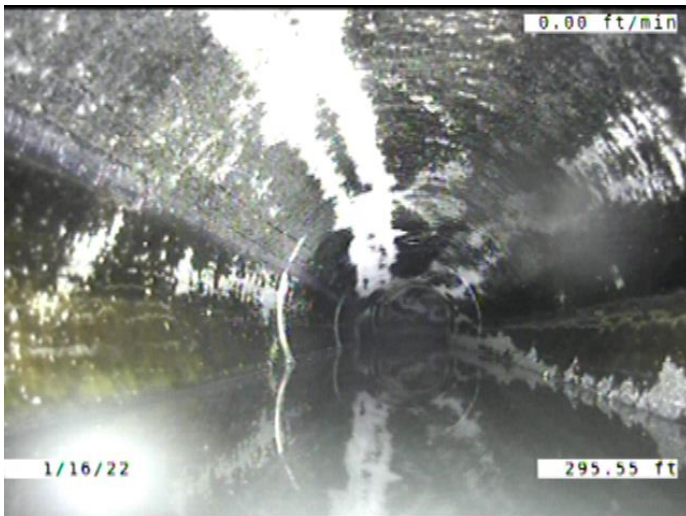
Code: **DAGS**
 Description: **Deposits Attached Grease**

Distance (ft): **295.5**
 Structural Grade: **0**
 O&M Grade: **2**
 Clock Start/From: **11**
 Clock To: **1**
 1st Value:
 2nd Value:
 Value Percent: **5.000**
 Continuous Index: **F04**
 Within 8" of Joint: **NO**
 Remarks:

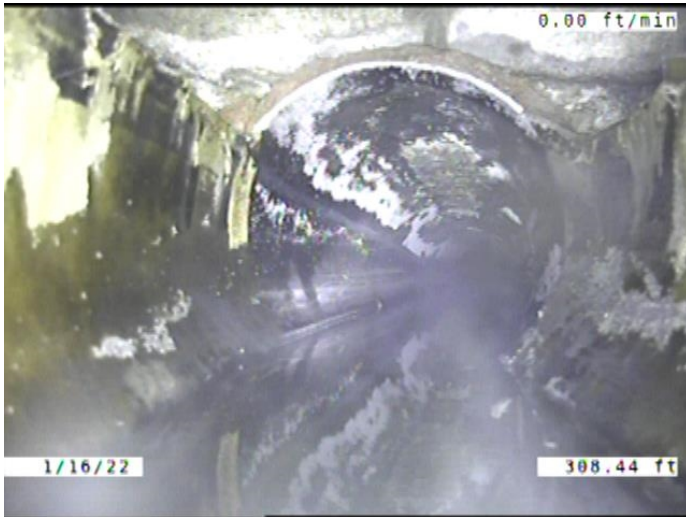
Code: **MWL**
 Description: **Miscellaneous Water Level**

Distance (ft): **308.4**
 Structural Grade: **0**
 O&M Grade: **0**
 Clock Start/From:
 Clock To:
 1st Value:
 2nd Value:
 Value Percent: **10.000**
 Continuous Index:
 Within 8" of Joint: **NO**
 Remarks:

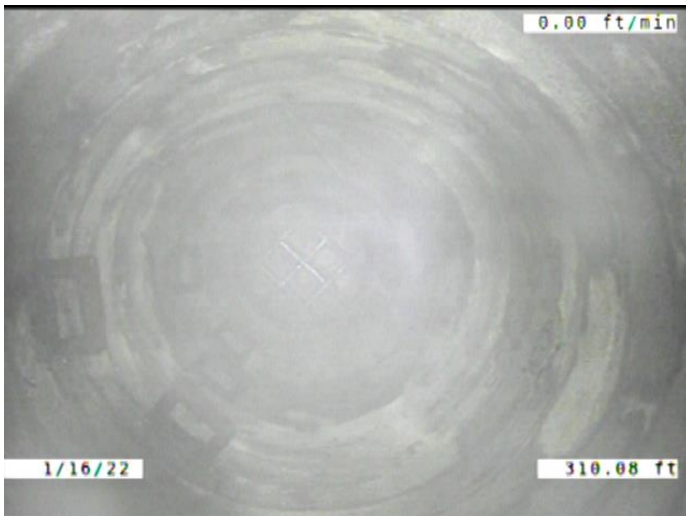
Code: **AMH**
 Description: **Manhole**

Distance (ft): **310.1**
 Structural Grade: **0**
 O&M Grade: **0**
 Clock Start/From:
 Clock To:
 1st Value:
 2nd Value:
 Value Percent:
 Continuous Index:
 Within 8" of Joint: **NO**
 Remarks: **M-405-006**
