## Profile/Photo Observation Report

Date:	<b>01/16/2022</b>	Weather:		Coding:	<b>PACP 7.0</b>
Pipe Length (ft):	<b>158.9</b>	Owner:	<b>City of Hobart</b>	Pre Clean:	<b>Heavy Cleaning</b>
P.O.#:	<b>YES502259</b>	Surveyor:	<b>S. Bucklin</b>	PSR:	<b>P-405-007-008</b>
Customer:	<b>City of Hobart</b>	Clean Date:	<b>01/15/2021</b>	Shape:	<b>C</b>

Street:	<b>South Wabash Street</b>	Flow Control:	<b>Not Controlled</b>
City:	<b>Hobart, IN</b>	Year Renewed:	
Location:	<b>Easement/Right of Way</b>	Tape/Media #:	
Purpose:	<b>Routine Assessment</b>	Dia/Height:	<b>12"</b>
Use:	<b>Sanitary Sewage Pipe</b>	Material:	<b>VCP</b>
Drain Area:		Lining:	<b>Not Known</b>

US MH: **M-405-008** DS MH: **M-405-007** Total Length Surveyed (ft): **158.9**

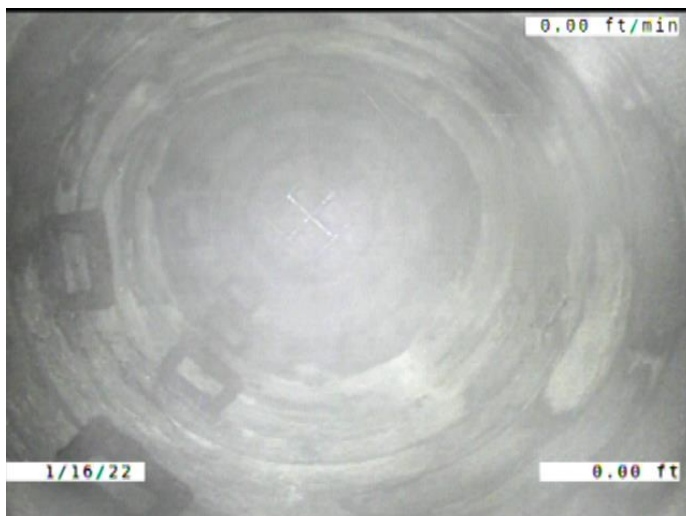
Code: **AMH**  
Description: **Manhole**

Distance (ft): **.0**  
Structural Grade: **0**  
O&M Grade: **0**  
Clock Start/From:  
Clock To:  
1st Value:  
2nd Value:  
Value Percent:  
Continuous Index:  
Within 8" of Joint: **NO**  
Remarks: **M-405-008**

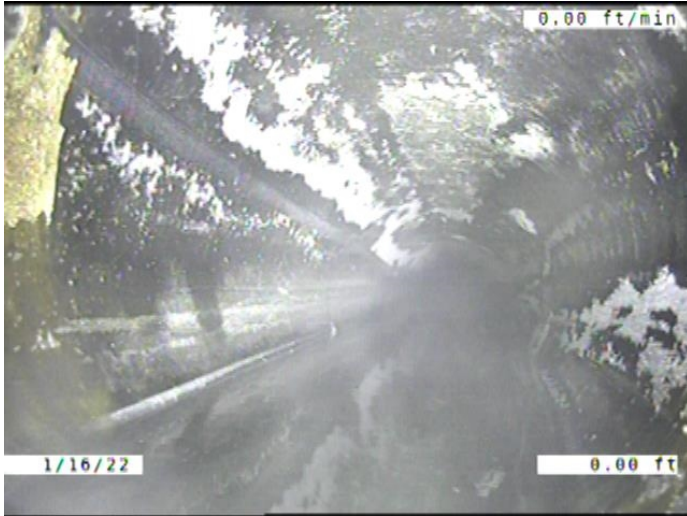
Code: **MWL**  
Description: **Miscellaneous Water Level**

Distance (ft): **.0**  
Structural Grade: **0**  
O&M Grade: **0**  
Clock Start/From:  
Clock To:  
1st Value:  
2nd Value:  
Value Percent: **10.000**  
Continuous Index:  
Within 8" of Joint: **NO**  
Remarks:

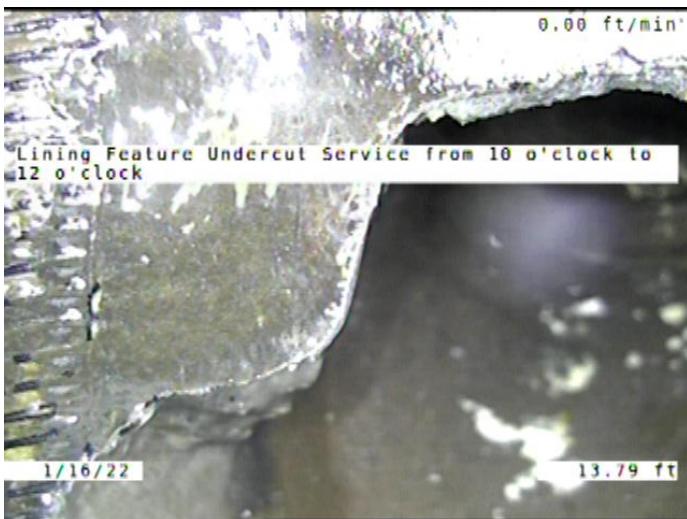
Code: **LFUC**  
Description: **Lining Feature Undercut Service**

Distance (ft): **13.8**  
Structural Grade: **3**  
O&M Grade: **0**  
Clock Start/From: **10**  
Clock To: **12**  
1st Value:  
2nd Value:  
Value Percent:  
Continuous Index:  
Within 8" of Joint: **NO**  
Remarks:

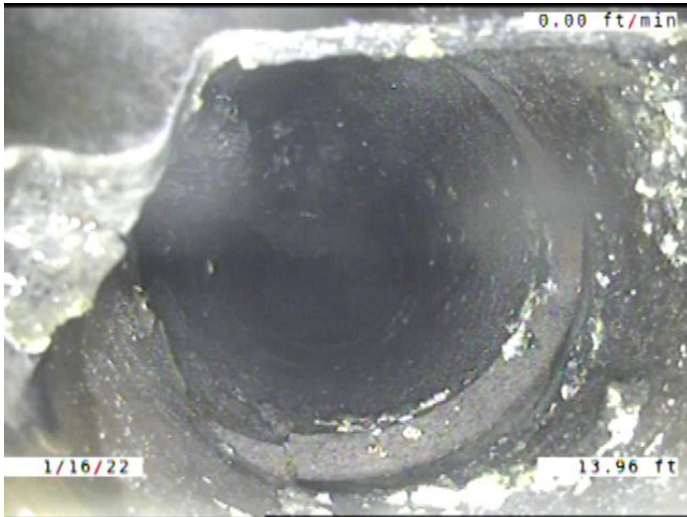
Code: **TBD**  
Description: **Tap Break-in/Hammer Defective**

Distance (ft): **14.0**  
Structural Grade: **0**  
O&M Grade: **3**  
Clock Start/From: **11**  
Clock To:  
1st Value: **4.000**  
2nd Value:  
Value Percent:  
Continuous Index:  
Within 8" of Joint: **NO**  
Remarks: **BROKEN. OFFSET JOINT. CONSTANTLY RUNNING WATER.**

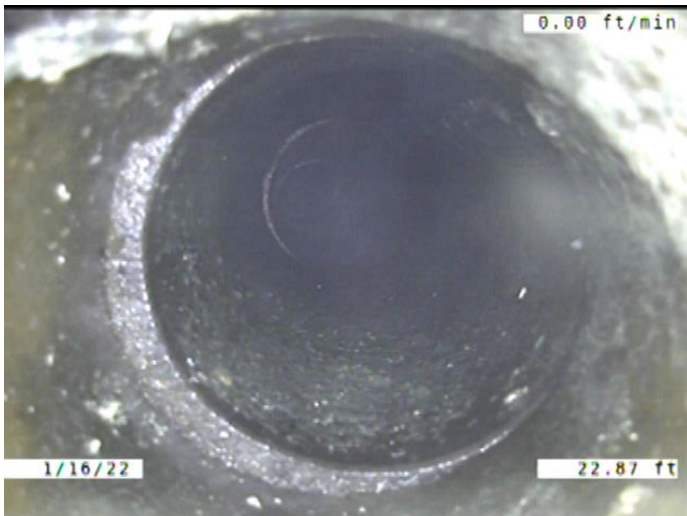
Code: **TB**  
Description: **Tap Break-in/Hammer**

Distance (ft): **22.9**  
Structural Grade: **0**  
O&M Grade: **0**  
Clock Start/From: **1**  
Clock To:  
1st Value: **4.000**  
2nd Value:  
Value Percent:  
Continuous Index:  
Within 8" of Joint: **NO**  
Remarks: **CONSTANTLY RUNNING WATER.**

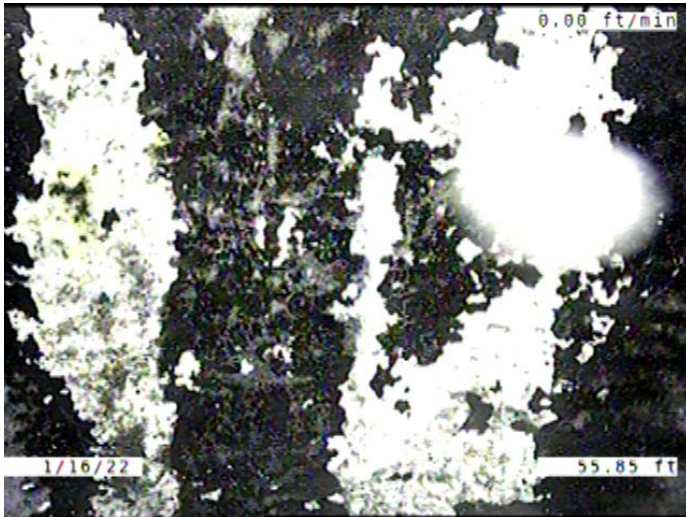
Code: **DAGS**  
 Description: **Deposits Attached Grease**

Distance (ft): **55.9**  
 Structural Grade: **0**  
 O&M Grade: **2**  
 Clock Start/From: **12**  
 Clock To:  
 1st Value:  
 2nd Value:  
 Value Percent: **5.000**  
 Continuous Index:  
 Within 8" of Joint: **NO**  
 Remarks:

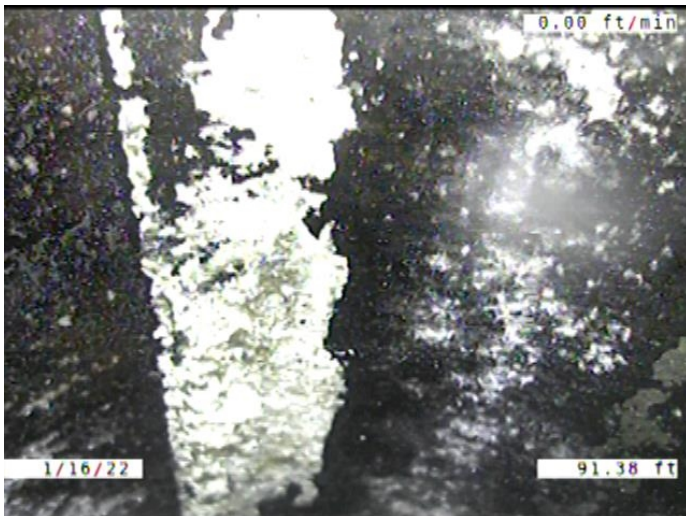
Code: **DAGS**  
 Description: **Deposits Attached Grease**

Distance (ft): **91.4**  
 Structural Grade: **0**  
 O&M Grade: **2**  
 Clock Start/From: **11**  
 Clock To: **1**  
 1st Value:  
 2nd Value:  
 Value Percent: **5.000**  
 Continuous Index: **S01**  
 Within 8" of Joint: **NO**  
 Remarks:

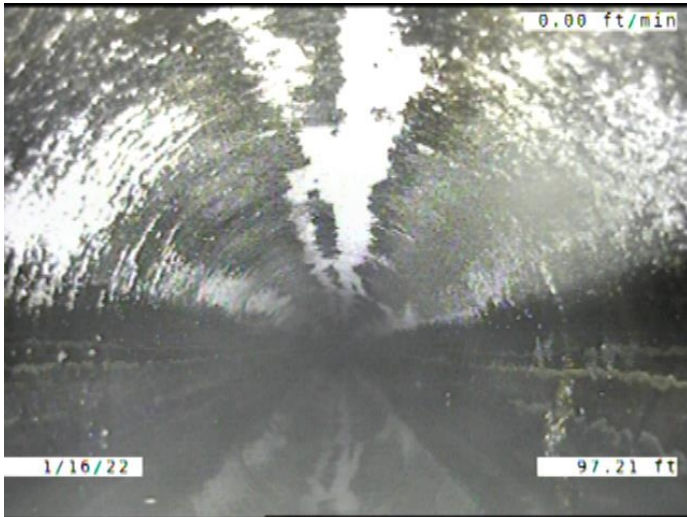
Code: **DAGS**  
 Description: **Deposits Attached Grease**

Distance (ft): **97.2**  
 Structural Grade: **0**  
 O&M Grade: **2**  
 Clock Start/From: **11**  
 Clock To: **1**  
 1st Value:  
 2nd Value:  
 Value Percent: **5.000**  
 Continuous Index: **F01**  
 Within 8" of Joint: **NO**  
 Remarks:

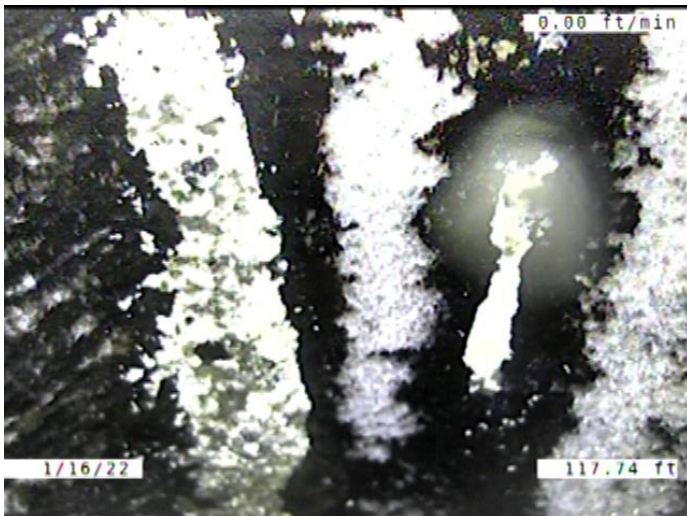
Code: **DAGS**  
 Description: **Deposits Attached Grease**

Distance (ft): **117.7**  
 Structural Grade: **0**  
 O&M Grade: **2**  
 Clock Start/From: **11**  
 Clock To: **12**  
 1st Value:  
 2nd Value:  
 Value Percent: **5.000**  
 Continuous Index:  
 Within 8" of Joint: **NO**  
 Remarks:

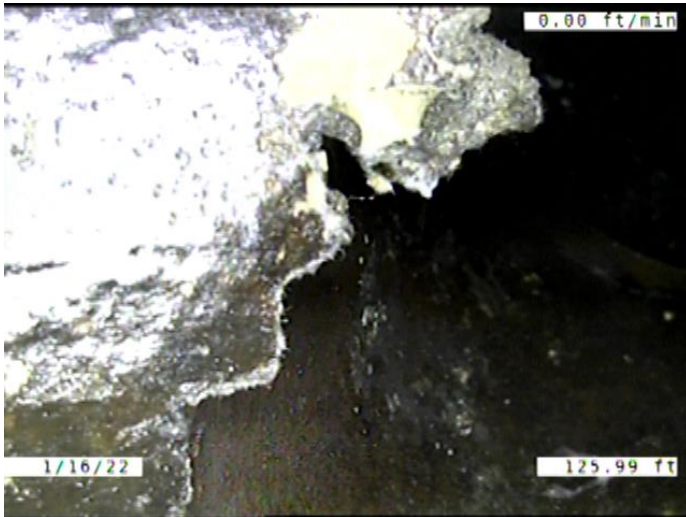
Code: **LFUC**  
 Description: **Lining Feature Undercut Service**

Distance (ft): **126.0**  
 Structural Grade: **3**  
 O&M Grade: **0**  
 Clock Start/From: **12**  
 Clock To: **2**  
 1st Value:  
 2nd Value:  
 Value Percent:  
 Continuous Index:  
 Within 8" of Joint: **NO**  
 Remarks:

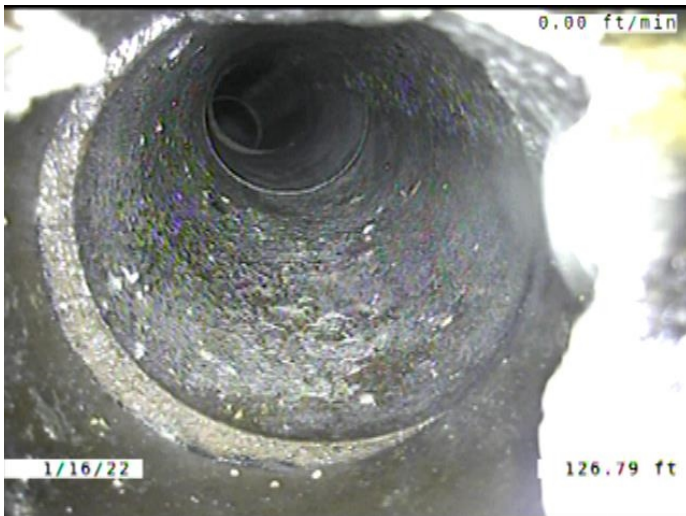
Code: **TB**  
 Description: **Tap Break-in/Hammer**

Distance (ft): **126.8**  
 Structural Grade: **0**  
 O&M Grade: **0**  
 Clock Start/From: **1**  
 Clock To:  
 1st Value: **4.000**  
 2nd Value:  
 Value Percent:  
 Continuous Index:  
 Within 8" of Joint: **NO**  
 Remarks: **CONSTANTLY RUNNING WATER.**

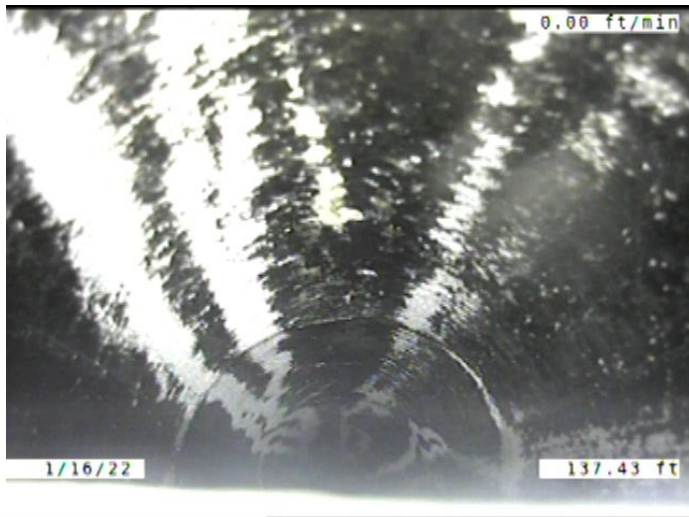
Code: **MWL**  
Description: **Miscellaneous Water Level**

Distance (ft): **137.4**  
Structural Grade: **0**  
O&M Grade: **0**  
Clock Start/From:  
Clock To:  
1st Value:  
2nd Value:  
Value Percent: **25.000**  
Continuous Index:  
Within 8" of Joint: **NO**  
Remarks:

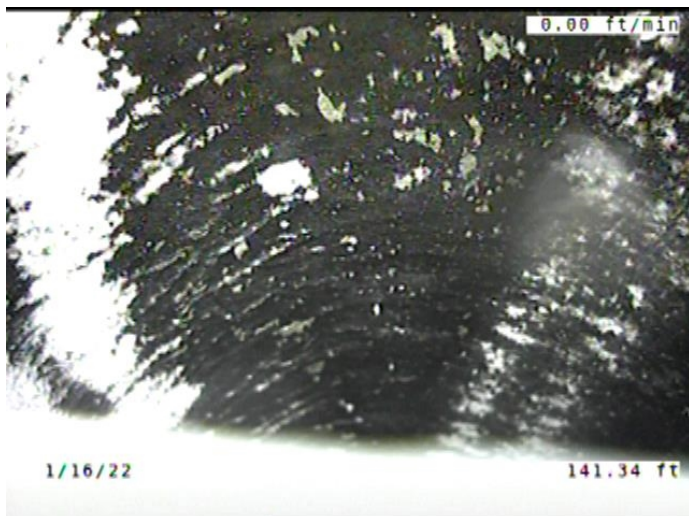
Code: **MWL**  
Description: **Miscellaneous Water Level**

Distance (ft): **141.3**  
Structural Grade: **0**  
O&M Grade: **0**  
Clock Start/From:  
Clock To:  
1st Value:  
2nd Value:  
Value Percent: **35.000**  
Continuous Index:  
Within 8" of Joint: **NO**  
Remarks:

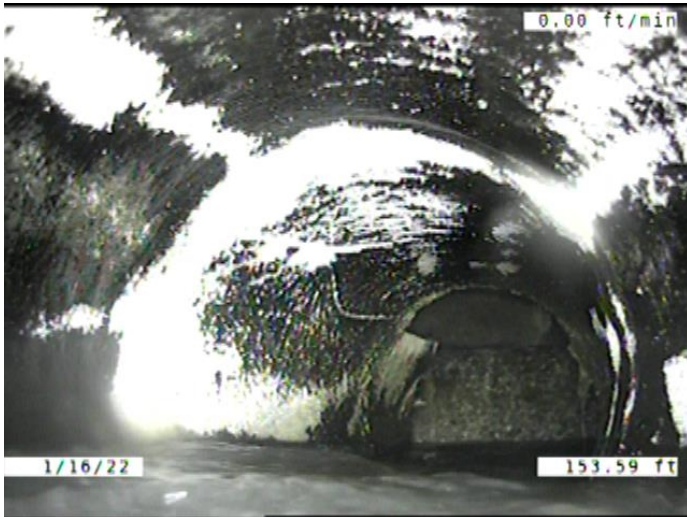
Code: **MWL**  
 Description: **Miscellaneous Water Level**

Distance (ft): **153.6**  
 Structural Grade: **0**  
 O&M Grade: **0**  
 Clock Start/From:  
 Clock To:  
 1st Value:  
 2nd Value:  
 Value Percent: **15.000**  
 Continuous Index:  
 Within 8" of Joint: **NO**  
 Remarks:

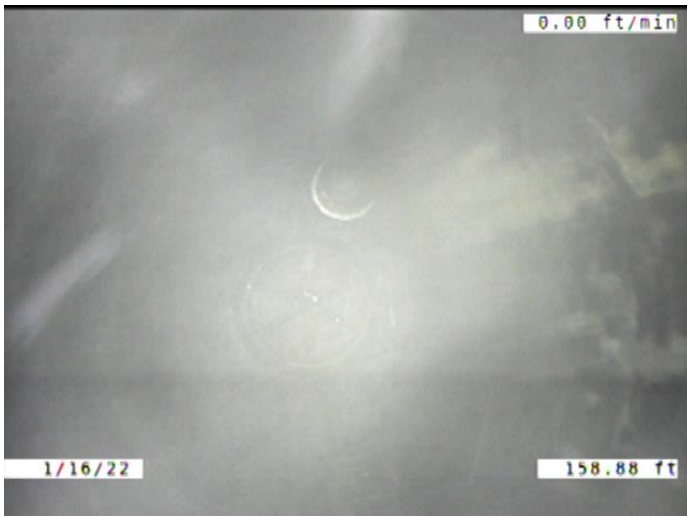
Code: **AMH**  
 Description: **Manhole**

Distance (ft): **158.9**  
 Structural Grade: **0**  
 O&M Grade: **0**  
 Clock Start/From:  
 Clock To:  
 1st Value:  
 2nd Value:  
 Value Percent:  
 Continuous Index:  
 Within 8" of Joint: **NO**  
 Remarks: **M-405-007**
