Profile/Photo Observation Report

Date:	04/25/2018	Weather:		Coding:	PACP 6.0
Pipe Length (ft):		Owner:	City of Hobart	Pre Clean:	No Pre-Cleaning
P.O.#:	85	Surveyor:	M. Pielacha	PSR:	P-405-008-069
Customer:	City of Hobart	Clean Date:		Shape:	C

Street:	3rd Street	Flow Control:	Not Controlled
City:	Hobart, IN	Year Renewed:	
Location:	Light Highway	Tape/Media #:	DEP 85
Purpose:	Routine Assessment	Dia/Height:	15"
Use:	Sanitary	Material:	CP
Drain Area:		Lining:	
Category:	NA		
Comment:	YES501824 Submittal 2		
Location Details:		Direction of Survey:	Upstream
US MH:	M-405-008	DS MH:	M-405-069
		Total Length Surveyed (ft):	41.1

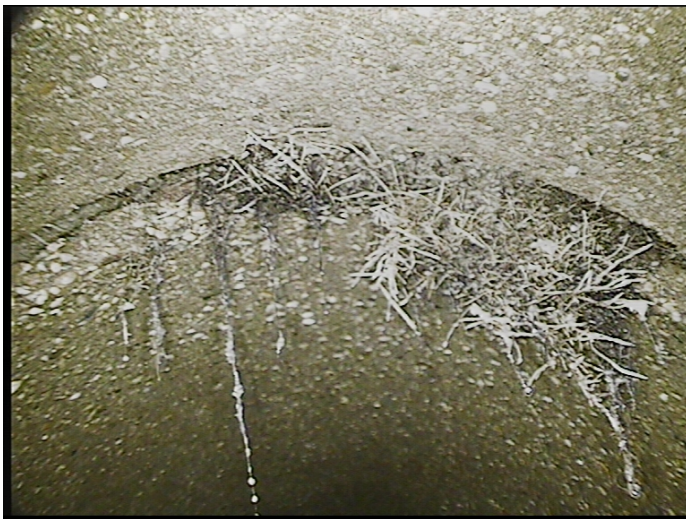
Code: **RFJ**
Description: **Roots Fine Joint**

Distance (ft): **.0**
Structural Grade: **0**
O&M Grade: **1**
Clock Start/From: **12**
Clock To: **2**
1st Value:
2nd Value:
Value Percent:
Continuous Index:
Within 8" of Joint: **YES**
Remarks:

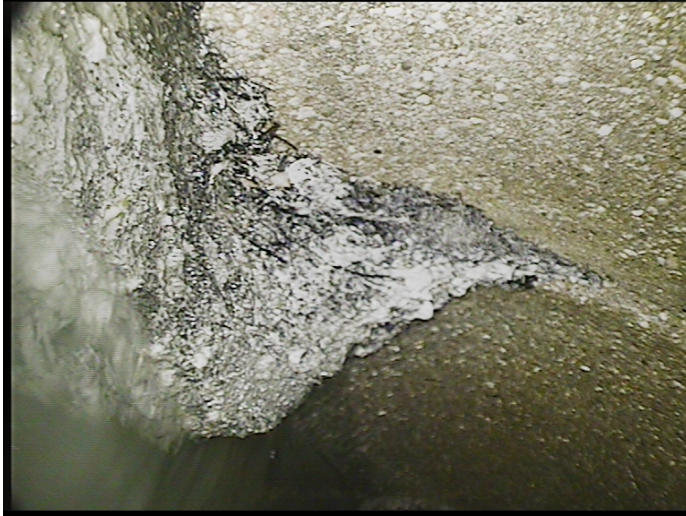
Code: **RMJ**
Description: **Roots Medium Joint**

Distance (ft): **7.0**
Structural Grade: **0**
O&M Grade: **3**
Clock Start/From: **8**
Clock To: **4**
1st Value:
2nd Value:
Value Percent: **10.000**
Continuous Index: **S01**
Within 8" of Joint: **YES**
Remarks:

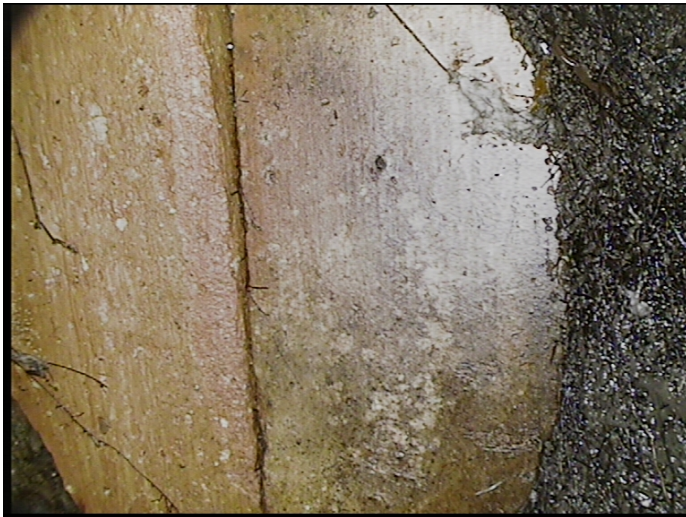
Code: **TBC**
Description: **Tap Break-in Capped**

Distance (ft): **28.9**
Structural Grade: **0**
O&M Grade: **2**
Clock Start/From: **3**
Clock To:
1st Value: **6.000**
2nd Value:
Value Percent:
Continuous Index:
Within 8" of Joint: **NO**
Remarks:

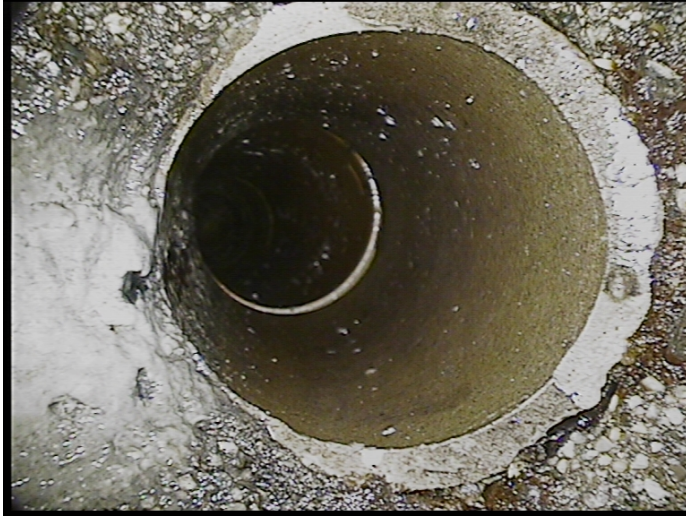
Code: **TB**
Description: **Tap Break-in**

Distance (ft): **32.9**
Structural Grade: **0**
O&M Grade: **0**
Clock Start/From: **10**
Clock To:
1st Value: **4.000**
2nd Value:
Value Percent:
Continuous Index:
Within 8" of Joint: **NO**
Remarks:

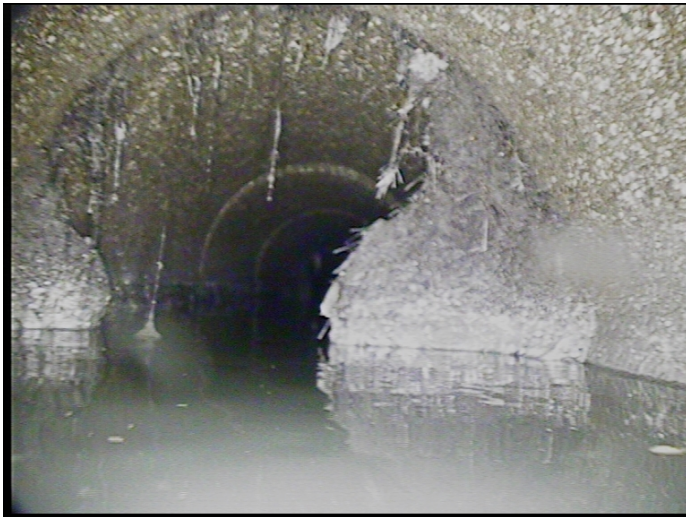
Code: **RMJ**
Description: **Roots Medium Joint**

Distance (ft): **40.7**
Structural Grade: **0**
O&M Grade: **3**
Clock Start/From: **8**
Clock To: **4**
1st Value:
2nd Value:
Value Percent: **20.000**
Continuous Index: **F01**
Within 8" of Joint: **YES**
Remarks:

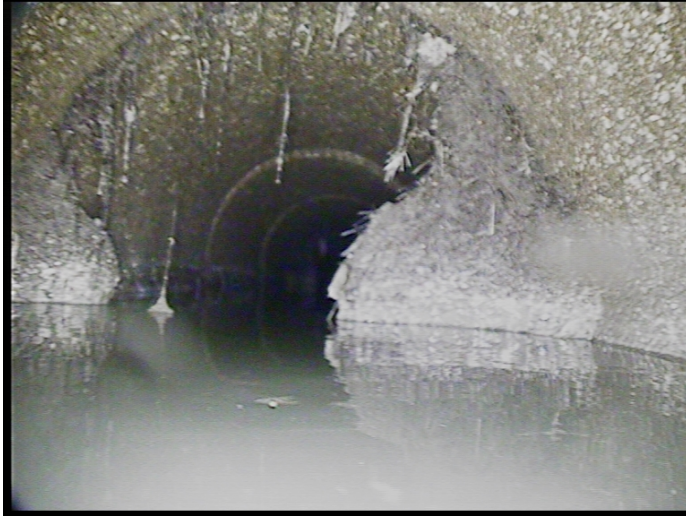
Code:	MSA
Description:	Abandoned Survey
Distance (ft):	40.7
Structural Grade:	0
O&M Grade:	0
Clock Start/From:	
Clock To:	
1st Value:	
2nd Value:	
Value Percent:	
Continuous Index:	
Within 8" of Joint:	NO
Remarks:	roots
