Profile/Photo Observation Report

Date:	07/28/2022	Weather:		Coding:	PACP 7.0
Pipe Length (ft):	305.0	Owner:	City of Hobart	Pre Clean:	Heavy Cleaning
P.O.#:	YES502259	Surveyor:	S. Bucklin	PSR:	P-405-008-069
Customer:	City of Hobart	Clean Date:	07/18/2022	Shape:	C

Street:	West 3rd Street	Flow Control:	Not Controlled
City:	Hobart, IN	Year Renewed:	
Location:	Easement/Right of Way	Tape/Media #:	
Purpose:	Routine Assessment	Dia/Height:	18"
Use:	Sanitary Sewage Pipe	Material:	RCP
Drain Area:		Lining:	None
Category:	NA		
Comment:

Location Details:		Direction of Survey:	Downstream
US MH:	M-405-008	DS MH:	M-405-069
		Total Length Surveyed (ft):	302.0

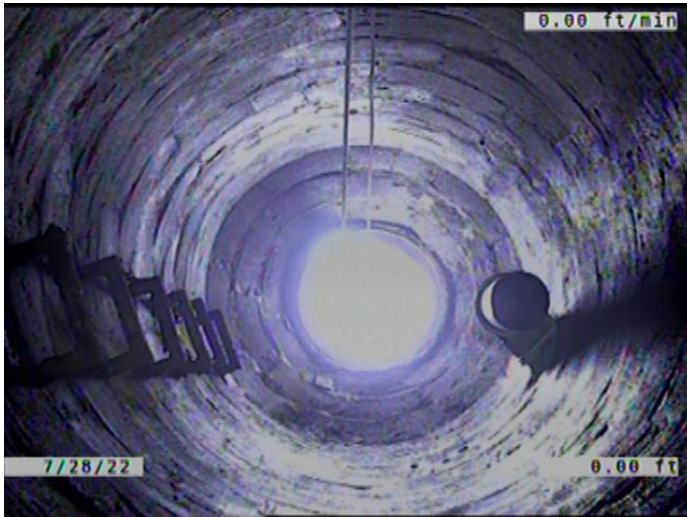
Code: **AMH**
Description: **Manhole**

Distance (ft): **.0**
Structural Grade: **0**
O&M Grade: **0**
Clock Start/From:
Clock To:
1st Value:
2nd Value:
Value Percent:
Continuous Index:
Within 8" of Joint: **NO**
Remarks: **M-405-008**

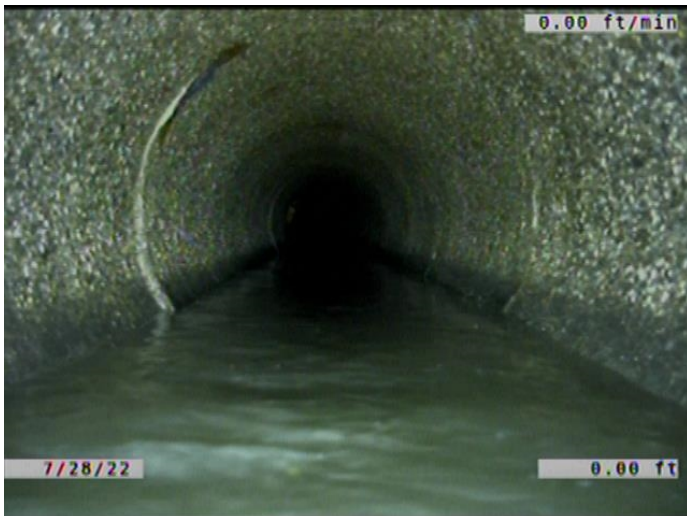
Code: **MWL**
Description: **Miscellaneous Water Level**

Distance (ft): **.0**
Structural Grade: **0**
O&M Grade: **0**
Clock Start/From:
Clock To:
1st Value:
2nd Value:
Value Percent: **15.000**
Continuous Index:
Within 8" of Joint: **NO**
Remarks:

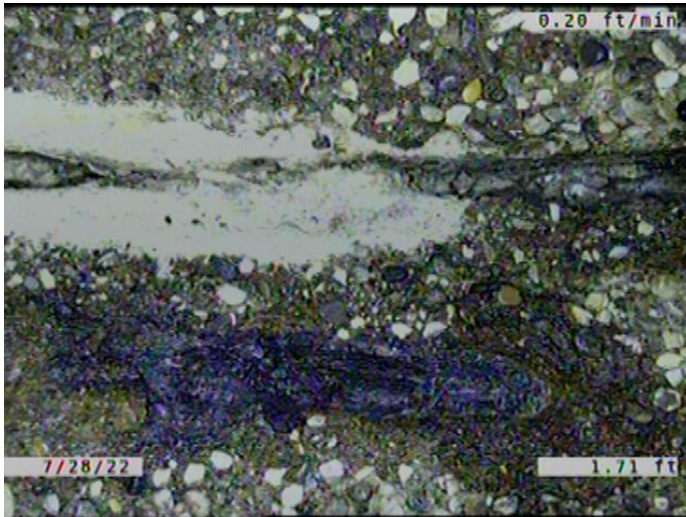
Code: **DAE**
 Description: **Deposits Attached Encrustation**

Distance (ft): **1.6**
 Structural Grade: **0**
 O&M Grade: **2**
 Clock Start/From: **9**
 Clock To: **11**
 1st Value:
 2nd Value:
 Value Percent: **5.000**
 Continuous Index:
 Within 8" of Joint: **YES**
 Remarks:

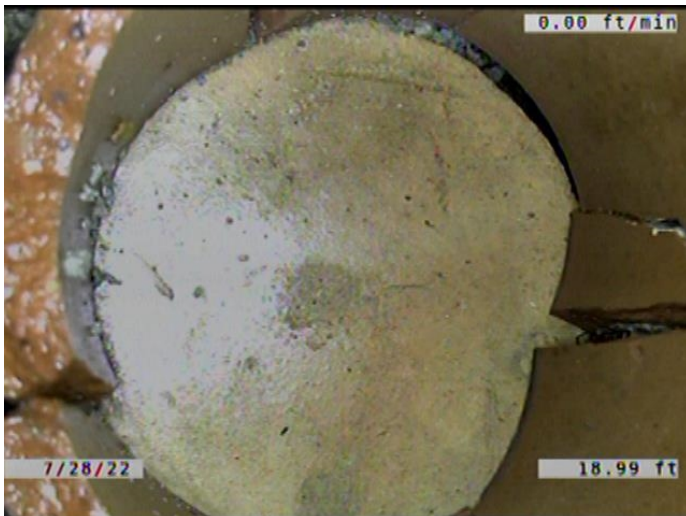
Code: **TBI**
 Description: **Tap Break-in Intruding**

Distance (ft): **19.0**
 Structural Grade: **0**
 O&M Grade: **2**
 Clock Start/From: **10**
 Clock To:
 1st Value: **6.000**
 2nd Value: **1.000**
 Value Percent:
 Continuous Index:
 Within 8" of Joint: **YES**
 Remarks: **TAP BROKEN. CAPPED. CAP BROKEN. SOIL VISIBLE.**

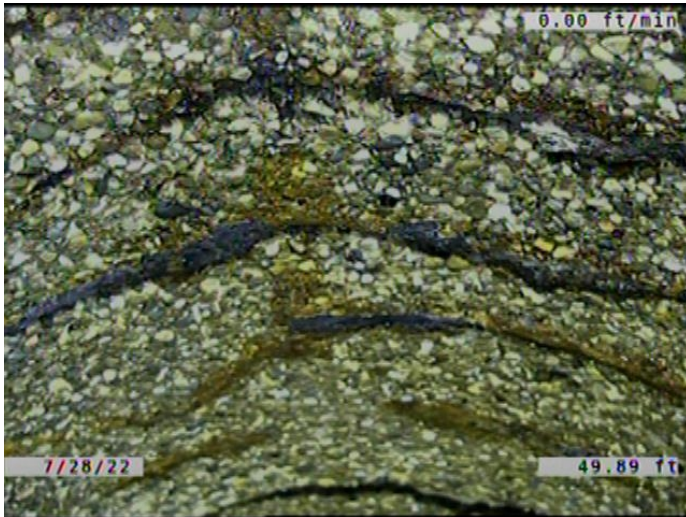
Code: **DAE**
Description: **Deposits Attached Encrustation**

Distance (ft): **49.9**
Structural Grade: **0**
O&M Grade: **2**
Clock Start/From: **9**
Clock To: **1**
1st Value:
2nd Value:
Value Percent: **5.000**
Continuous Index:
Within 8" of Joint: **YES**
Remarks:

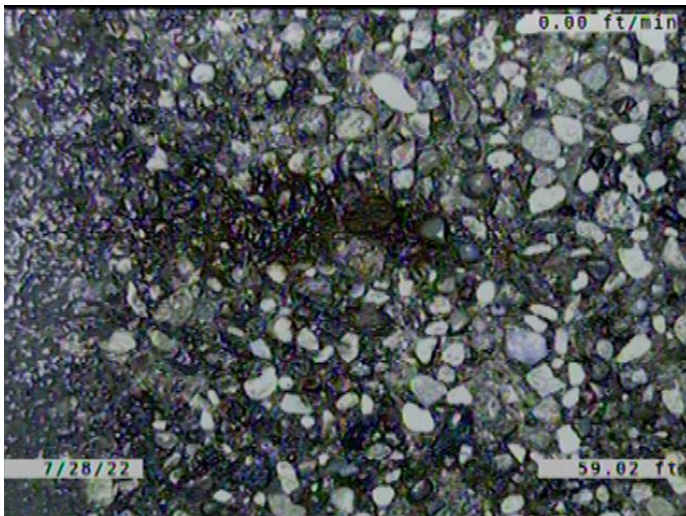
Code: **DAE**
Description: **Deposits Attached Encrustation**

Distance (ft): **59.0**
Structural Grade: **0**
O&M Grade: **2**
Clock Start/From: **8**
Clock To: **9**
1st Value:
2nd Value:
Value Percent: **5.000**
Continuous Index:
Within 8" of Joint: **NO**
Remarks:

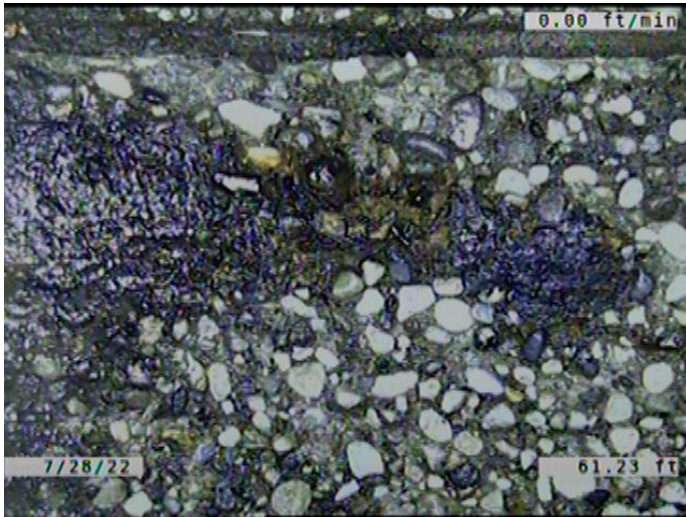
Code: **DAE**
 Description: **Deposits Attached Encrustation**

Distance (ft): **61.2**
 Structural Grade: **0**
 O&M Grade: **2**
 Clock Start/From: **8**
 Clock To: **9**
 1st Value:
 2nd Value:
 Value Percent: **5.000**
 Continuous Index:
 Within 8" of Joint: **YES**
 Remarks:

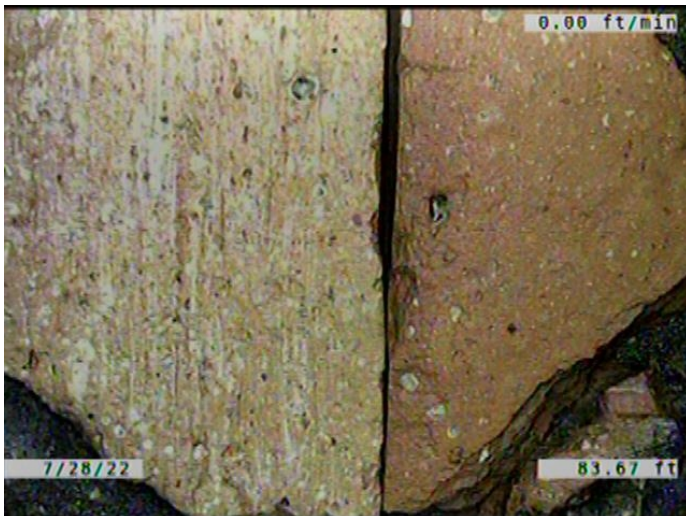
Code: **TBC**
 Description: **Tap Break-in Capped**

Distance (ft): **83.7**
 Structural Grade: **0**
 O&M Grade: **0**
 Clock Start/From: **10**
 Clock To:
 1st Value: **6.000**
 2nd Value:
 Value Percent:
 Continuous Index:
 Within 8" of Joint: **YES**
 Remarks:

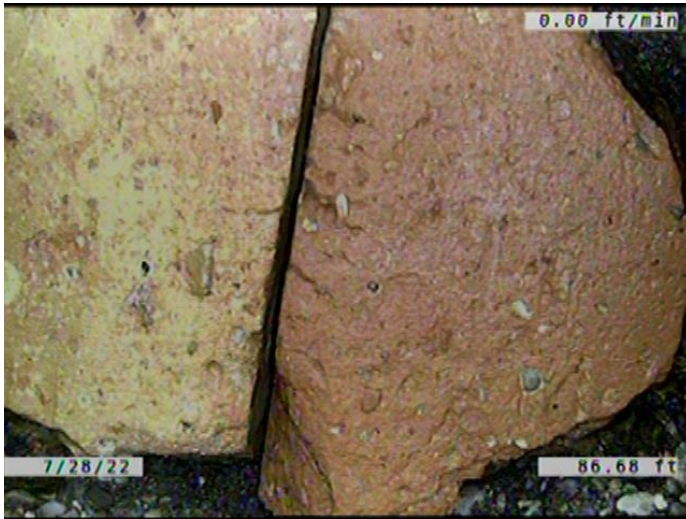
Code: **TBC**
 Description: **Tap Break-in Capped**

Distance (ft): **86.7**
 Structural Grade: **0**
 O&M Grade: **0**
 Clock Start/From: **3**
 Clock To:
 1st Value: **6.000**
 2nd Value:
 Value Percent:
 Continuous Index:
 Within 8" of Joint: **YES**
 Remarks:

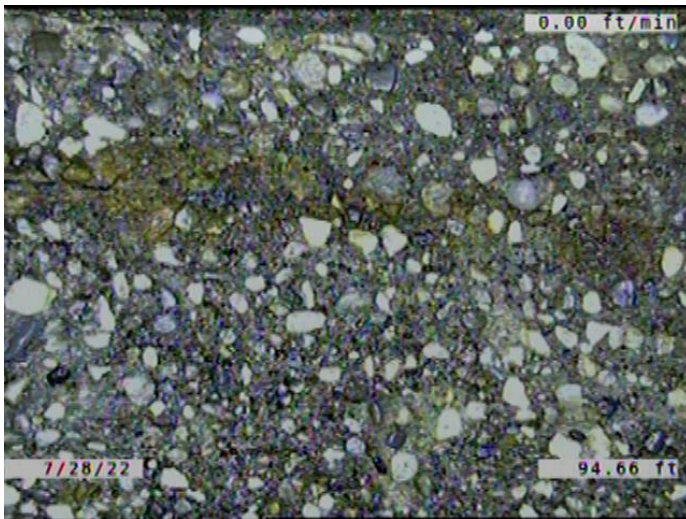
Code: **ISB**
 Description: **Infiltration Stain Barrel**

Distance (ft): **94.7**
 Structural Grade: **0**
 O&M Grade: **1**
 Clock Start/From: **8**
 Clock To: **10**
 1st Value:
 2nd Value:
 Value Percent:
 Continuous Index:
 Within 8" of Joint: **YES**
 Remarks:

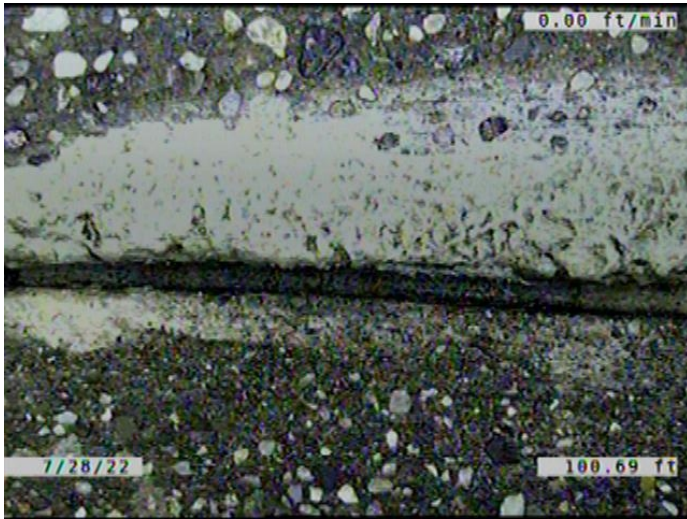
Code: **DAE**
 Description: **Deposits Attached Encrustation**

Distance (ft): **100.7**
 Structural Grade: **0**
 O&M Grade: **2**
 Clock Start/From: **12**
 Clock To: **4**
 1st Value:
 2nd Value:
 Value Percent: **5.000**
 Continuous Index:
 Within 8" of Joint: **YES**
 Remarks:

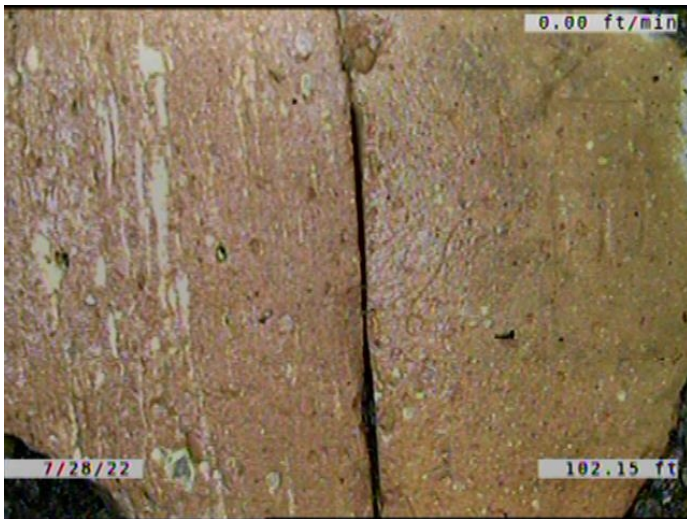
Code: **TBC**
 Description: **Tap Break-in Capped**

Distance (ft): **102.1**
 Structural Grade: **0**
 O&M Grade: **0**
 Clock Start/From: **9**
 Clock To:
 1st Value: **6.000**
 2nd Value:
 Value Percent:
 Continuous Index:
 Within 8" of Joint: **YES**
 Remarks:

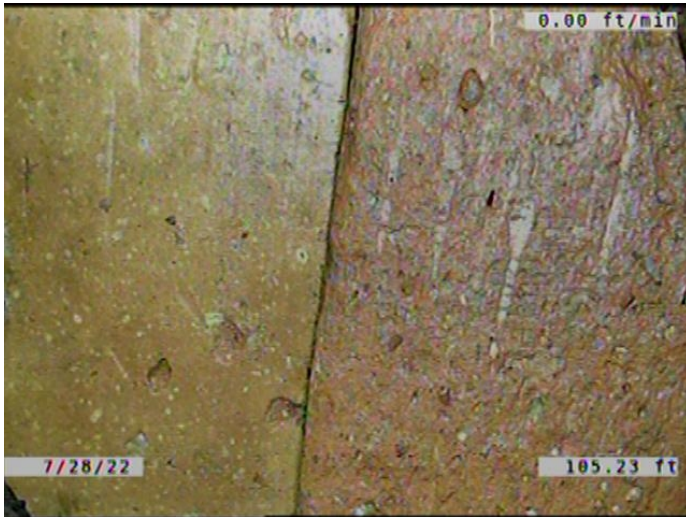
Code: **TBC**
 Description: **Tap Break-in Capped**

Distance (ft): **105.2**
 Structural Grade: **0**
 O&M Grade: **0**
 Clock Start/From: **2**
 Clock To:
 1st Value: **6.000**
 2nd Value:
 Value Percent:
 Continuous Index:
 Within 8" of Joint: **YES**
 Remarks:

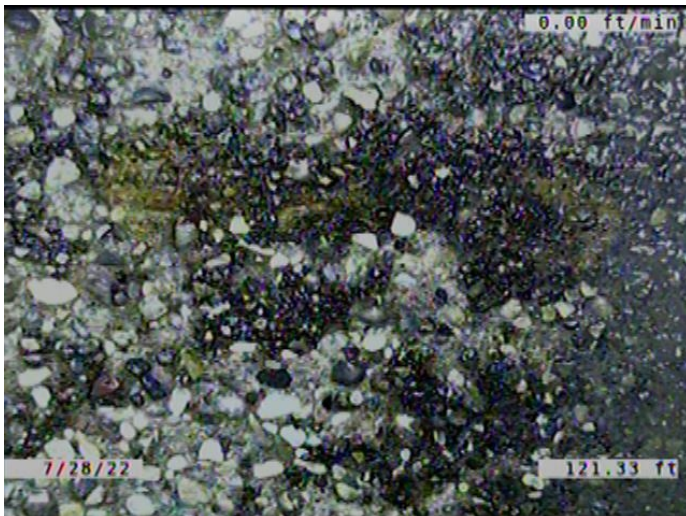
Code: **ISB**
 Description: **Infiltration Stain Barrel**

Distance (ft): **121.3**
 Structural Grade: **0**
 O&M Grade: **1**
 Clock Start/From: **3**
 Clock To: **4**
 1st Value:
 2nd Value:
 Value Percent:
 Continuous Index:
 Within 8" of Joint: **NO**
 Remarks:

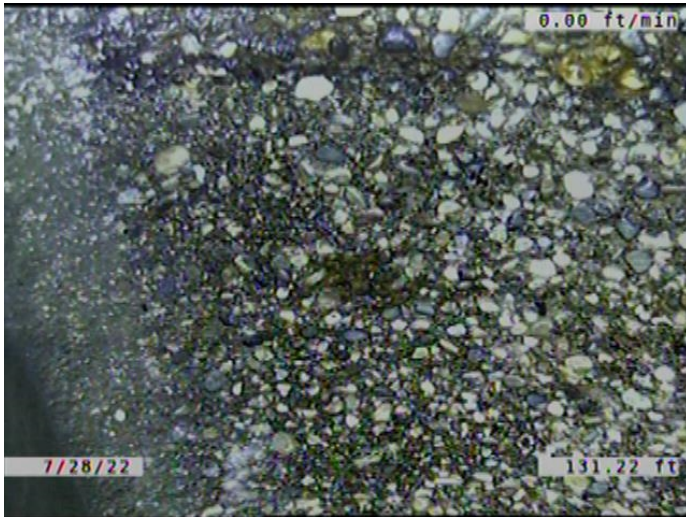
Code: **ISB**
 Description: **Infiltration Stain Barrel**

Distance (ft): **131.2**
 Structural Grade: **0**
 O&M Grade: **1**
 Clock Start/From: **8**
 Clock To: **2**
 1st Value:
 2nd Value:
 Value Percent:
 Continuous Index: **S01**
 Within 8" of Joint: **YES**
 Remarks:

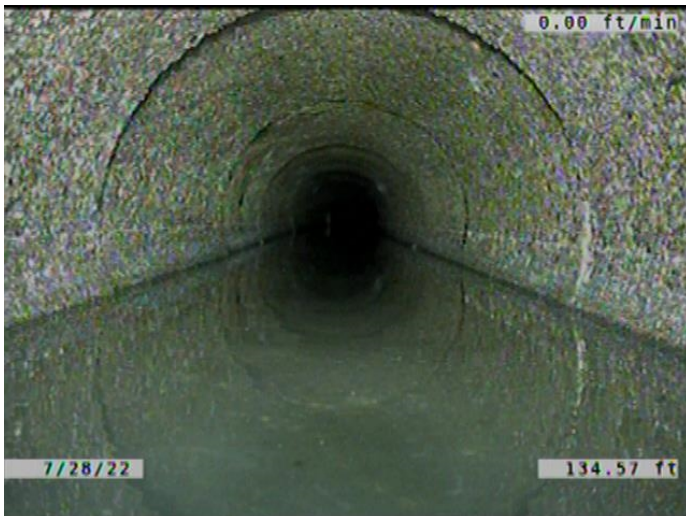
Code: **MWL**
 Description: **Miscellaneous Water Level**

Distance (ft): **134.6**
 Structural Grade: **0**
 O&M Grade: **0**
 Clock Start/From:
 Clock To:
 1st Value:
 2nd Value:
 Value Percent: **25.000**
 Continuous Index:
 Within 8" of Joint: **NO**
 Remarks:

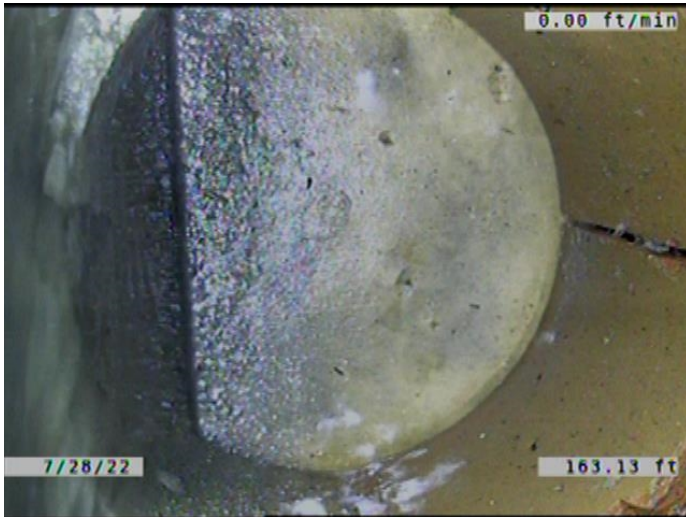
Code: **TBD**
 Description: **Tap Break-in/Hammer Defective**

Distance (ft): **163.1**
 Structural Grade: **0**
 O&M Grade: **3**
 Clock Start/From: **9**
 Clock To:
 1st Value: **6.000**
 2nd Value:
 Value Percent:
 Continuous Index:
 Within 8" of Joint: **YES**
 Remarks: **TAP BROKEN. HOLE, CAPPED.**

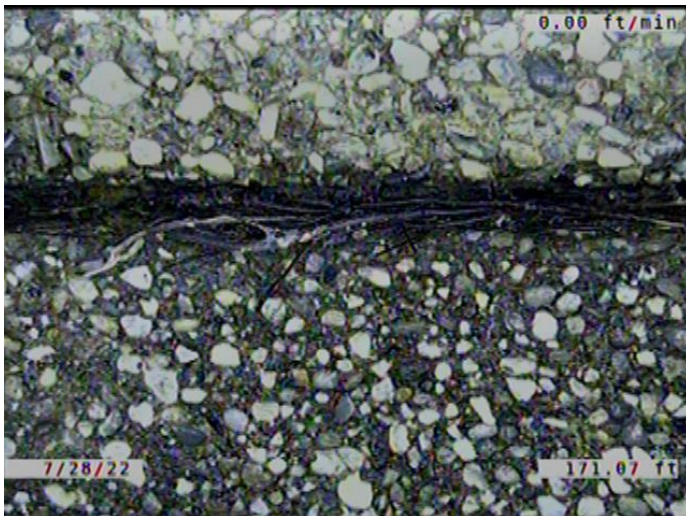
Code: **RFJ**
 Description: **Roots Fine Joint**

Distance (ft): **171.1**
 Structural Grade: **0**
 O&M Grade: **1**
 Clock Start/From: **8**
 Clock To: **4**
 1st Value:
 2nd Value:
 Value Percent:
 Continuous Index: **S02**
 Within 8" of Joint: **YES**
 Remarks:

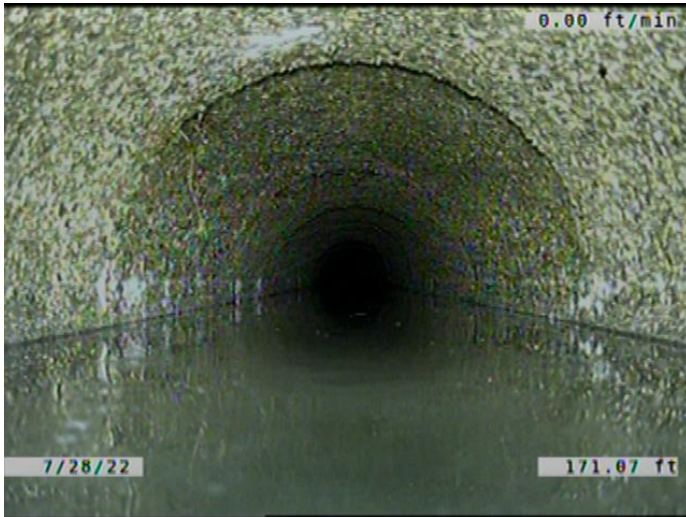
Code: **MWL**
 Description: **Miscellaneous Water Level**

Distance (ft): **171.1**
 Structural Grade: **0**
 O&M Grade: **0**
 Clock Start/From:
 Clock To:
 1st Value:
 2nd Value:
 Value Percent: **40.000**
 Continuous Index:
 Within 8" of Joint: **NO**
 Remarks:

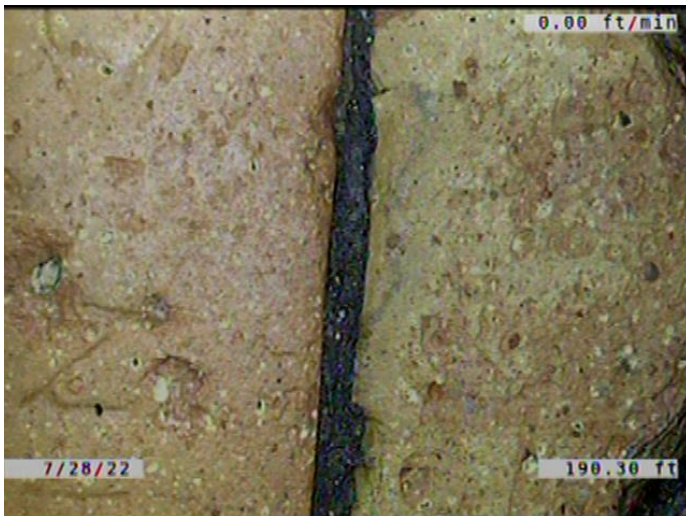
Code: **TBC**
 Description: **Tap Break-in Capped**

Distance (ft): **190.3**
 Structural Grade: **0**
 O&M Grade: **0**
 Clock Start/From: **3**
 Clock To:
 1st Value: **6.000**
 2nd Value:
 Value Percent:
 Continuous Index:
 Within 8" of Joint: **YES**
 Remarks:

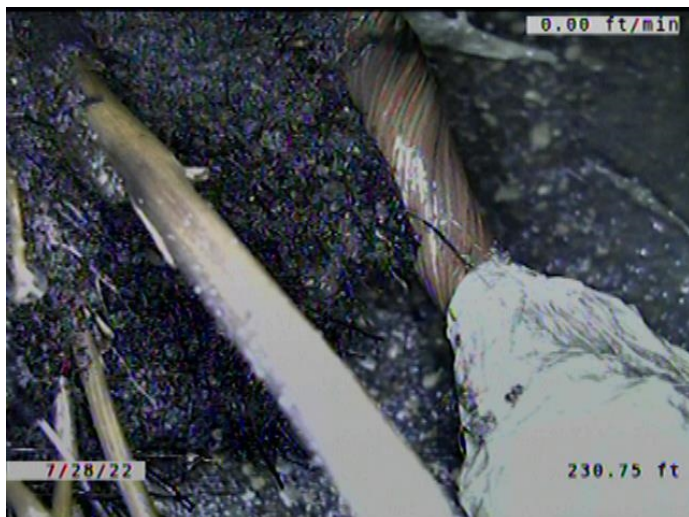
Code: **RTJ**
 Description: **Roots Tap Joint**

Distance (ft): **228.1**
 Structural Grade: **0**
 O&M Grade: **2**
 Clock Start/From: **8**
 Clock To: **4**
 1st Value:
 2nd Value:
 Value Percent: **5.000**
 Continuous Index:
 Within 8" of Joint: **YES**
 Remarks:

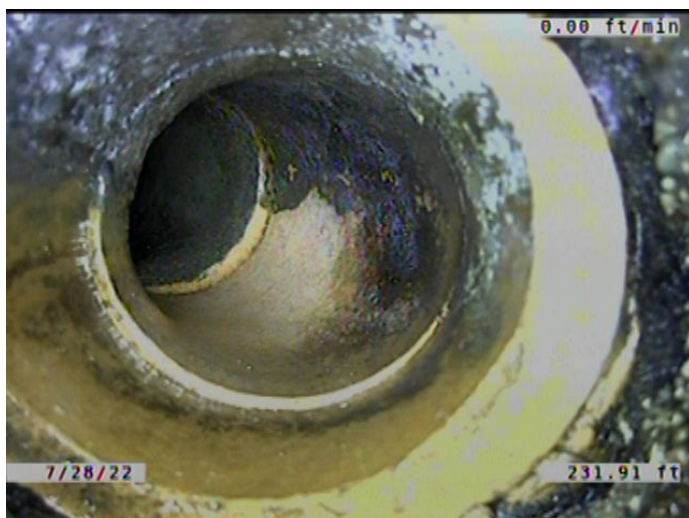
Code: **TBD**
 Description: **Tap Break-in/Hammer Defective**

Distance (ft): **231.9**
 Structural Grade: **0**
 O&M Grade: **3**
 Clock Start/From: **12**
 Clock To:
 1st Value: **6.000**
 2nd Value:
 Value Percent:
 Continuous Index:
 Within 8" of Joint: **YES**
 Remarks: **CONSTANTLY RUNING WATER.
 ROOTS GROWING AROUND THE TAP.**

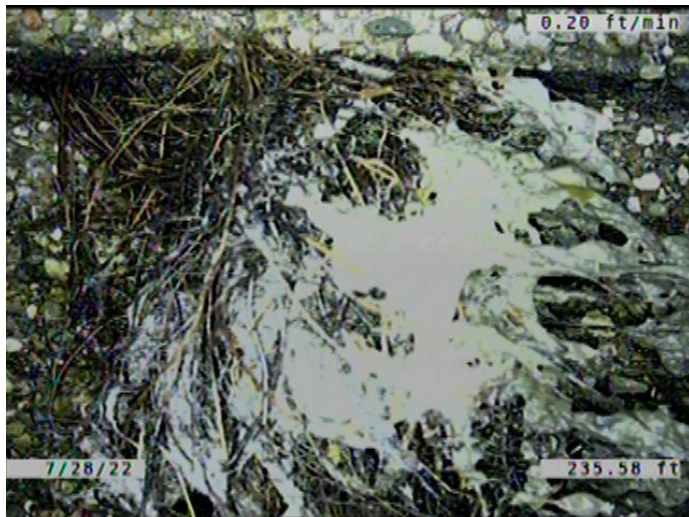
Code: **RMJ**
 Description: **Roots Medium Joint**

Distance (ft): **235.6**
 Structural Grade: **0**
 O&M Grade: **3**
 Clock Start/From: **8**
 Clock To: **4**
 1st Value:
 2nd Value:
 Value Percent: **5.000**
 Continuous Index: **S03**
 Within 8" of Joint: **YES**
 Remarks:

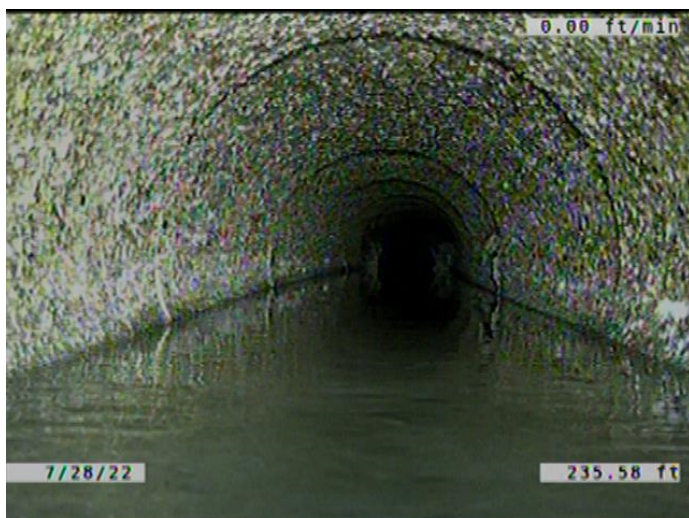
Code: **RFJ**
 Description: **Roots Fine Joint**

Distance (ft): **235.6**
 Structural Grade: **0**
 O&M Grade: **1**
 Clock Start/From: **8**
 Clock To: **4**
 1st Value:
 2nd Value:
 Value Percent:
 Continuous Index: **F02**
 Within 8" of Joint: **YES**
 Remarks:

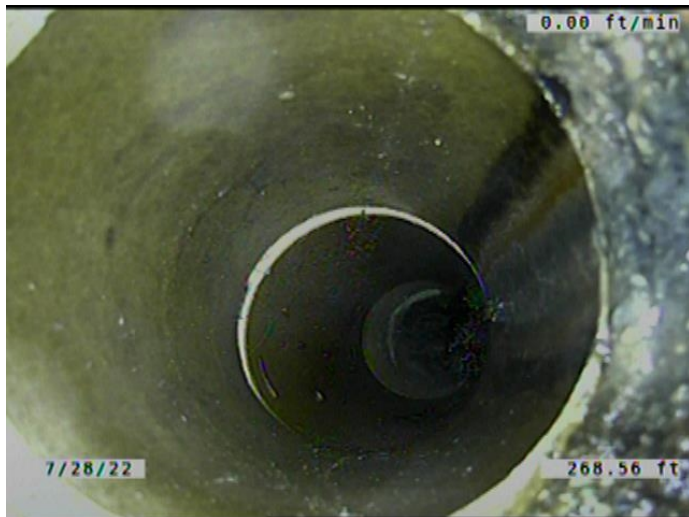
Code: **TBD**
 Description: **Tap Break-in/Hammer Defective**

Distance (ft): **268.6**
 Structural Grade: **0**
 O&M Grade: **3**
 Clock Start/From: **1**
 Clock To:
 1st Value: **6.000**
 2nd Value:
 Value Percent:
 Continuous Index:
 Within 8" of Joint: **YES**
 Remarks: **CONSTANTLY RUNNING WATER, ROOTS GROWING IN THE JOINTS.**

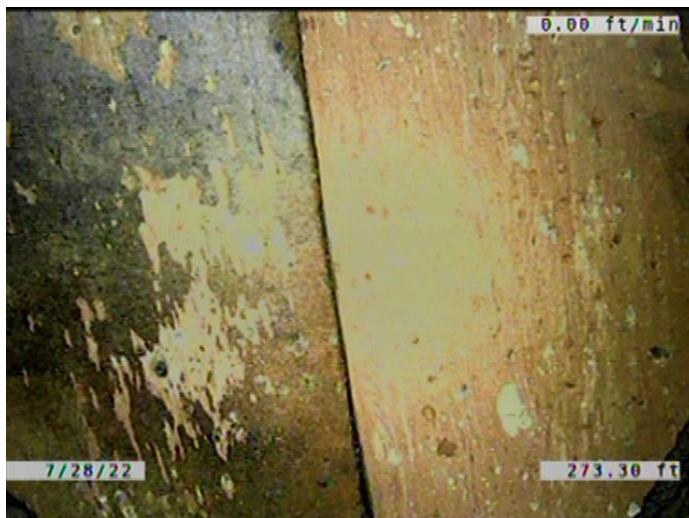
Code: **TBC**
 Description: **Tap Break-in Capped**

Distance (ft): **273.3**
 Structural Grade: **0**
 O&M Grade: **0**
 Clock Start/From: **10**
 Clock To:
 1st Value: **6.000**
 2nd Value:
 Value Percent:
 Continuous Index:
 Within 8" of Joint: **YES**
 Remarks:

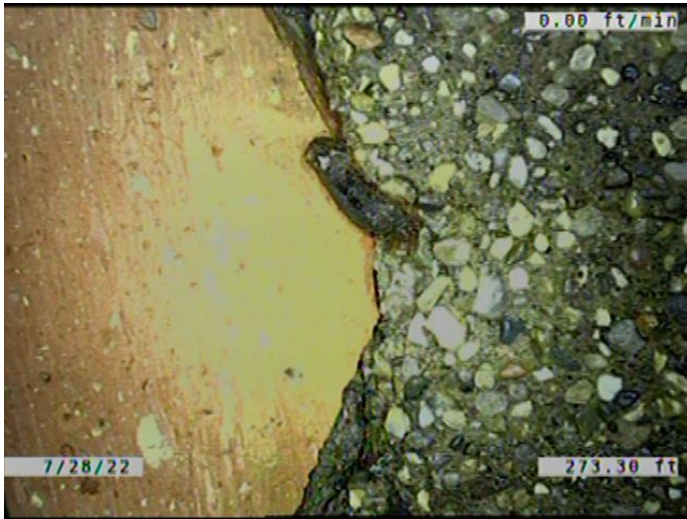
Code: **SRP**
 Description: **Surface Damage Reinforcement Projecting**

Distance (ft): **273.3**
 Structural Grade: **5**
 O&M Grade: **0**
 Clock Start/From: **10**
 Clock To:
 1st Value:
 2nd Value:
 Value Percent:
 Continuous Index:
 Within 8" of Joint: **YES**
 Remarks:

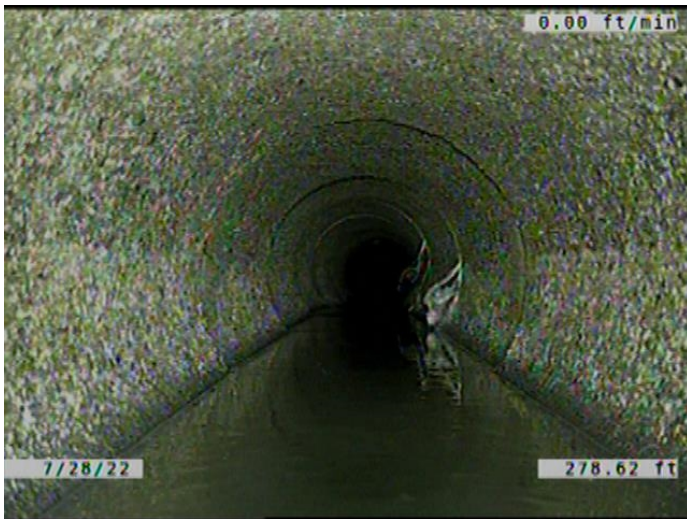
Code: **MWL**
 Description: **Miscellaneous Water Level**

Distance (ft): **278.6**
 Structural Grade: **0**
 O&M Grade: **0**
 Clock Start/From:
 Clock To:
 1st Value:
 2nd Value:
 Value Percent: **15.000**
 Continuous Index:
 Within 8" of Joint: **NO**
 Remarks:

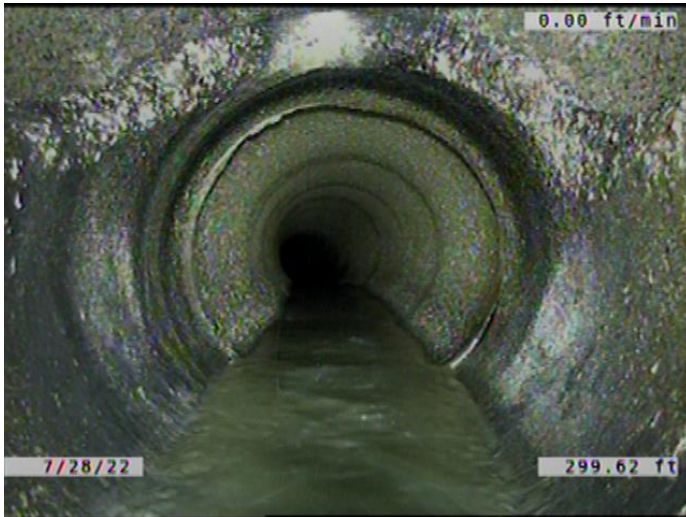
Code: **ISB**
 Description: **Infiltration Stain Barrel**

Distance (ft): **299.6**
 Structural Grade: **0**
 O&M Grade: **1**
 Clock Start/From: **8**
 Clock To: **2**
 1st Value:
 2nd Value:
 Value Percent:
 Continuous Index: **F01**
 Within 8" of Joint: **YES**
 Remarks:

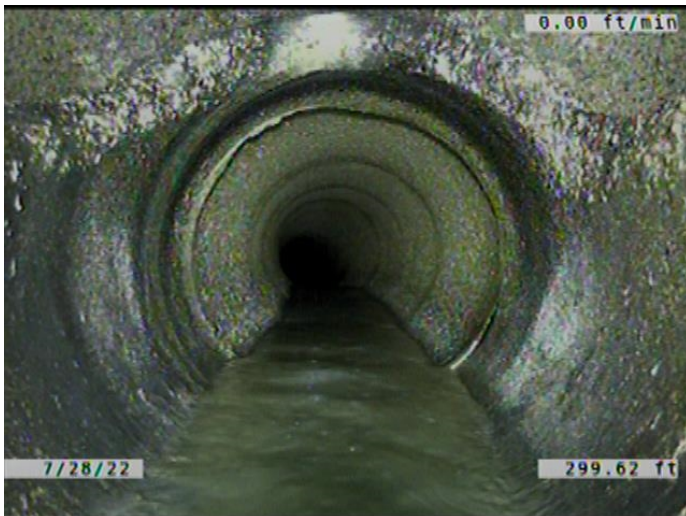
Code: **RMJ**
 Description: **Roots Medium Joint**

Distance (ft): **299.6**
 Structural Grade: **0**
 O&M Grade: **3**
 Clock Start/From: **8**
 Clock To: **4**
 1st Value:
 2nd Value:
 Value Percent: **5.000**
 Continuous Index: **F03**
 Within 8" of Joint: **YES**
 Remarks:

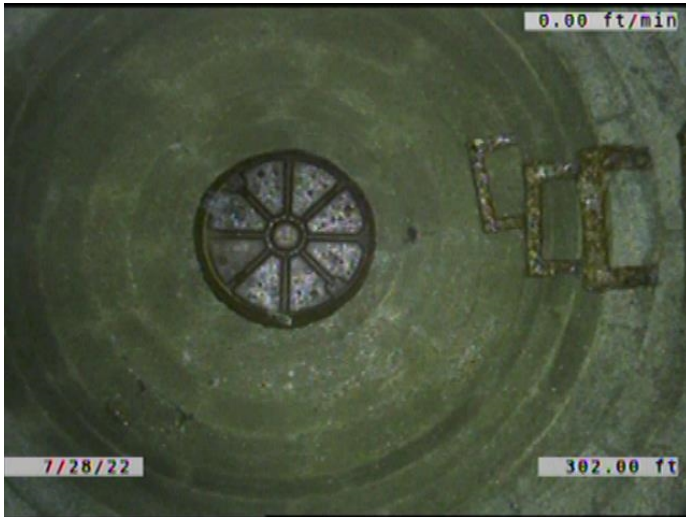
Code:	AMH
Description:	Manhole
Distance (ft):	302.0
Structural Grade:	0
O&M Grade:	0
Clock Start/From:	
Clock To:	
1st Value:	
2nd Value:	
Value Percent:	
Continuous Index:	
Within 8" of Joint:	NO
Remarks:	M-405-069
