Profile/Photo Observation Report

Date:	04/25/2018	Weather:		Coding:	PACP 6.0
Pipe Length (ft):		Owner:	City of Hobart	Pre Clean:	No Pre-Cleaning
P.O.#:	82	Surveyor:	M. Pielacha	PSR:	P-405-010-008
Customer:	City of Hobart	Clean Date:		Shape:	C

Street:	3rd Street	Flow Control:	Not Controlled
City:	Hobart, IN	Year Renewed:	
Location:	Light Highway	Tape/Media #:	DEP 82
Purpose:	Routine Assessment	Dia/Height:	15"
Use:	Sanitary	Material:	CP
Drain Area:		Lining:	
Category:	NA		
Comment:	YES501824 Submittal 2		
Location Details:		Direction of Survey:	Downstream
US MH:	M-405-010	DS MH:	M-405-008
		Total Length Surveyed (ft):	99.4

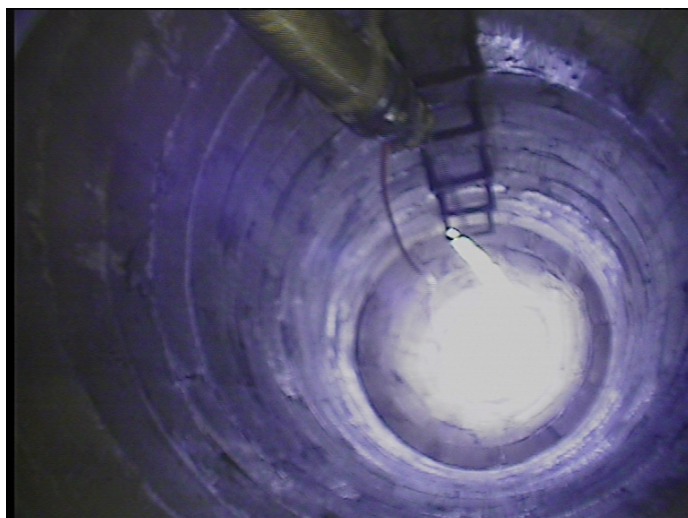
Code: **AMH**
 Description: **Manhole**

Distance (ft): **.0**
 Structural Grade: **0**
 O&M Grade: **0**
 Clock Start/From:
 Clock To:
 1st Value:
 2nd Value:
 Value Percent:
 Continuous Index:
 Within 8" of Joint: **NO**
 Remarks: **M-405-010**

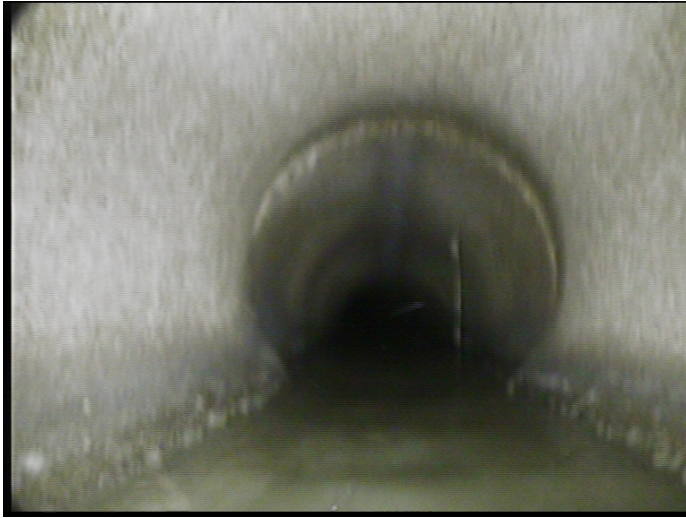
Code:	MWL
Description:	Water Level
Distance (ft):	.0
Structural Grade:	0
O&M Grade:	0
Clock Start/From:	
Clock To:	
1st Value:	
2nd Value:	
Value Percent:	10.000
Continuous Index:	
Within 8" of Joint:	NO
Remarks:

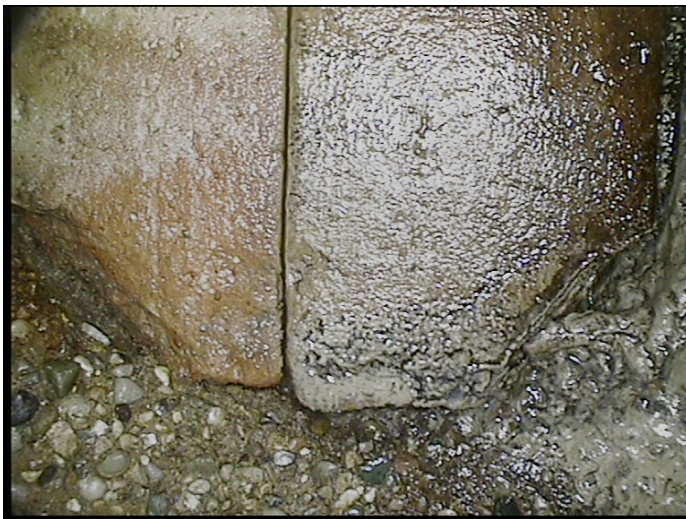
Code:	RPP
Description:	Repair Patch
Distance (ft):	31.0
Structural Grade:	0
O&M Grade:	0
Clock Start/From:	2
Clock To:	4
1st Value:	
2nd Value:	
Value Percent:	
Continuous Index:	
Within 8" of Joint:	NO
Remarks:	repair

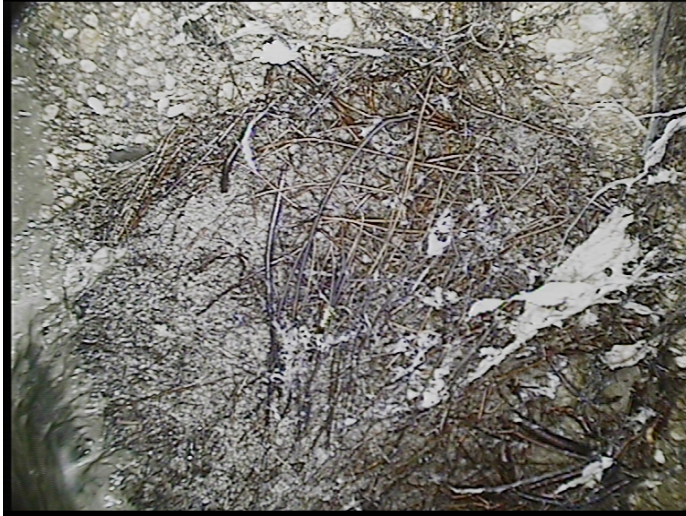
Code: **RMJ**
Description: **Roots Medium Joint**

Distance (ft): **33.1**
Structural Grade: **0**
O&M Grade: **3**
Clock Start/From: **7**
Clock To: **10**
1st Value:
2nd Value:
Value Percent: **5.000**
Continuous Index:
Within 8" of Joint: **YES**
Remarks:

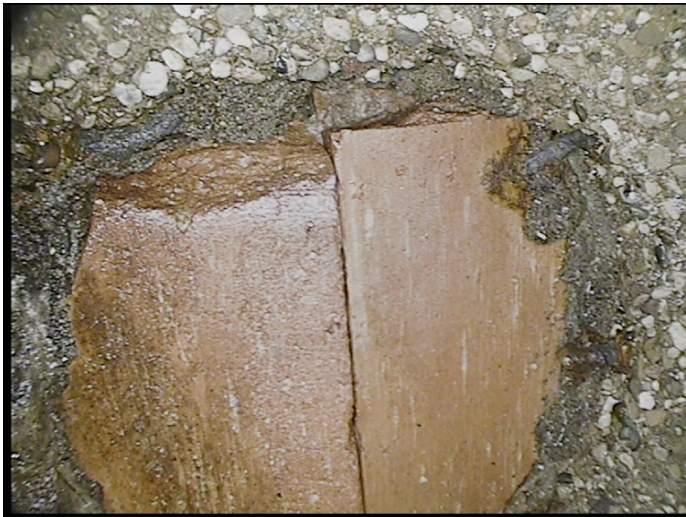
Code: **RPP**
Description: **Repair Patch**

Distance (ft): **36.5**
Structural Grade: **0**
O&M Grade: **0**
Clock Start/From: **7**
Clock To: **10**
1st Value:
2nd Value:
Value Percent:
Continuous Index:
Within 8" of Joint: **YES**
Remarks: **repair**

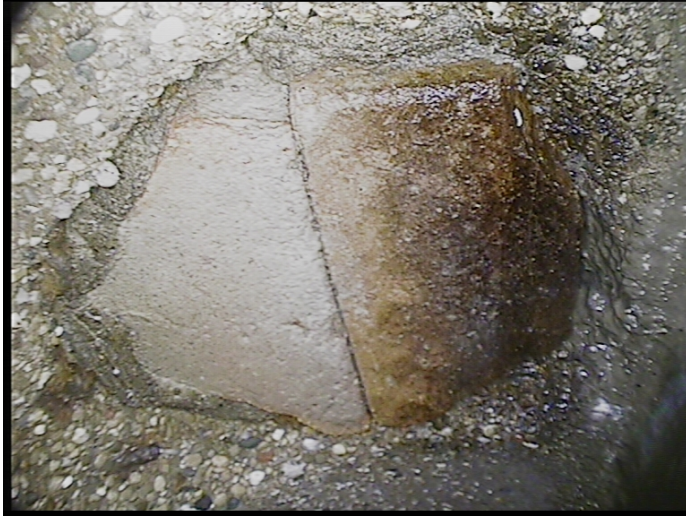
Code:	RPP
Description:	Repair Patch
Distance (ft):	48.4
Structural Grade:	0
O&M Grade:	0
Clock Start/From:	2
Clock To:	4
1st Value:	
2nd Value:	
Value Percent:	
Continuous Index:	
Within 8" of Joint:	YES
Remarks:	repair

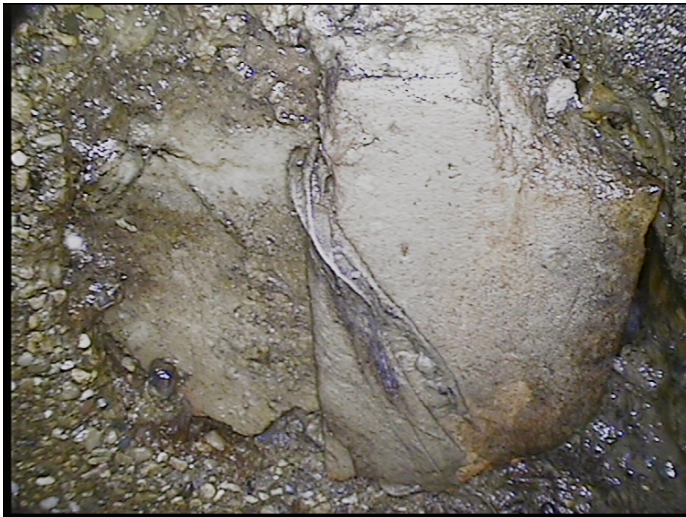
Code:	TFC
Description:	Tap Factory Capped
Distance (ft):	51.7
Structural Grade:	0
O&M Grade:	0
Clock Start/From:	3
Clock To:	
1st Value:	4.000
2nd Value:	
Value Percent:	
Continuous Index:	
Within 8" of Joint:	NO
Remarks:

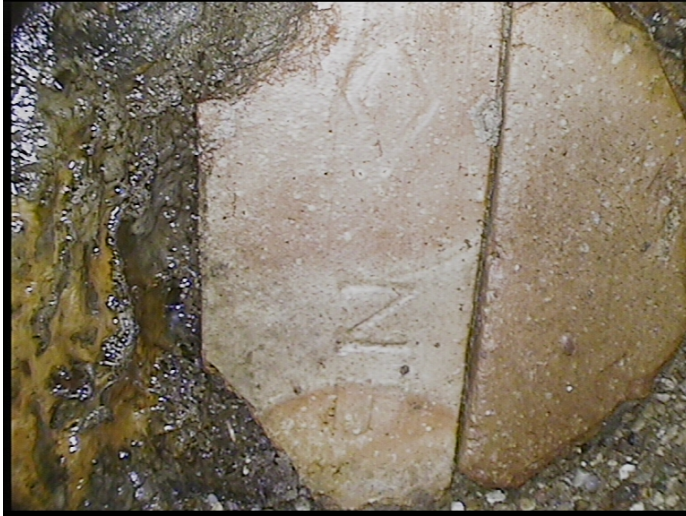
Code: **TFC**
Description: **Tap Factory Capped**

Distance (ft): **55.0**
Structural Grade: **0**
O&M Grade: **0**
Clock Start/From: **9**
Clock To:
1st Value: **6.000**
2nd Value:
Value Percent:
Continuous Index:
Within 8" of Joint: **NO**
Remarks:

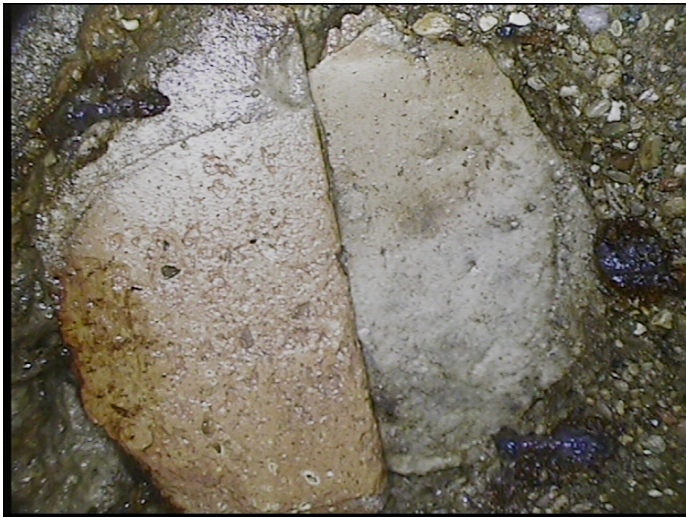
Code: **TFC**
Description: **Tap Factory Capped**

Distance (ft): **57.9**
Structural Grade: **0**
O&M Grade: **0**
Clock Start/From: **10**
Clock To:
1st Value: **4.000**
2nd Value:
Value Percent:
Continuous Index:
Within 8" of Joint: **NO**
Remarks:

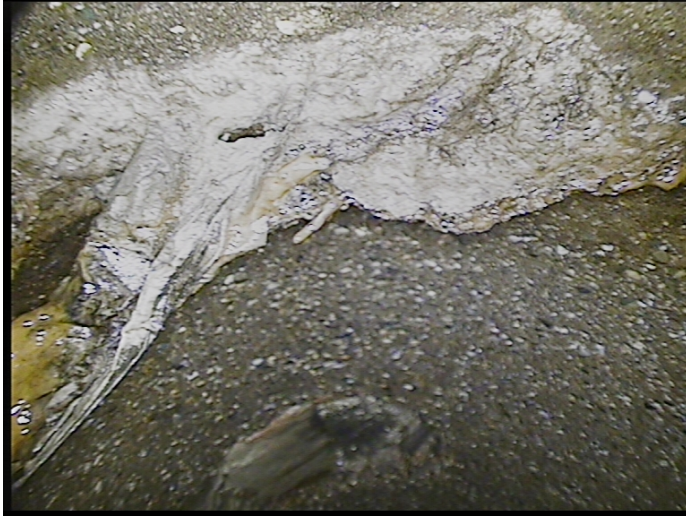
Code:	DAE
Description:	Deposits Attached Encrustation
Distance (ft):	65.4
Structural Grade:	0
O&M Grade:	2
Clock Start/From:	7
Clock To:	11
1st Value:	
2nd Value:	
Value Percent:	5.000
Continuous Index:	
Within 8" of Joint:	YES
Remarks:

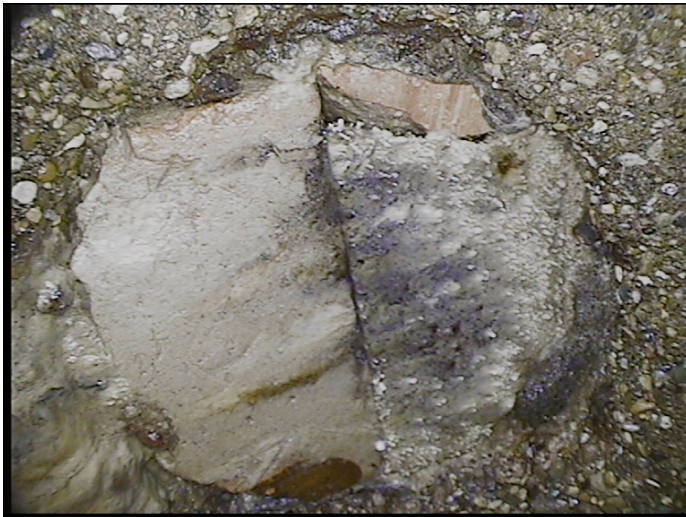
Code:	TFC
Description:	Tap Factory Capped
Distance (ft):	67.0
Structural Grade:	0
O&M Grade:	0
Clock Start/From:	10
Clock To:	
1st Value:	6.000
2nd Value:	
Value Percent:	
Continuous Index:	
Within 8" of Joint:	NO
Remarks:

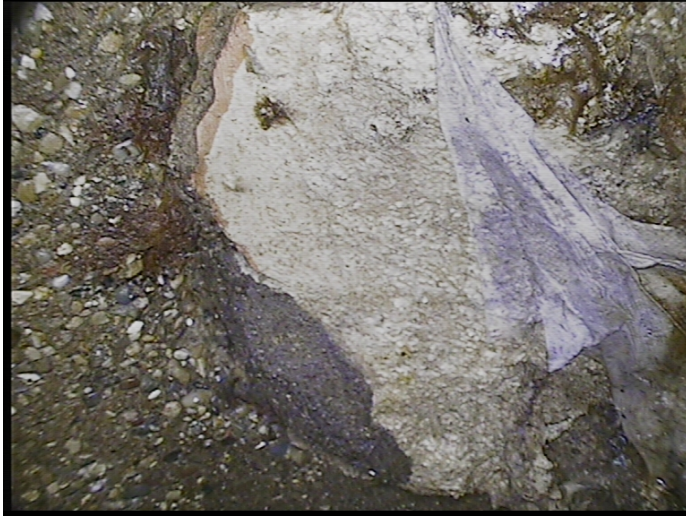
Code:	TFC
Description:	Tap Factory Capped
Distance (ft):	70.0
Structural Grade:	0
O&M Grade:	0
Clock Start/From:	3
Clock To:	
1st Value:	6.000
2nd Value:	
Value Percent:	
Continuous Index:	
Within 8" of Joint:	NO
Remarks:

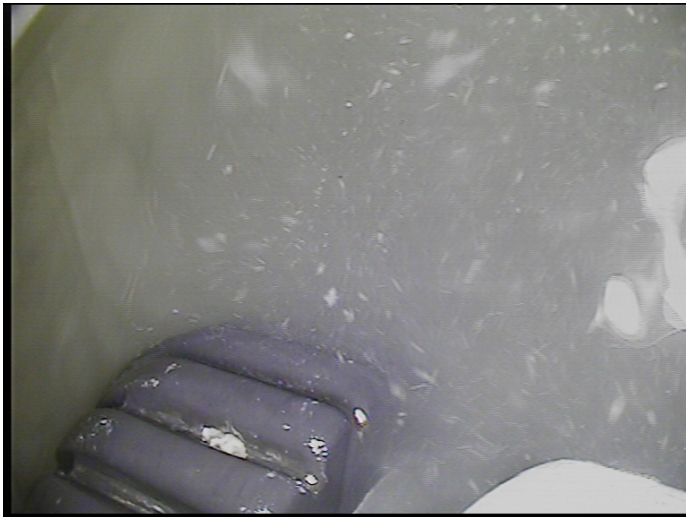
Code:	OBZ
Description:	Obstacle Other
Distance (ft):	99.4
Structural Grade:	0
O&M Grade:	2
Clock Start/From:	5
Clock To:	7
1st Value:	
2nd Value:	
Value Percent:	10.000
Continuous Index:	
Within 8" of Joint:	NO
Remarks:	underwater debris

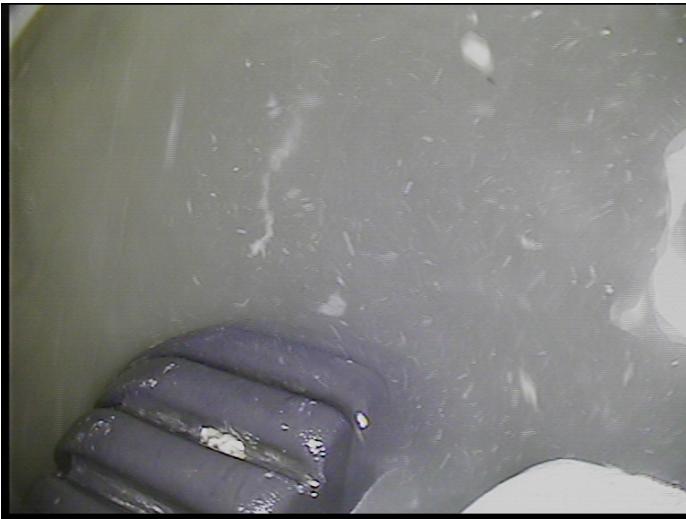
Code:	MSA
Description:	Abandoned Survey
Distance (ft):	99.4
Structural Grade:	0
O&M Grade:	0
Clock Start/From:	
Clock To:	
1st Value:	
2nd Value:	
Value Percent:	
Continuous Index:	
Within 8" of Joint:	NO
Remarks:	debris
