Profile/Photo Observation Report

Date:	04/25/2018	Weather:		Coding:	PACP 6.0
Pipe Length (ft):		Owner:	City of Hobart	Pre Clean:	No Pre-Cleaning
P.O.#:	81	Surveyor:	M. Pielacha	PSR:	P-405-011-010
Customer:	City of Hobart	Clean Date:		Shape:	C

Street:	3rd Street	Flow Control:	Not Controlled
City:	Hobart, IN	Year Renewed:	
Location:	Light Highway	Tape/Media #:	DEP 81
Purpose:	Routine Assessment	Dia/Height:	15"
Use:	Sanitary	Material:	CP
Drain Area:		Lining:	
Category:	NA		
Comment:	YES501824 Submittal 2		
Location Details:		Direction of Survey:	Downstream
US MH:	M-405-011	DS MH:	M-405-010
		Total Length Surveyed (ft):	235.2

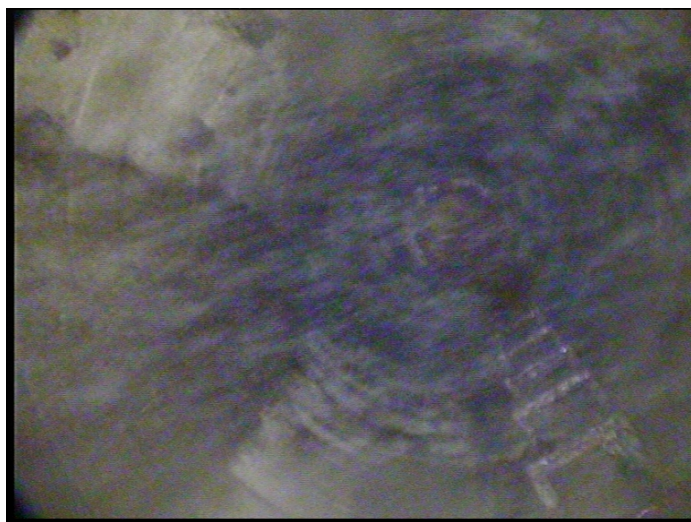
Code: **AMH**
Description: **Manhole**

Distance (ft): **.0**
Structural Grade: **0**
O&M Grade: **0**
Clock Start/From:
Clock To:
1st Value:
2nd Value:
Value Percent:
Continuous Index:
Within 8" of Joint: **NO**
Remarks: **M-405-011**

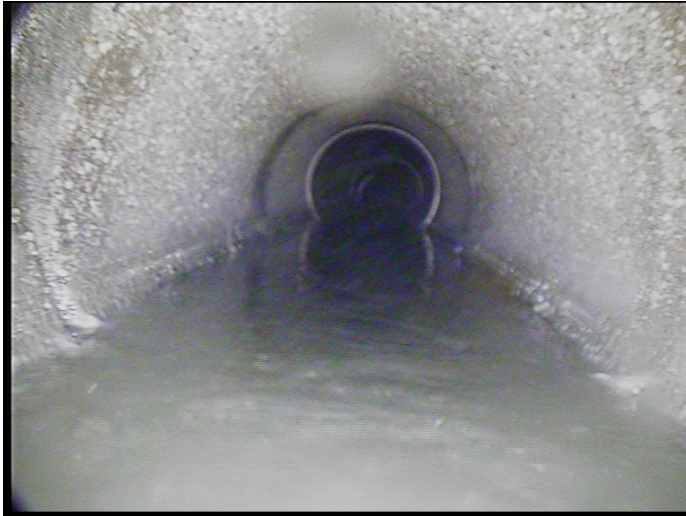
Code: **MWL**
Description: **Water Level**

Distance (ft): **.0**
Structural Grade: **0**
O&M Grade: **0**
Clock Start/From:
Clock To:
1st Value:
2nd Value:
Value Percent: **10.000**
Continuous Index:
Within 8" of Joint: **NO**
Remarks:

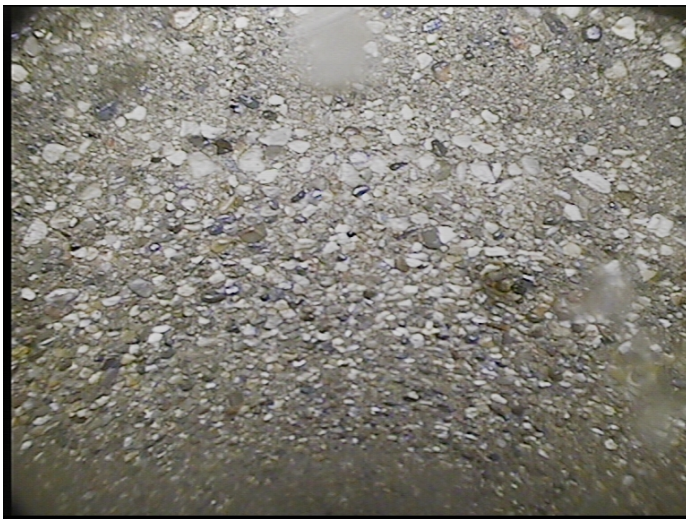
Code: **SAV**
Description: **Surface Aggregate Visible**

Distance (ft): **1.1**
Structural Grade: **3**
O&M Grade: **0**
Clock Start/From: **8**
Clock To: **4**
1st Value:
2nd Value:
Value Percent:
Continuous Index: **S01**
Within 8" of Joint: **YES**
Remarks:

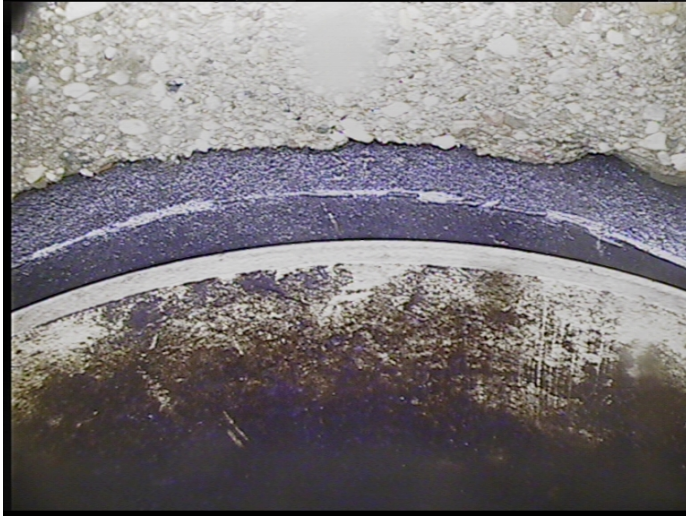
Code: **MMC**
Description: **Material Change**

Distance (ft): **7.0**
Structural Grade: **0**
O&M Grade: **0**
Clock Start/From:
Clock To:
1st Value:
2nd Value:
Value Percent:
Continuous Index:
Within 8" of Joint: **NO**
Remarks: **pvc**

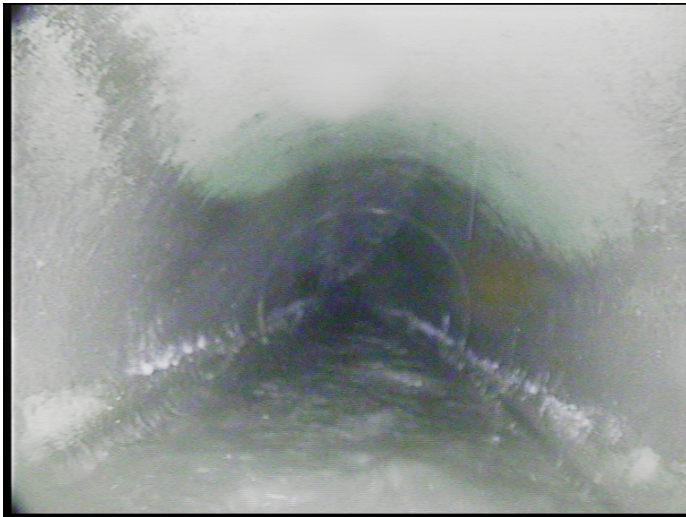
Code: **SAV**
Description: **Surface Aggregate Visible**

Distance (ft): **17.7**
Structural Grade: **3**
O&M Grade: **0**
Clock Start/From: **8**
Clock To: **4**
1st Value:
2nd Value:
Value Percent:
Continuous Index: **F01**
Within 8" of Joint: **NO**
Remarks:

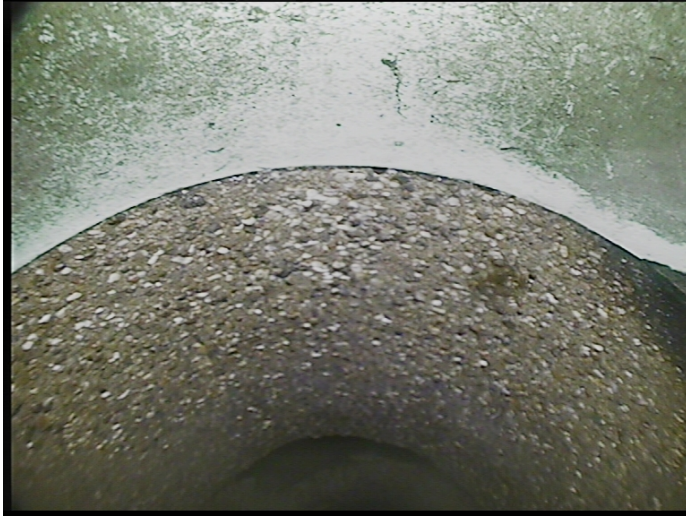
Code: **MMC**
Description: **Material Change**

Distance (ft): **232.6**
Structural Grade: **0**
O&M Grade: **0**
Clock Start/From:
Clock To:
1st Value:
2nd Value:
Value Percent:
Continuous Index:
Within 8" of Joint: **NO**
Remarks: **CP**

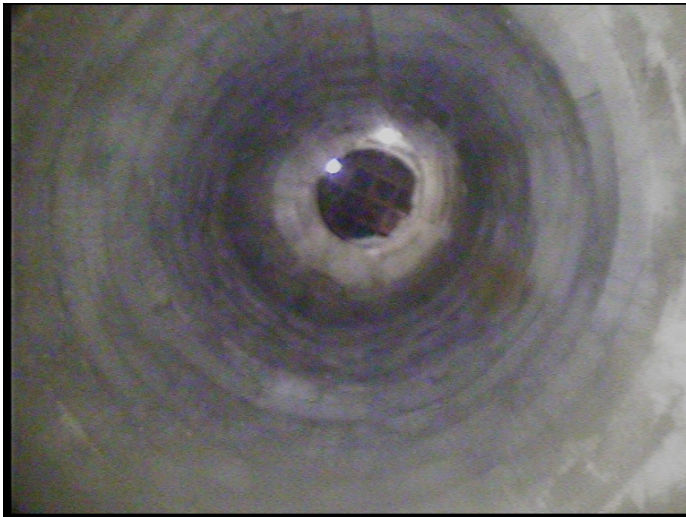
Code: **AMH**
Description: **Manhole**

Distance (ft): **235.2**
Structural Grade: **0**
O&M Grade: **0**
Clock Start/From:
Clock To:
1st Value:
2nd Value:
Value Percent:
Continuous Index:
Within 8" of Joint: **NO**
Remarks: **M-405-010**
